HABS OUTLINE

The Redeemer Presbyterian Church and Fellowship Hall (HABS number)  
Location: 43 Wentworth Street, Charleston, SC 29401  
Present Owner: Holy Spirit Evangelical Lutheran Church  
Present Use: 43 Wentworth Street is used for its own church services and programs.  
Significance: The 43 Wentworth Street annex is currently undergoing the legal process of possibly being converted into a residential site. The Redeemer Presbyterian Church congregation is hoping to halt this process, and as a result this HABS report acts in part as a rescue preservation plan.

# Redeemer Episcopal Church and Annex

DOCUMENTARY DRAWINGS  
College of Charleston  
Program in Historic Preservation and Community Planning

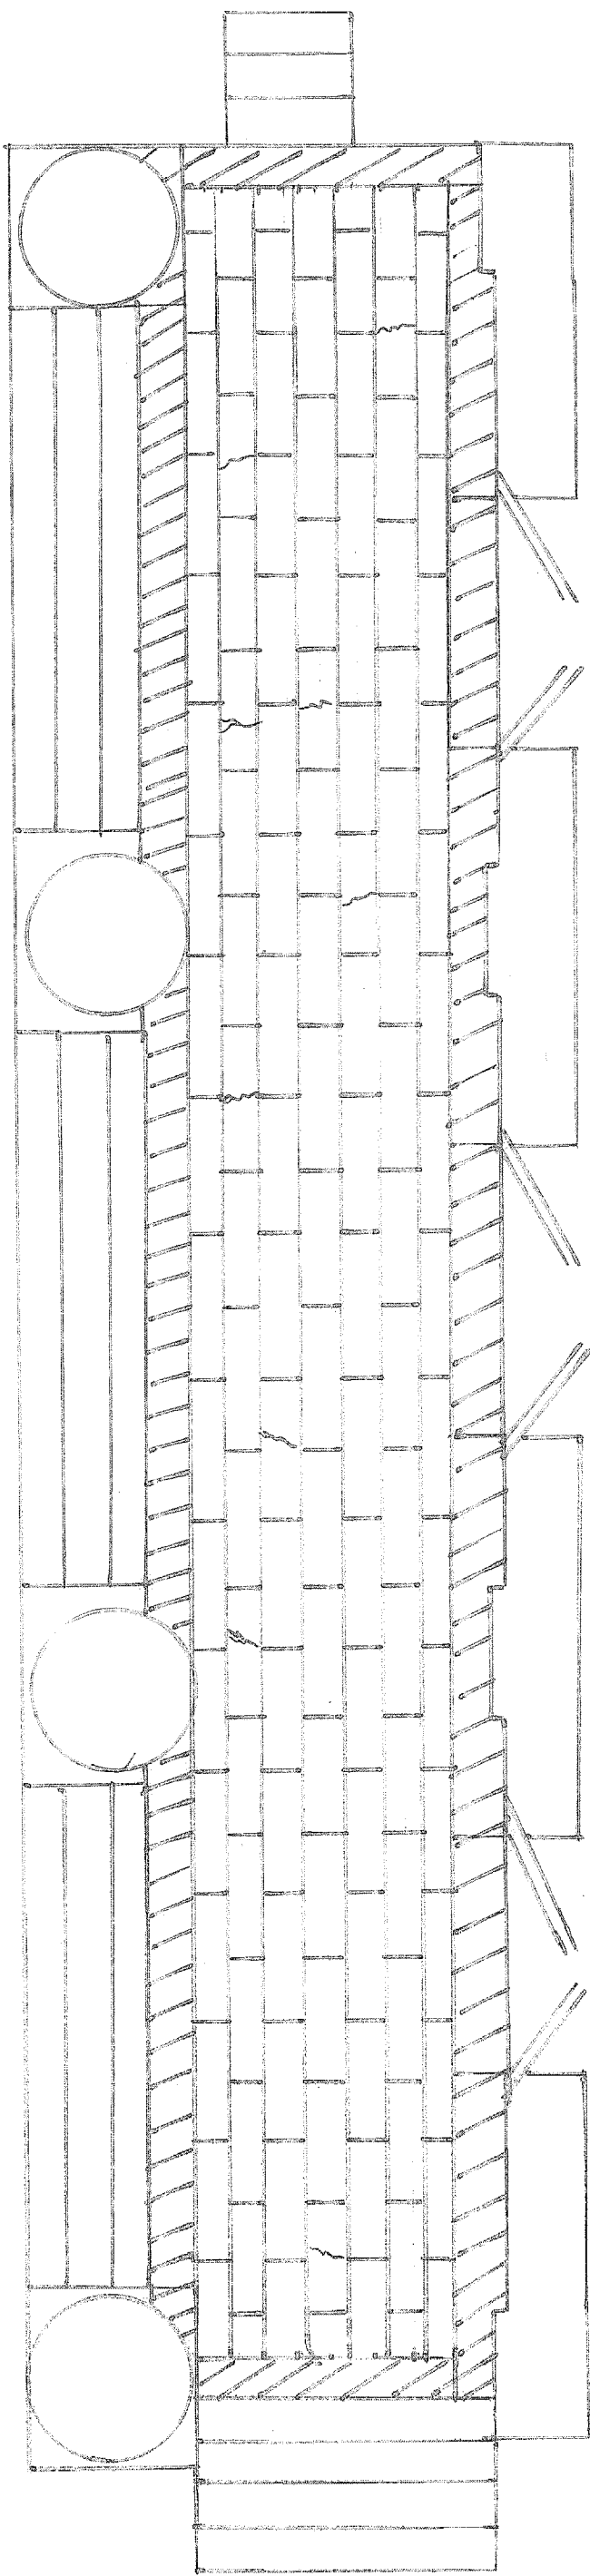
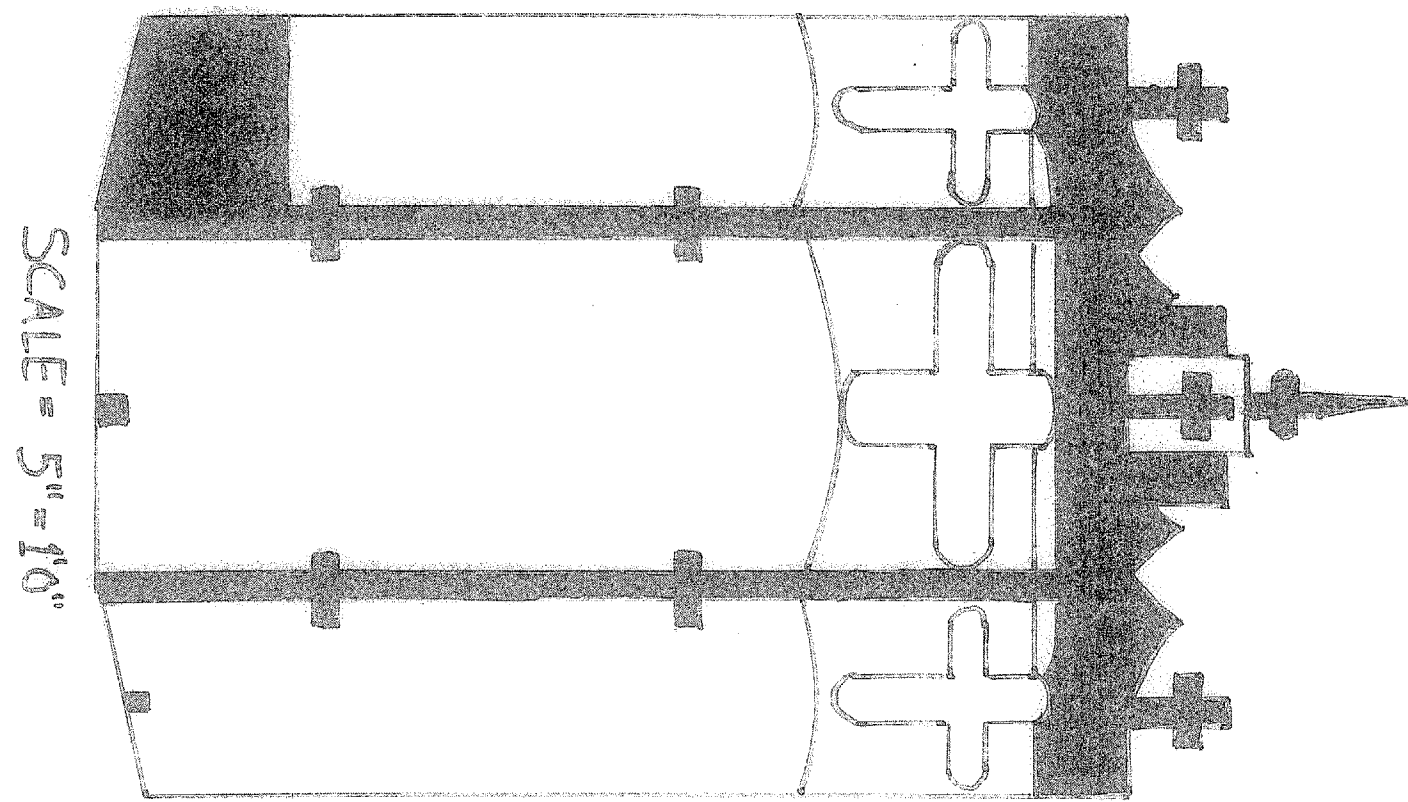
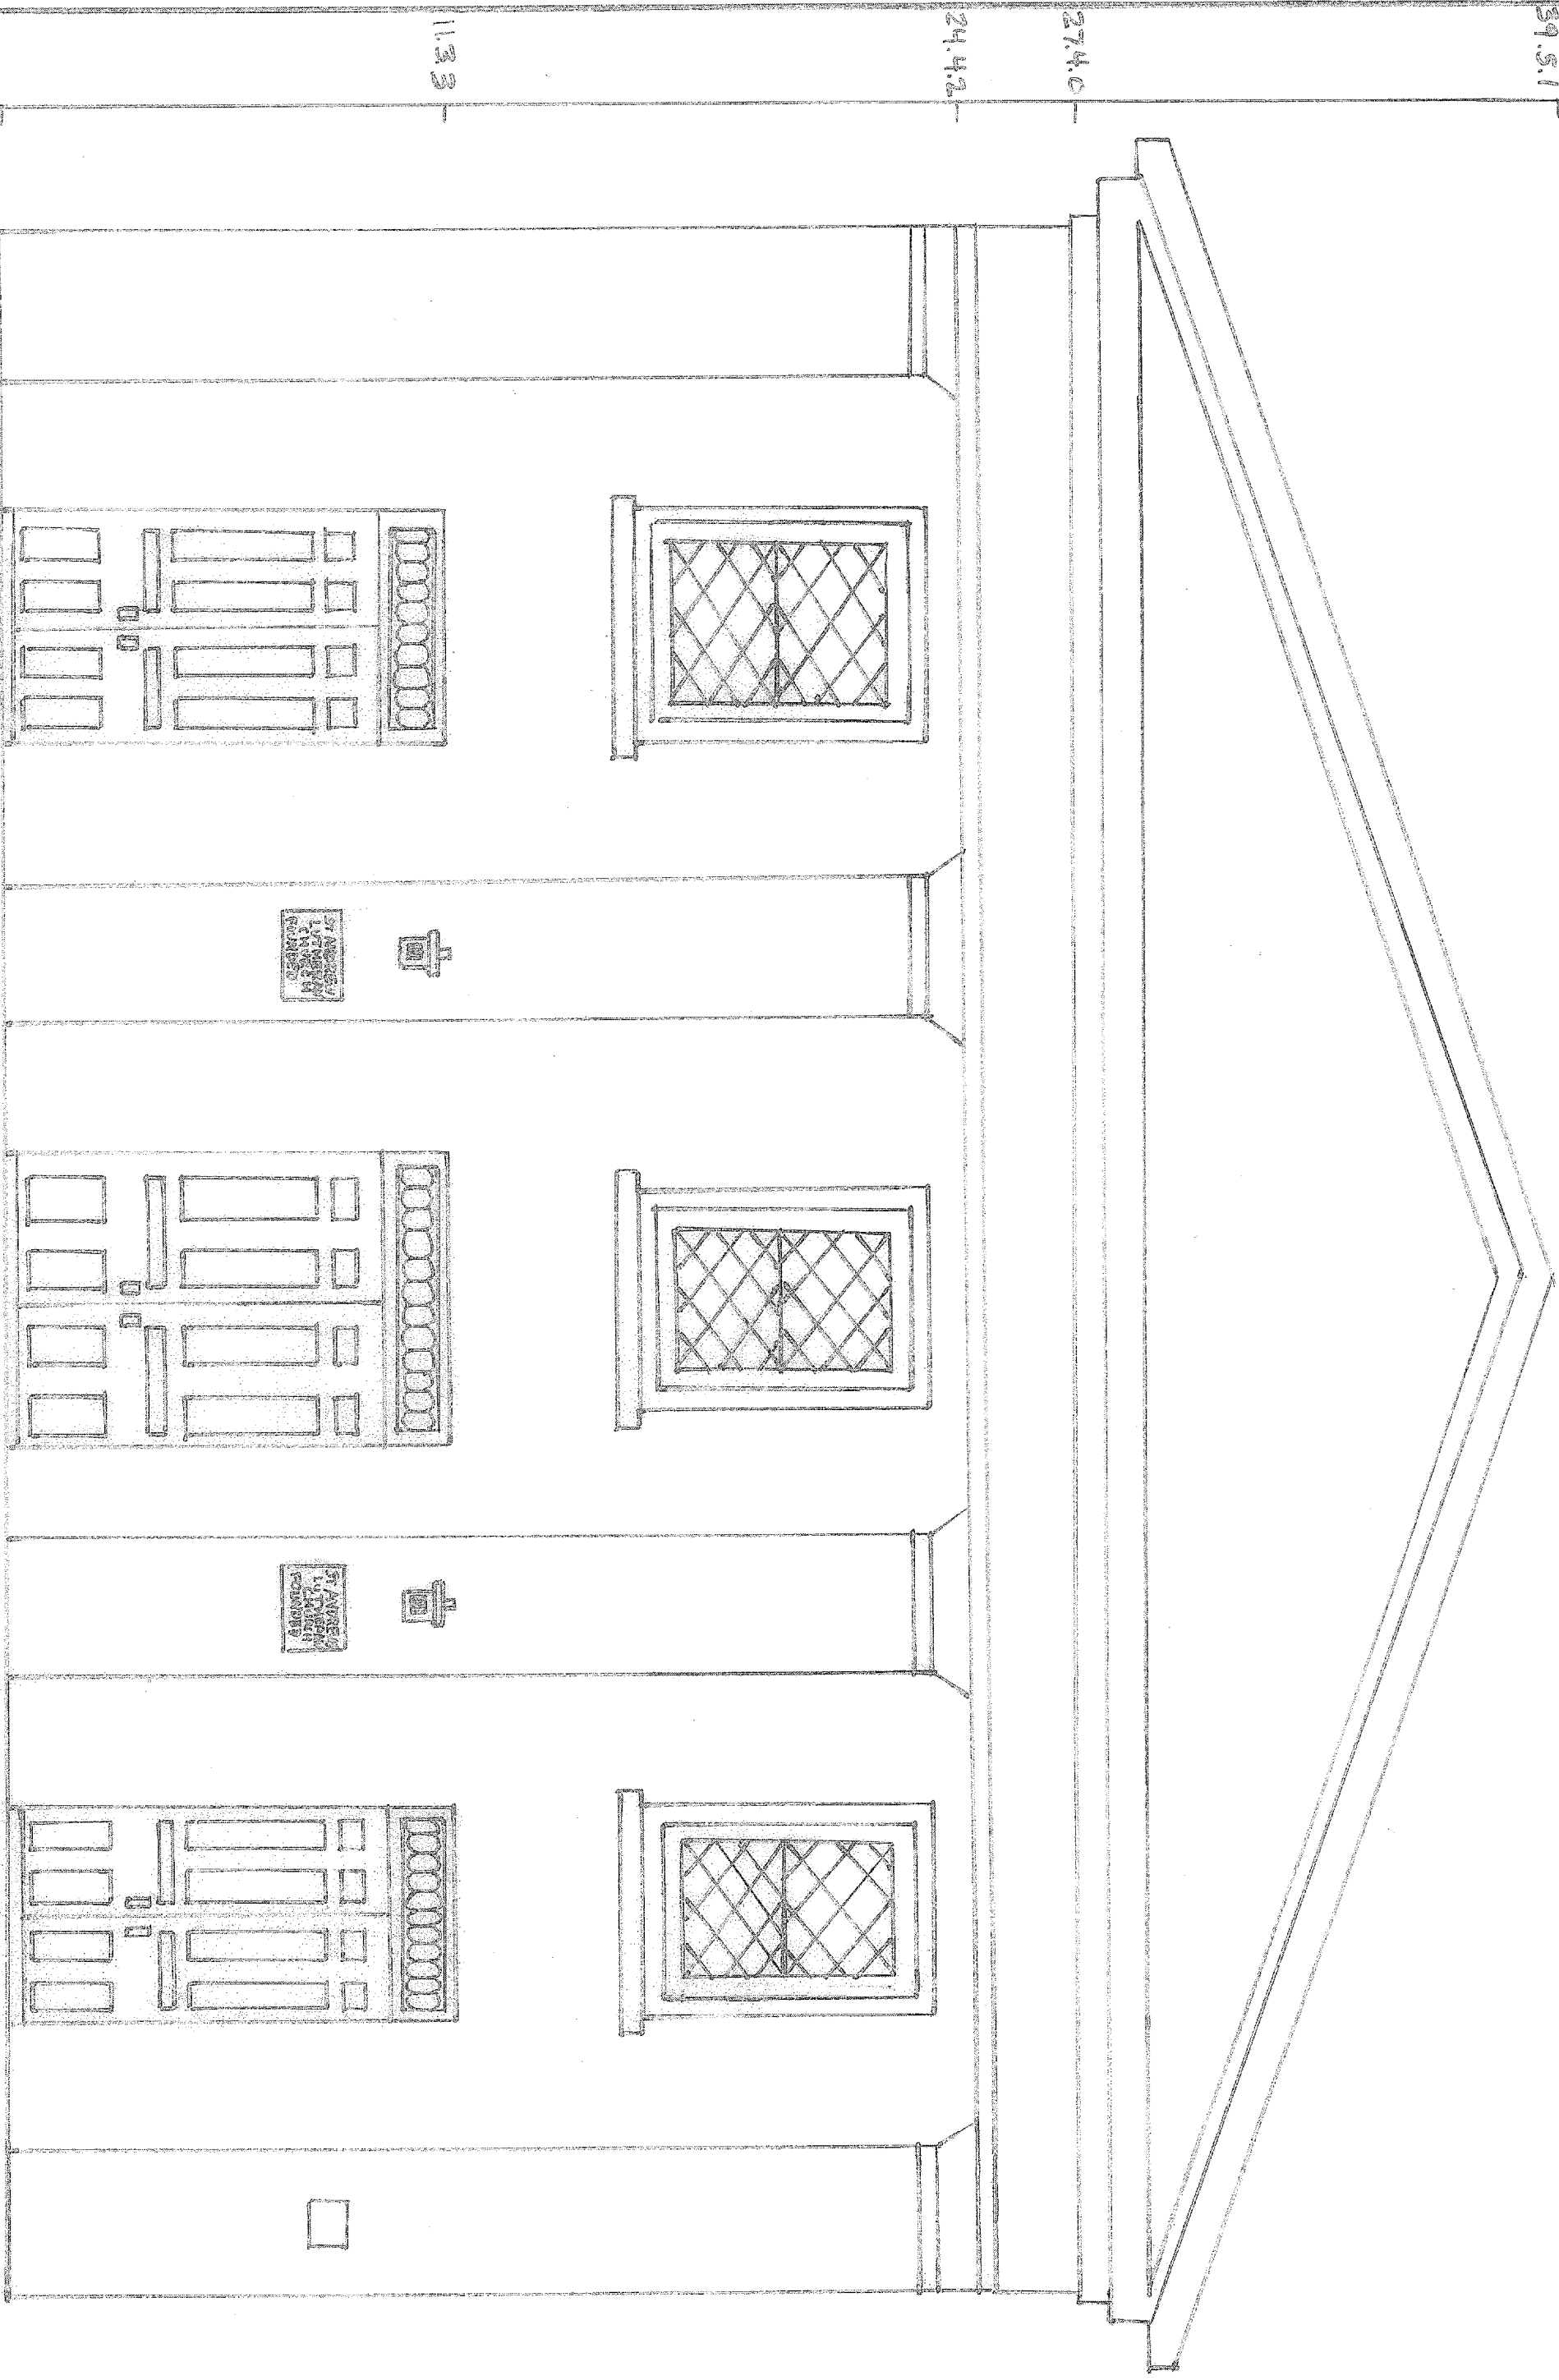
The portico on the front of the structure makes for an impressive entry into the church. It is made up of three stained glass windows on the balcony level, three main front doors, four support columns, granite and marble stone flooring, and beautifully custom made iron handrails and gates. On the exterior of the North facade hangs a couple of signs with St. Andrews Lutheran carved out of steel and lanterns to light them. The portico is structurally sound, however the floor has begun to crack over time. The granite surround of the floor does not seem to be damaged, but the marble inside of that has many breaks in the stone. This could be due to tremors from the earthquake of 1886 or winds from Hurricane Hugo. These natural disasters or possibly even human

based events could be responsible for these stones cracking in the portico. Regardless of the cause, it is most likely from the soil beneath the building's foundation settling. This allows air and open space to develop under the structure and the foundation is left with no support. As a whole, the building appears to be in sound structural condition.

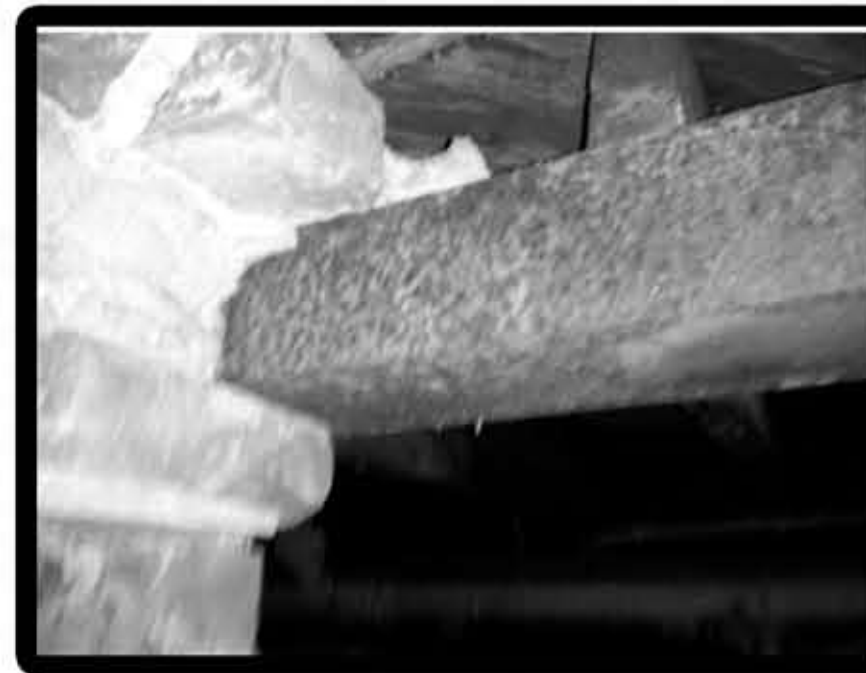
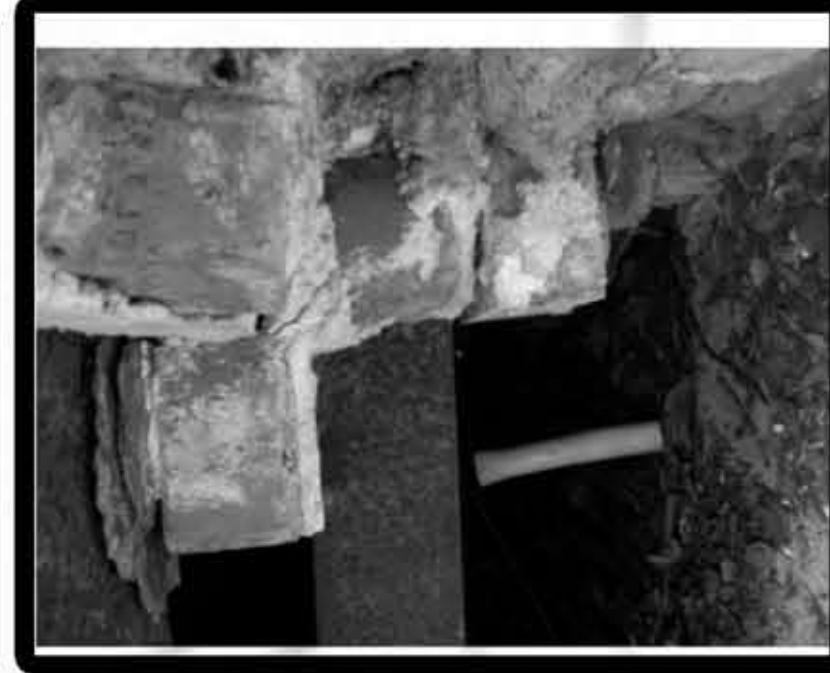
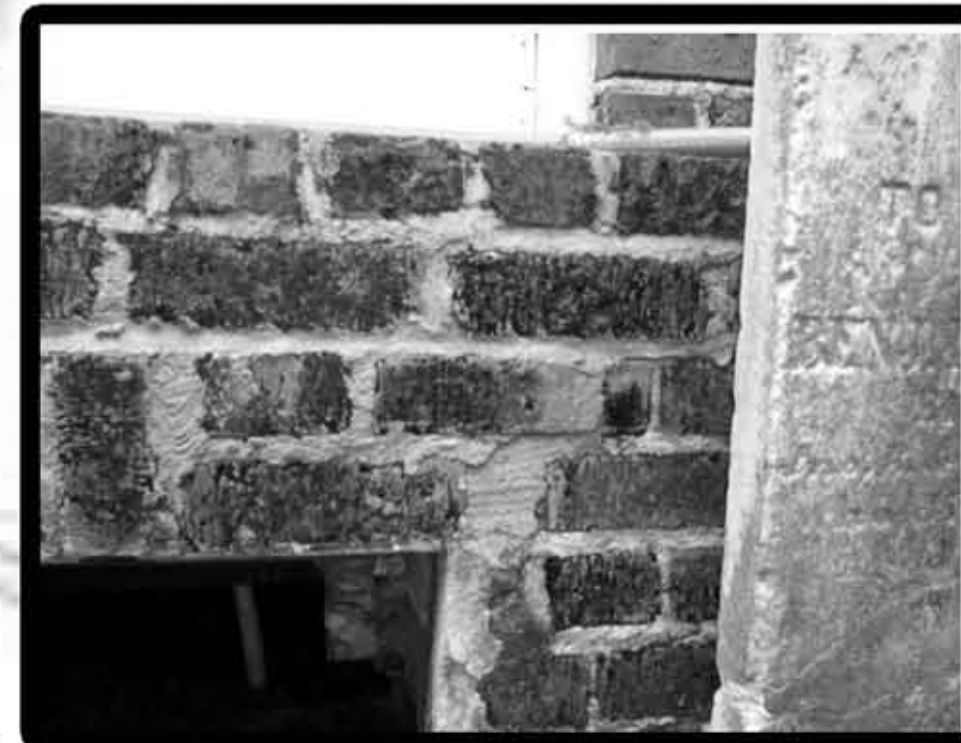
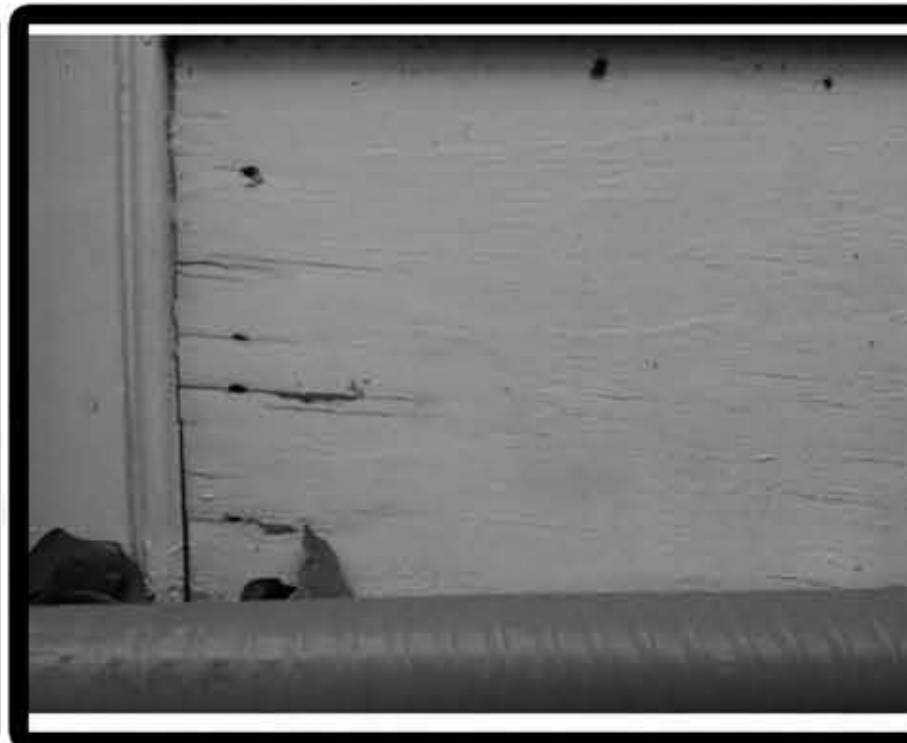
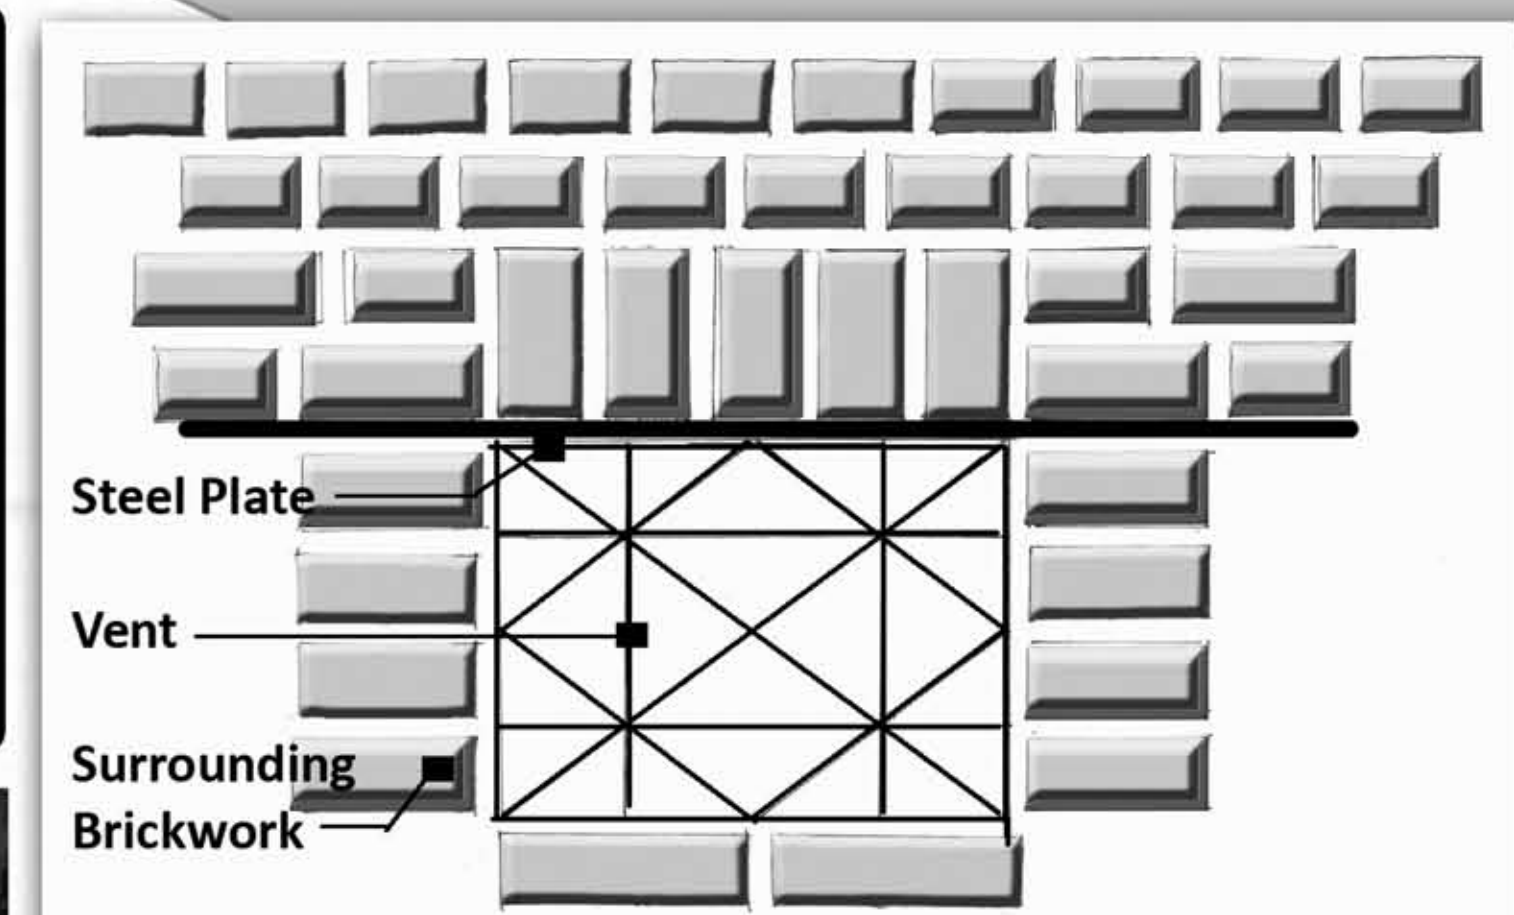
Redeemer Episcopal Church  
43 Wentworth St Charleston, SC

## Floor Problems

As I looked under the building and analyze the structure underneath, it was clear that there was a domino effect occurring, with one problem causing a buildup of other complications. an L-shaped iron beam under the building as well as each looked to be rusted, likely due to water damage. This can cause the rusted beam to expand, allowing for opportunities for water to seep between the bricks, causing separation and cracks in the brick. The steel angle bracket is also supporting the floor there which could cause additional problems if left unresolved.

## Rust Problems

There are significant portions of the façade brick that are being adversely affected by this rusting steel that is built into the wall. These steel pieces are primarily the plates above the vents all around the building. It is probable that this is caused by excessive moisture in the wall section from all the sources noted here. The continuing deterioration of the steel is causing it to expand further to further crack the mortar joints and opening the structure up to even more water intrusion.

## Recommendations

We are trying to take an incremental and observational approach to avoid excessive expense or changes. The following would be a reasonable approach:

1. Replace rusted steel throughout
2. Repoint brick
3. Rework brick along water table where bricks are sloping to the inside of the wall
4. Inspect wood structure for probable rot and remediation
5. Evaluate over time the internal moisture content of the wall for possible further action. This would necessitate taking internal moisture readings over time to develop an idea of what is going on. For example, it seems likely that excessive moisture is also entering the walls around the windows especially on the North elevation. If this is so then some consideration for storm windows may also be appropriate. The wood issues are beyond the scope of this evaluation; however, it may have some bearing indirectly.

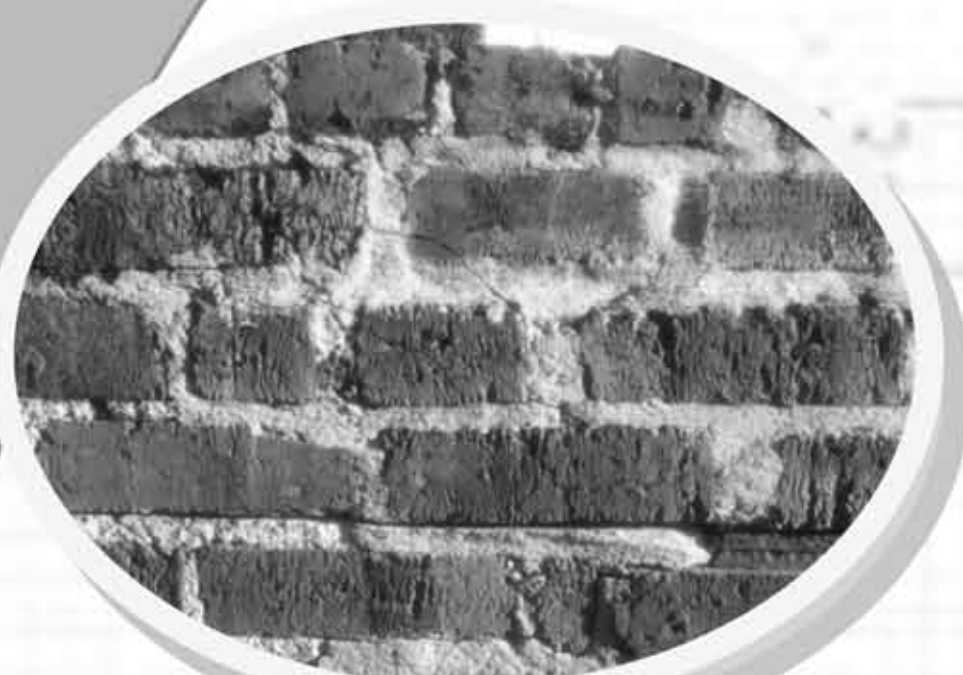
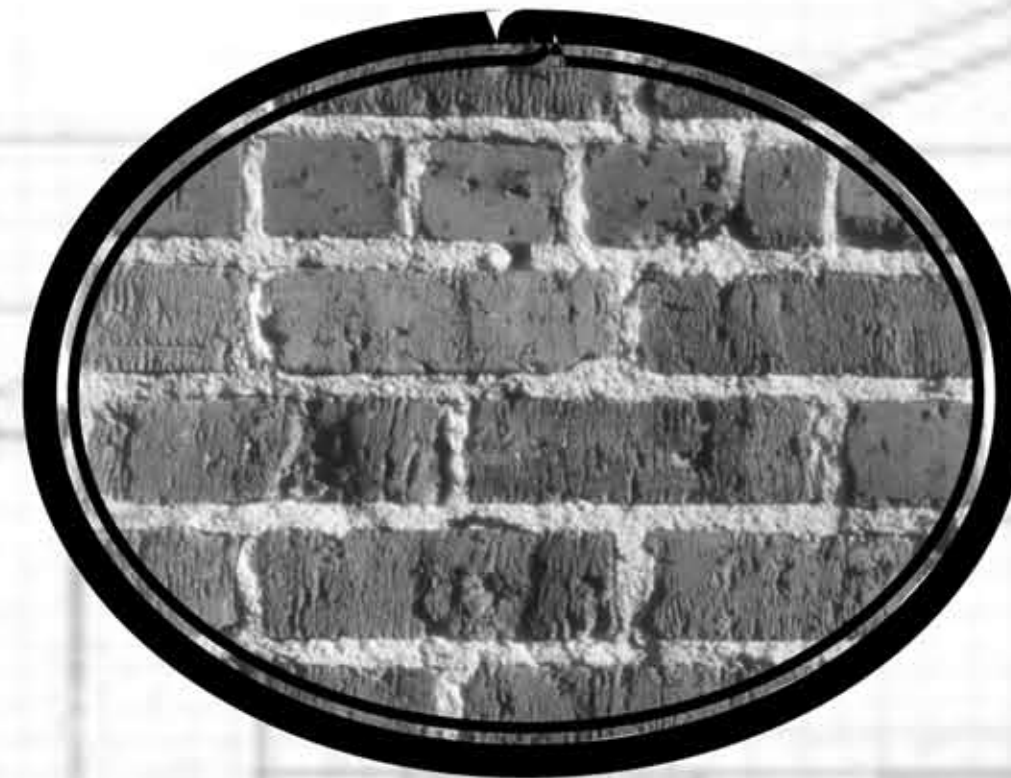
It is also likely that the wood floor joists are adversely affected by the excessive moisture content in the walls especially on the north wall which is also the most inaccessible to inspection. As such, we have not been able to evaluate this further.

## Repointing

Every so often, the joints between bricks are worn away due to weathering that occurs naturally due to wind and rain and are repointed as such. When pointing, it is necessary that one matches the color and has a mortar mix similar to the one that was originally used on the house. On the Fellowship Hall, there is evidence of poor pointing done on areas of the wall. The original mortar on the wall had a higher composition of sand in the mix, giving off a tan color with remnants of pebbles embedded in the wall. The repointed sections are done most likely with Portland Cement, which gives off a grayish color. The mortar is touching the outside face of the brick and is overfilled in the joints. In this situation, It is necessary to repoint the areas of the wall that are messy. The new mortar would needs to match the old as best as possible, and it would be evenly distributed. The bricks should be brushed when pointing to remove any mortar that touches the outer face. The new batch has to be at the right consistency as to prevent water from passing through

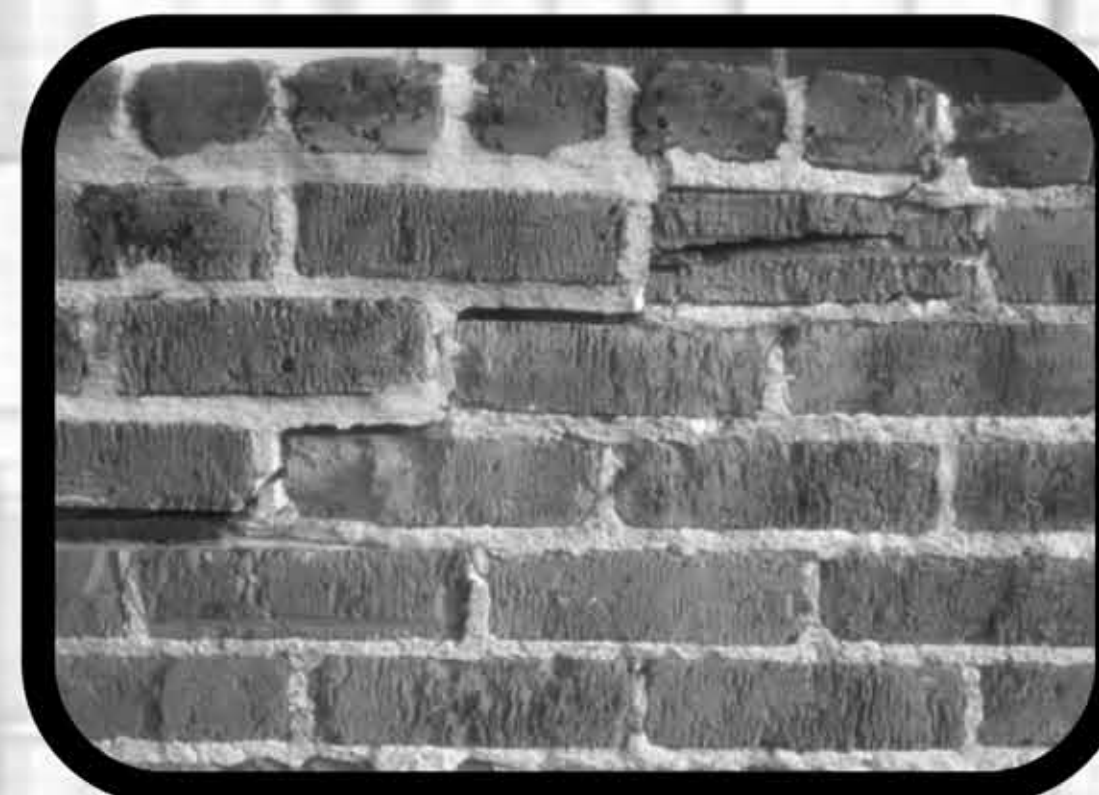
## Cracks

Throughout the façade, cracks and gaps are forming , creating chances of more damage that can be done to the brick. Gaps in the bricks permits water to enter, which through contraction and expansion, causes bricks to become soft and break. This is known as “spalling”. If this occurs, It could be handled by replacing the brick and repositioning the brick and close up the cracks. The “Stair-Step” cracks that were found could be due to settling or thermal expansion. The frames on the gate-like vents have rusted, which when in contact with water, has great lifting power and can expand as well, ultimately causing cracking. Another possibility is that earthquake damage could have been the cause of some the cracks as well. Under one of the windows, water penetration has expanded the bricks and cause them to bulge and lean toward the structure, which if rain water were to fall on the brick, it would drain into the wood, causing them to rot and be replaced. Evidence suggest that many of the wood is rotted on the outside and/or has been replaced. I was unable to go underneath the house to determine if the interior play a role on the exterior problems so that is an issue that is not ruled out until there is time to investigate.
