| JAMES L. WARD<br>ASSISTANT PROFESSOR<br><br>COLLEGE OF CHARLESTON<br>ARTH 299-001 FALL 2007<br><br>HISTORIC PRESERVATION &<br>COMMUNITY PLANNING | | LANCE HALL & ADDITION<br>MEETING STREET - CHARLESTON, SC | |
| ASSIGNMENT NO: 5 | | DRAWING TITLE:<br><b>FINAL SITE PLAN<br/>LANCE HALL &amp; ADDITION</b> | |
| DATE: 11.09.07 | | DRAWING PREPARED BY (TEAM/INDIVIDUAL):<br>G. BROWN, B. L'HULLIER, A. MILLER, P. REED | |

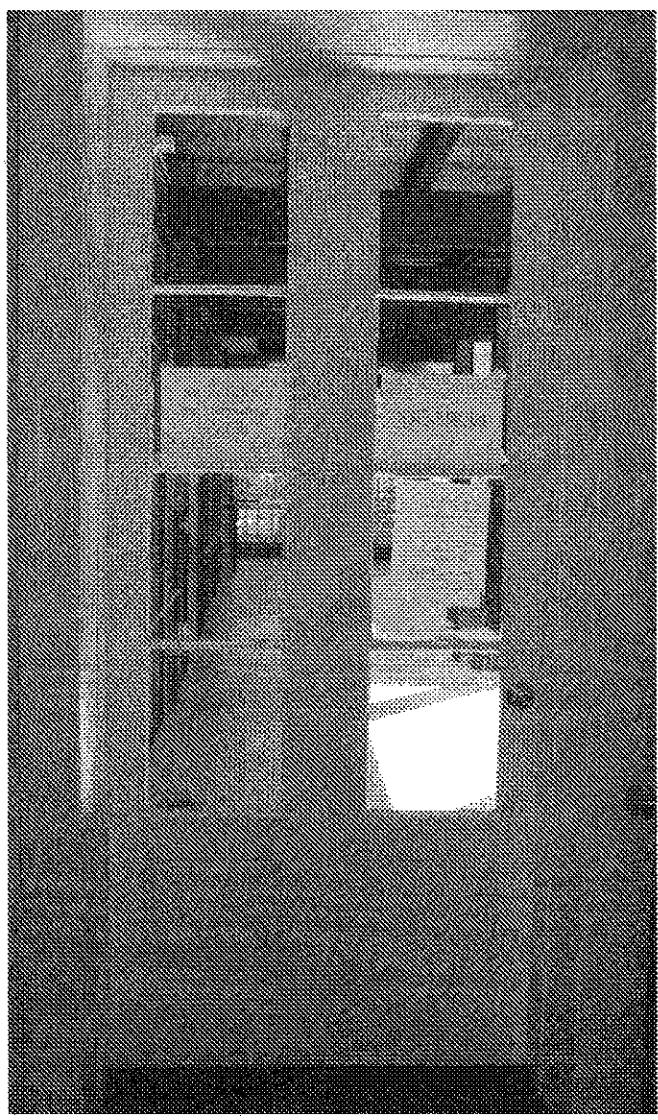
**ABOVE:**  
THIS PHOTOGRAPH IS AN INTERIOR ELEVATION OF THE DOOR TO ILLUSTRATE THE SLIGHT DIFFERENCE IN THE TRIM AND SURROUND OF THE DOOR. FROM THE INTERIOR, ONE CAN VIEW THE BREEZEWAY THAT LEADSTO THE ELEVATOR SHAFT.

**RECOMMENDATIONS**  
ALTHOUGH THIS DOOR ACCOMODATES THE MODERN LOOK OF THE NEW GREEN ADDITION, THE DOOR LACKS TRUE HARMONY WITH THE HISTORIC LANCE HALL. THE DOOR HAS A SLIGHT HISTORIC LOOK: THERE IS AN INDENTION DOWN THE CENTER TO SIMULATE TWO PANELS, SIMILAR TO THE HISTORIC DOORS AROUND DOWNTOWN CHARLESTON. A REPLACEMENT DOOR TO COORDINATE WITH THE DARK DOORS UNDER THE PORTICO OF LANCE HALL WOULD ACHIEVE HARMONY ON THE CHURCH SITE.

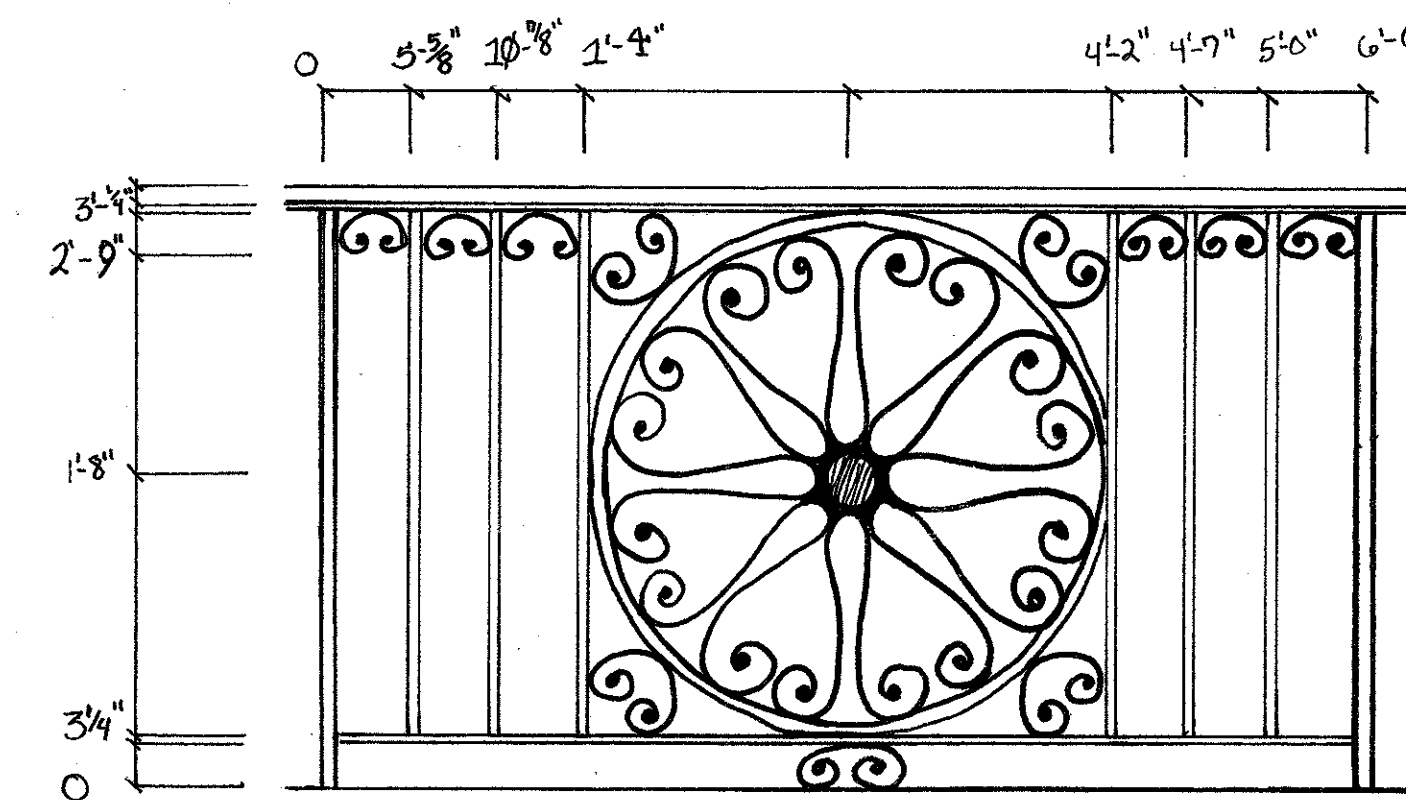
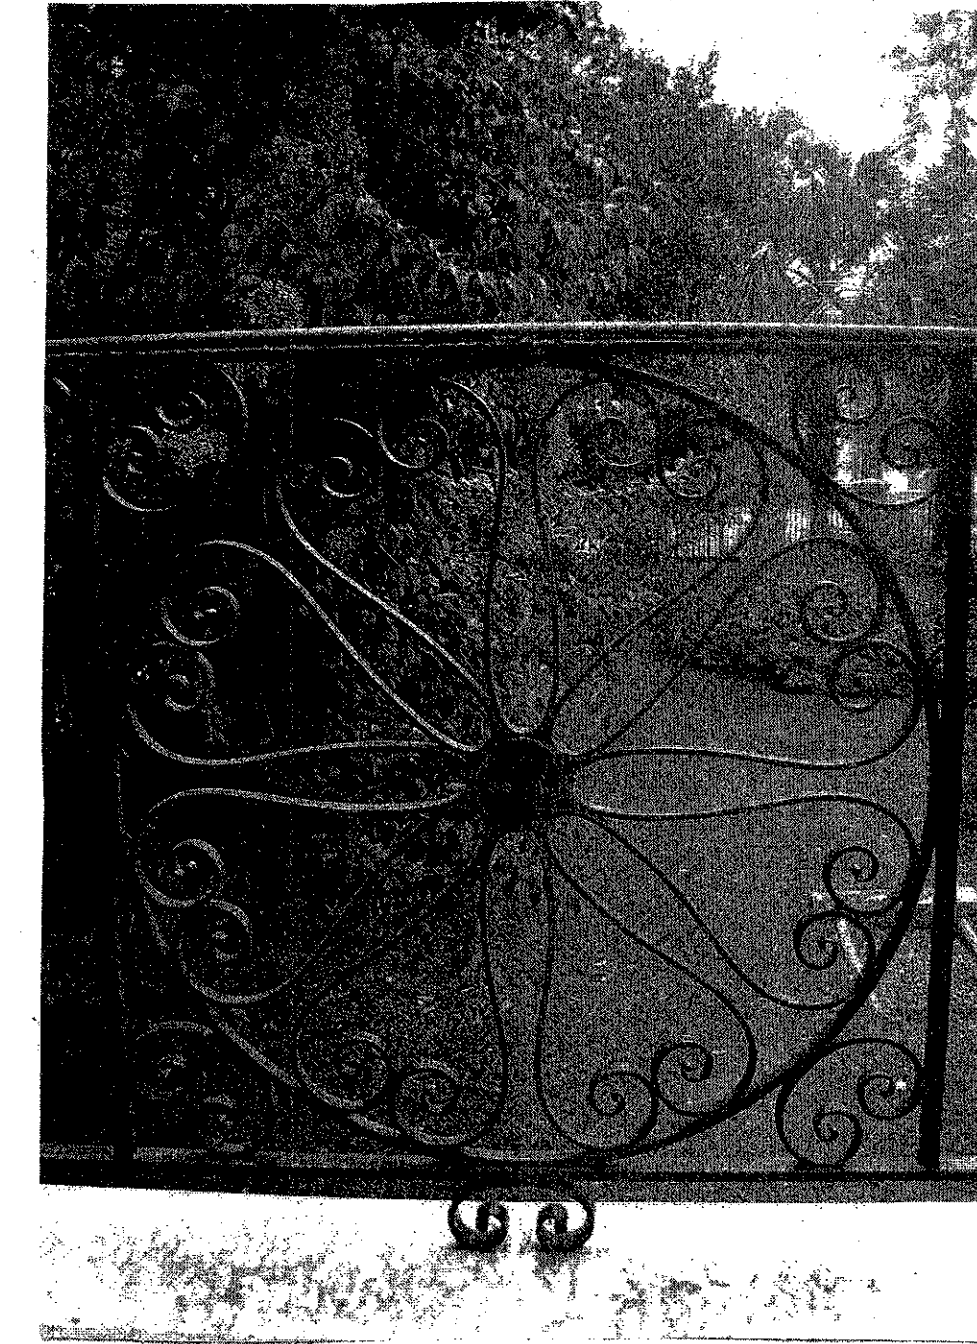
Much of the wrought iron work on Lance Hall and the surrounding property is in great need of maintenance and repair due to its age and little attention given to it. On the building, the railings have been painted over; most likely as quick solutions to repairing rust spots and other issues. The metal will last longer and look better without any paint on the surface because the paint builds in small spots muting the important details.

The safest way to remove the paint is to use chemical agents and steam cleaning. This will restore it to the metal's original appearance. To repair the rust spots it is necessary to physically remove the iron detail from its location and reheat the metal. When the metal heats it will expand but the rust will not causing it to loosen from the metal allowing it to be brushed off. This will not alter the structural qualities of the metal or the appearance other than improving it. The most important thing to take note of when cleaning iron is the high lead content, proper care must be taken to not inhale or ingest dust or vapors when working with the metal.

- THE PRESERVATION OF HISTORIC IRON WORK, WHETHER A MAJOR OR MINOR REPAIR, IS THE RECOMMENDED APPROACH OVER REPLACEMENT.
- WHEN POSSIBLE, ALL REPAIRS SHOULD BE REVERSIBLE.

- THE MOST EFFECTIVE WAY TO PRESERVE ARCHITECTURAL IRON IS TO MAINTAIN A PROTECTIVE COAT OF PAINT ON THE METAL.
- BEFORE REMOVING PAINT FROM HISTORIC IRON, A ANALYSIS OF THE HISTORIC PAINT IS STRONGLY RECOMMENDED.

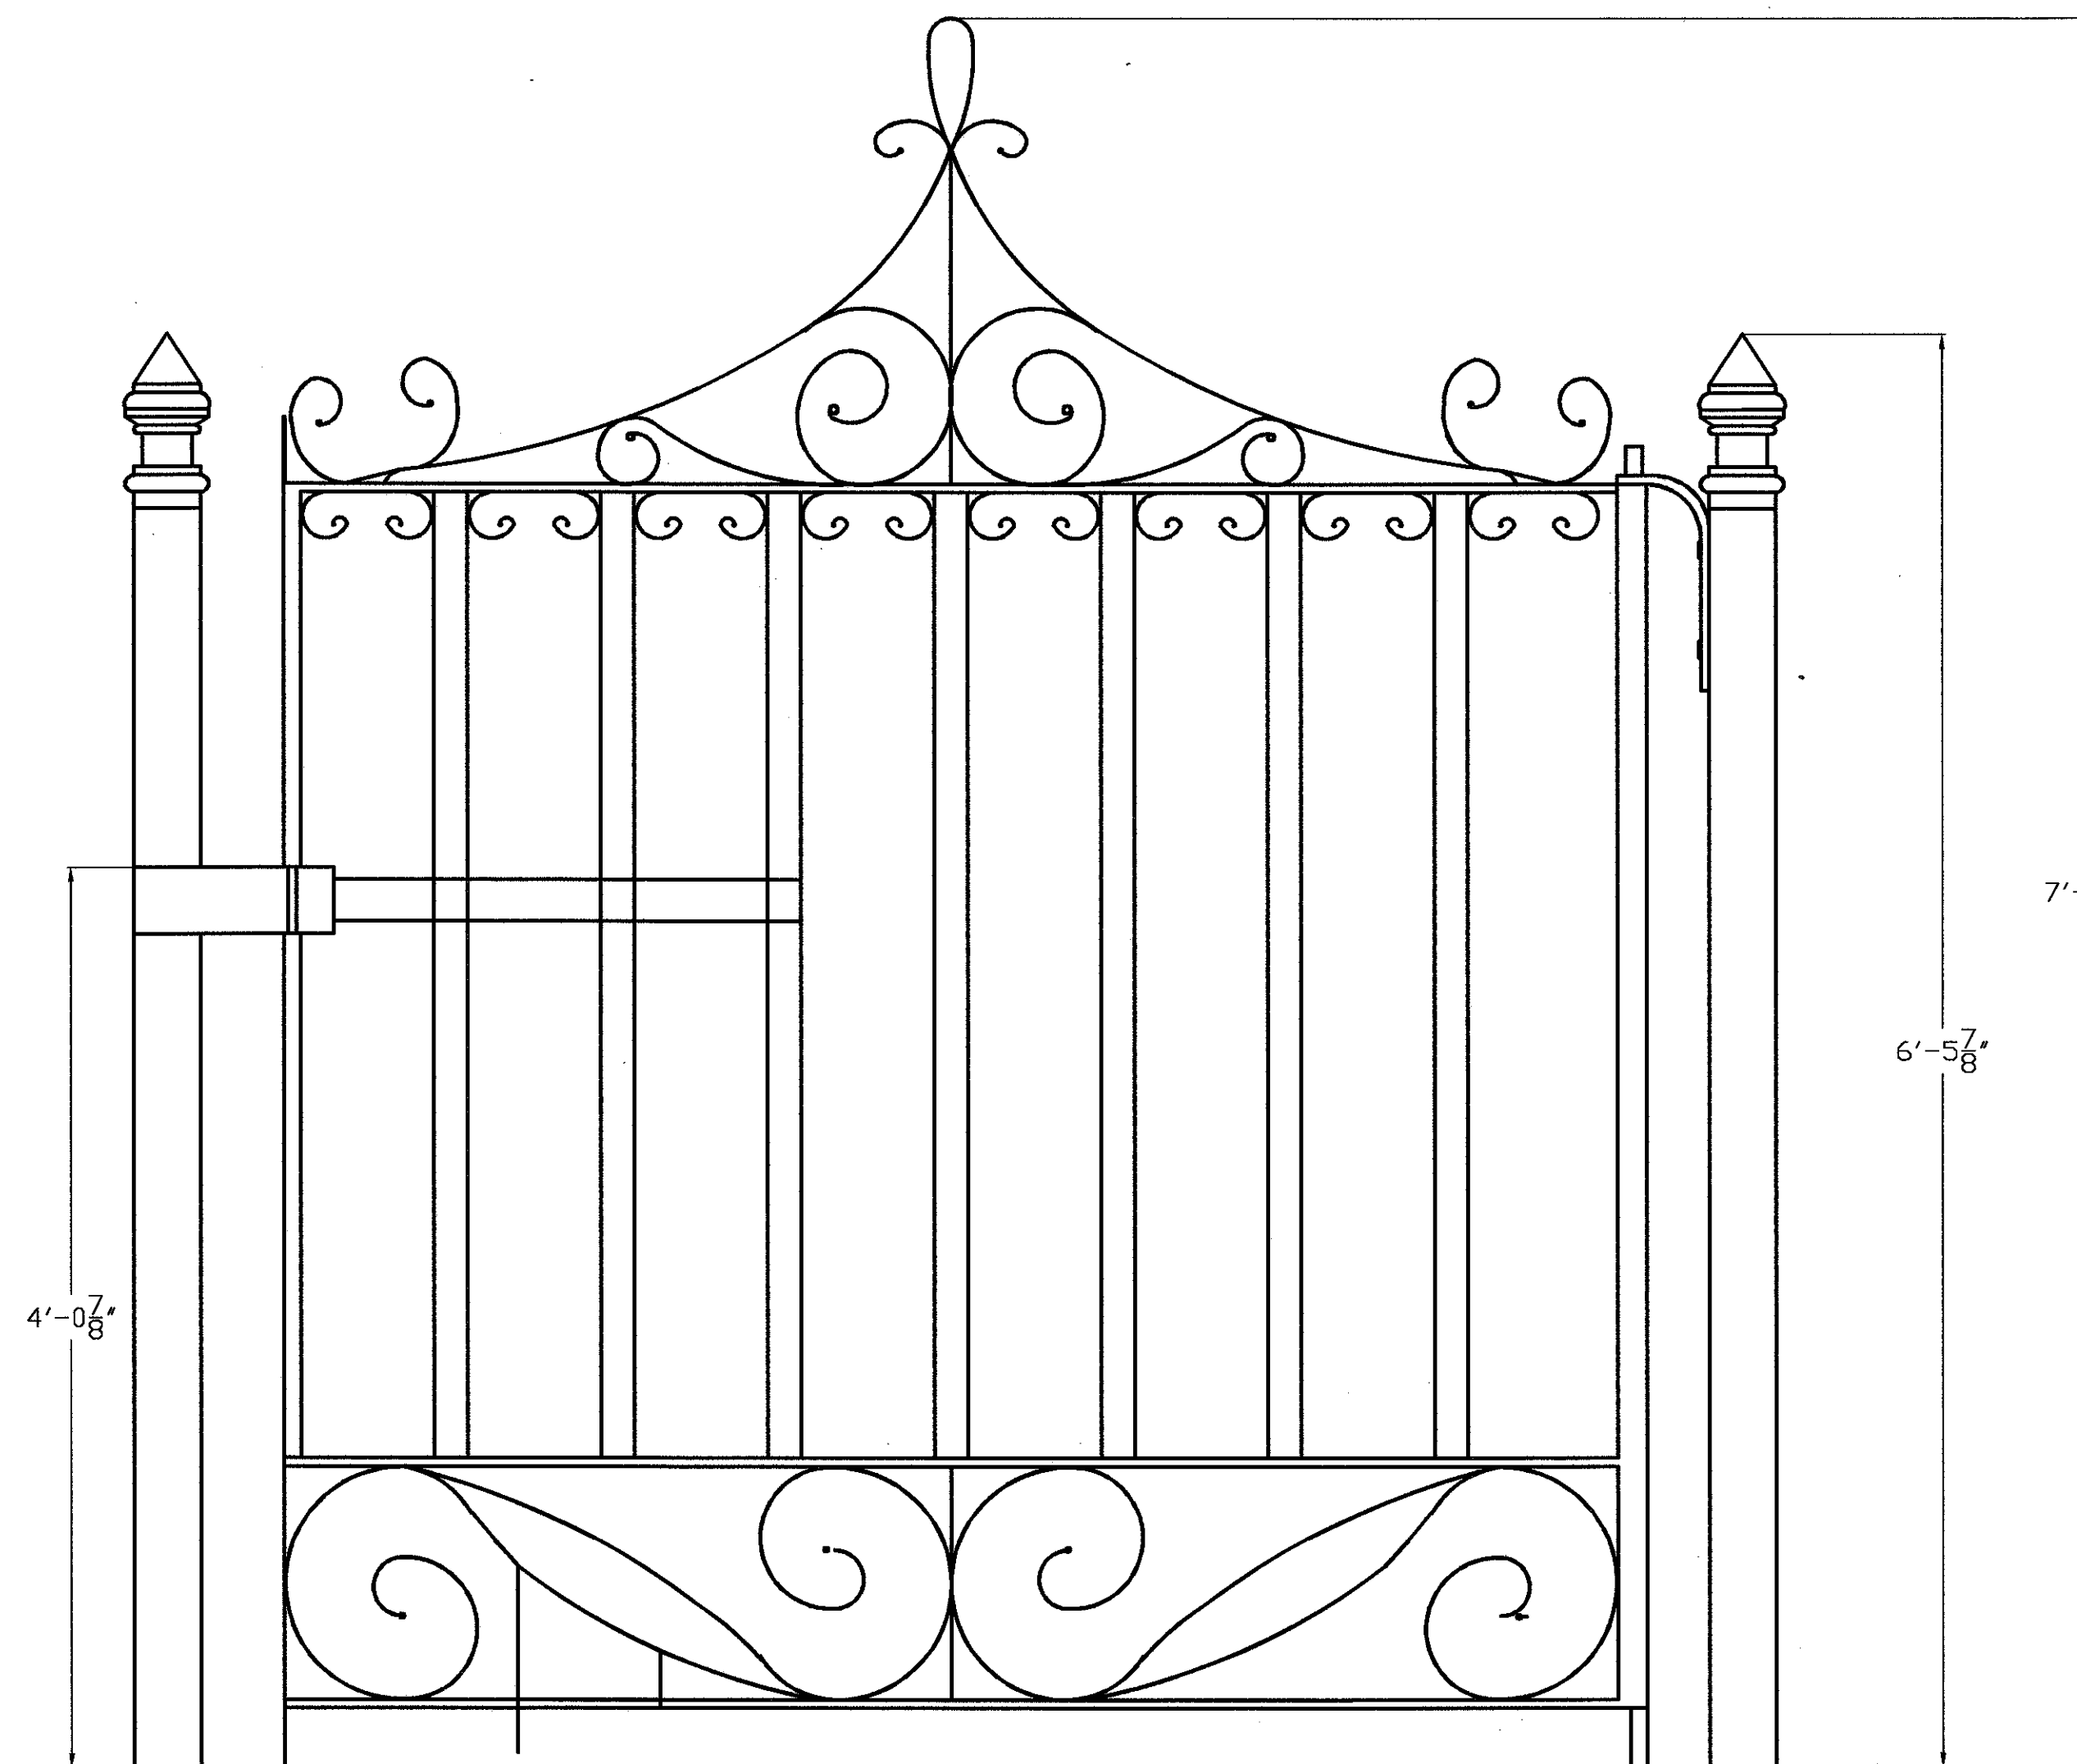
Cast Iron became popular in the 1850's after James Bogardus introduced the cast iron store front. Noted for it's durability, Cast iron is an alloy with a high carbon content that makes it more resistant to corosion than either wrought iron or steel. However unlike wraught Iron or steel Cast iron is very hard and brittle and has little tensile strength. Cast Iron elements are usually very uniform in apperance, are often displayed in repition and are usually bolted or screwed together as they do not respond well to welding.

This gate is not original to the site however it is a good exapmle of early cast ironwork. Part of a much larger perimeter fence that aligns along Meeting St. the fence also contians another larger gate. The fence and gate are painted black and the fence is situated upon a brick base covered with cast iron this cast iron and brick base has fallen into disrepair and has broken or fallen off. The significance of this gate is the fact that it aligns to the center of Lance Hall and there used to be a pathway linking the street to the building. This gate is raised off the sidewalk by 8 inches with a slab of granite. Other than the Base of the fence it is in good condition. Proper matienence will ensure that this important gate will stand the test of time.

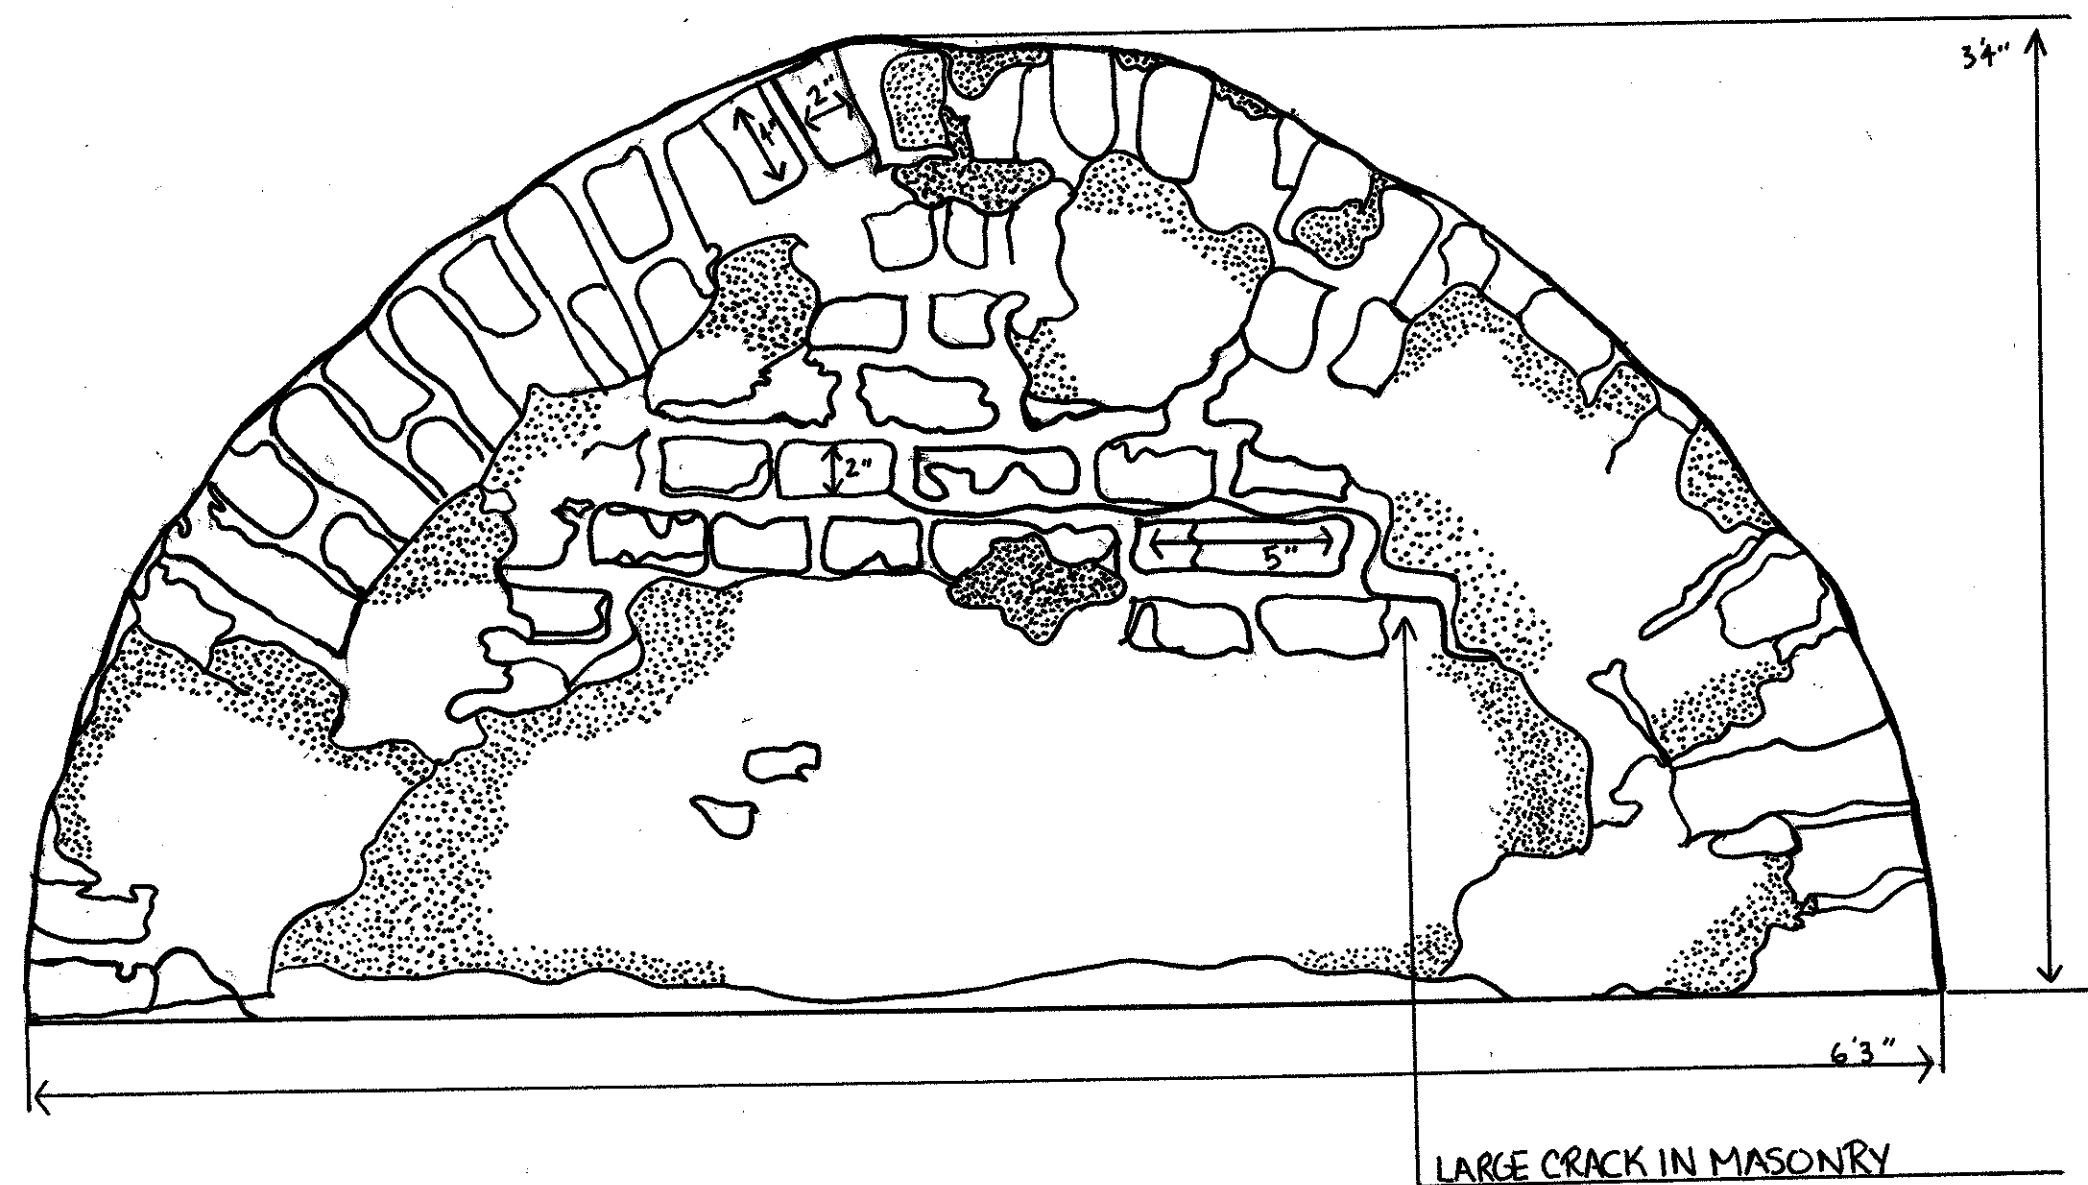
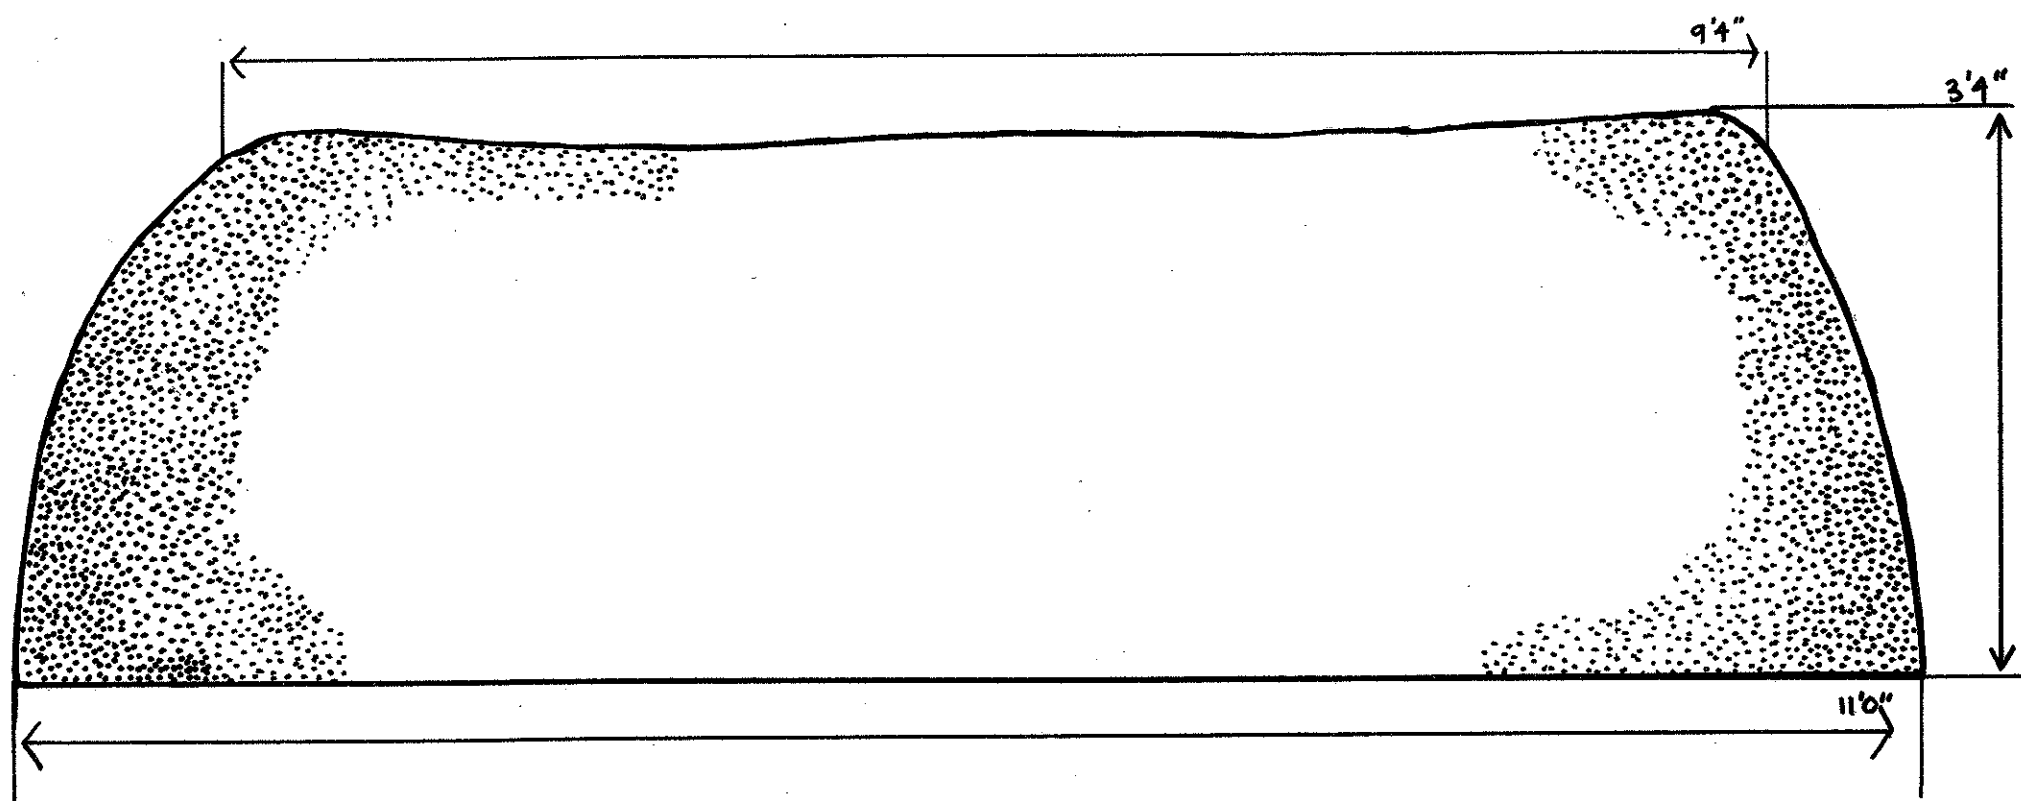
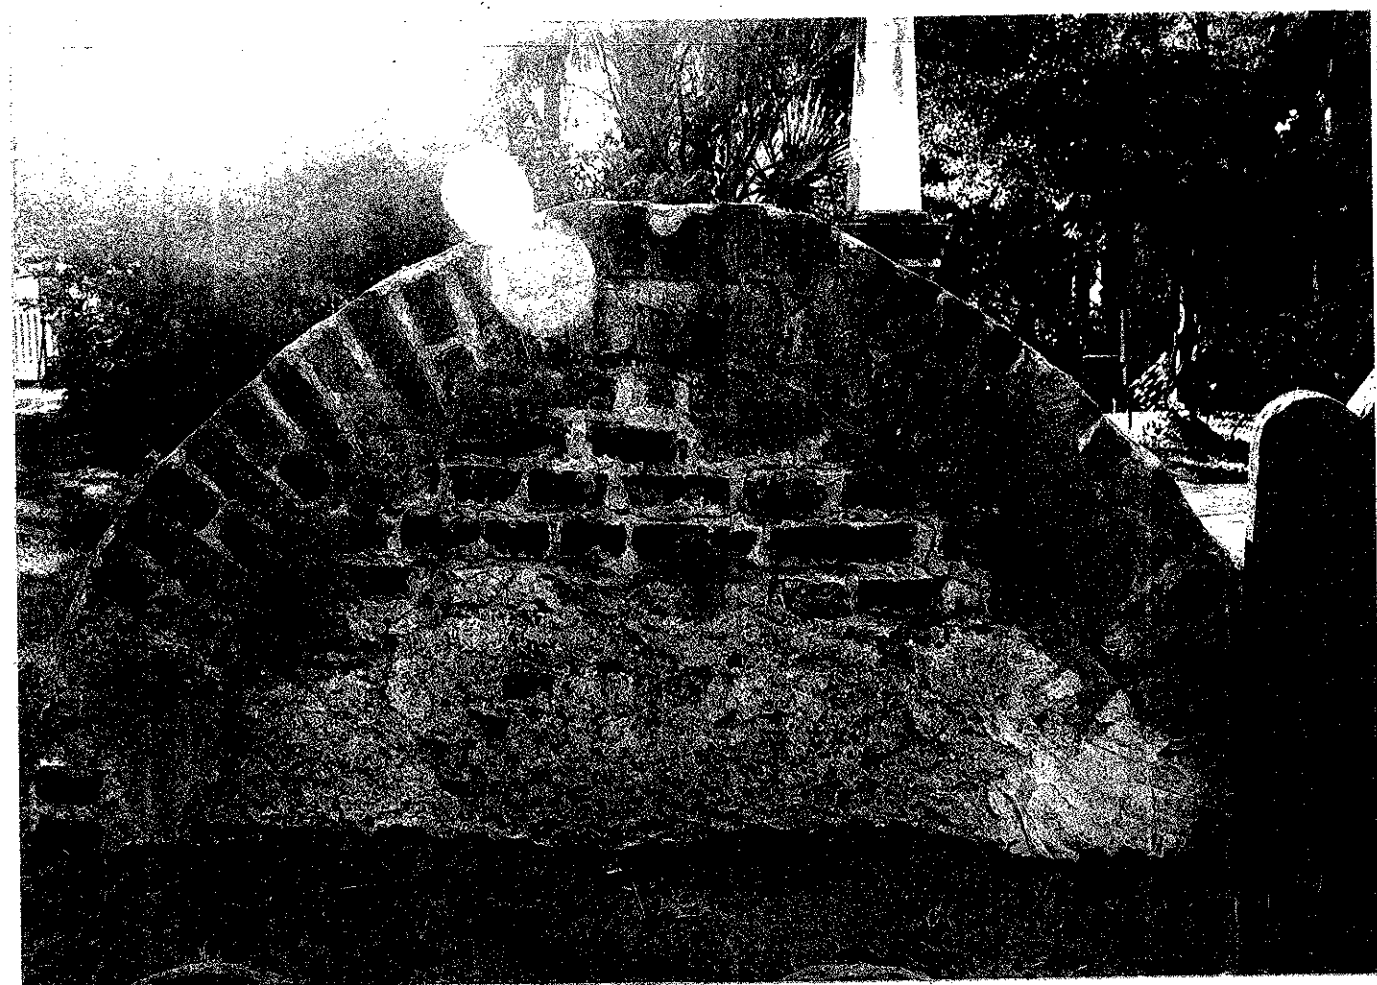
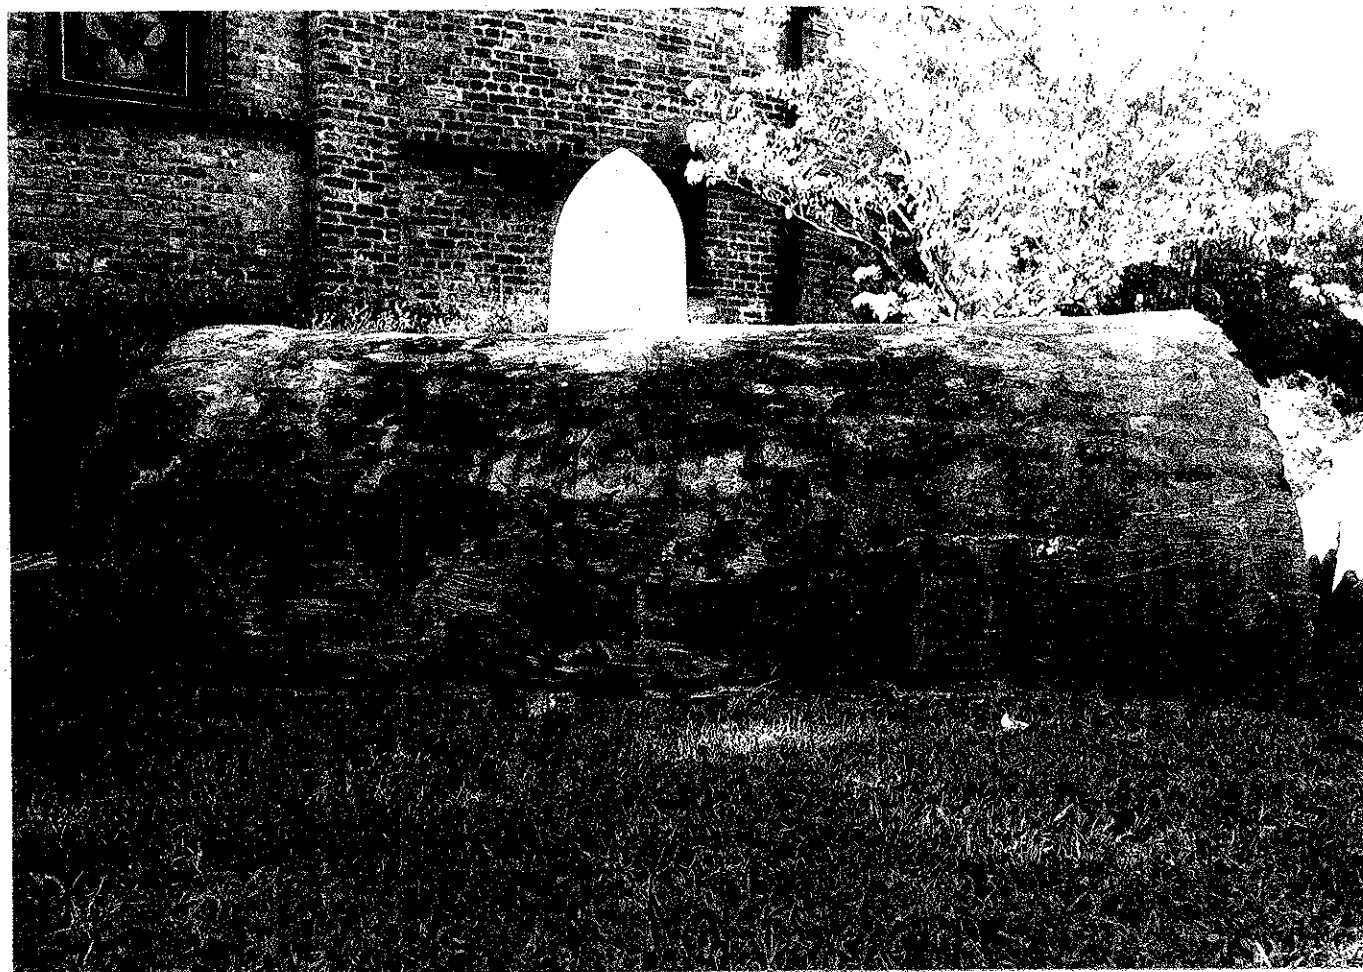
SIMONDS FAMILY TOMB  
MAP LOCATION: 039P

- THIS TOMB IS LOCATED TO THE SOUTH OF CIRCULAR CONGREGATIONAL CHURCH IN GRAVEYARD 'A'
- THE TOMB IS UNMARKED; IT HAS NEITHER A HEAD, FOOTSTONE OR INSCRIPTION
- THE TOMB IS A BRICK MOUND STRUCTURE
- IN 1984 ONE PREVIOUSLY OPEN END OF THE TOMB WAS BRICKED UP
- IN 1984 THE STRUCTURE UNDERWENT REPAIRS. THIS INCLUDED COVERING THE EXTERIOR IN CEMENT (AS CAN BE SEEN TODAY)
- THE SIMONDS FAMILY TOMB HOLDS THE BODIES OF HENRY SIMONDS, WIFE, FRANCIS SIMONDS & THE BODY OF THEIR SON (NAME UNKNOWN)
- HENRY SIMONDS DIED CIRCA 1695
- THE SIMONDS FAMILY WAS THE DONOR OF THE ORIGINAL LOT ON WHICH CIRCULAR CHURCH WAS BUILT (1694/1695)
- AS IT IS TODAY THE STRUCTURE IS IN NEED OF REPAIRS WHICH INCLUDE REPOINTING AND REMOVAL AND REPLACEMENT OF CRACKED MASONRY

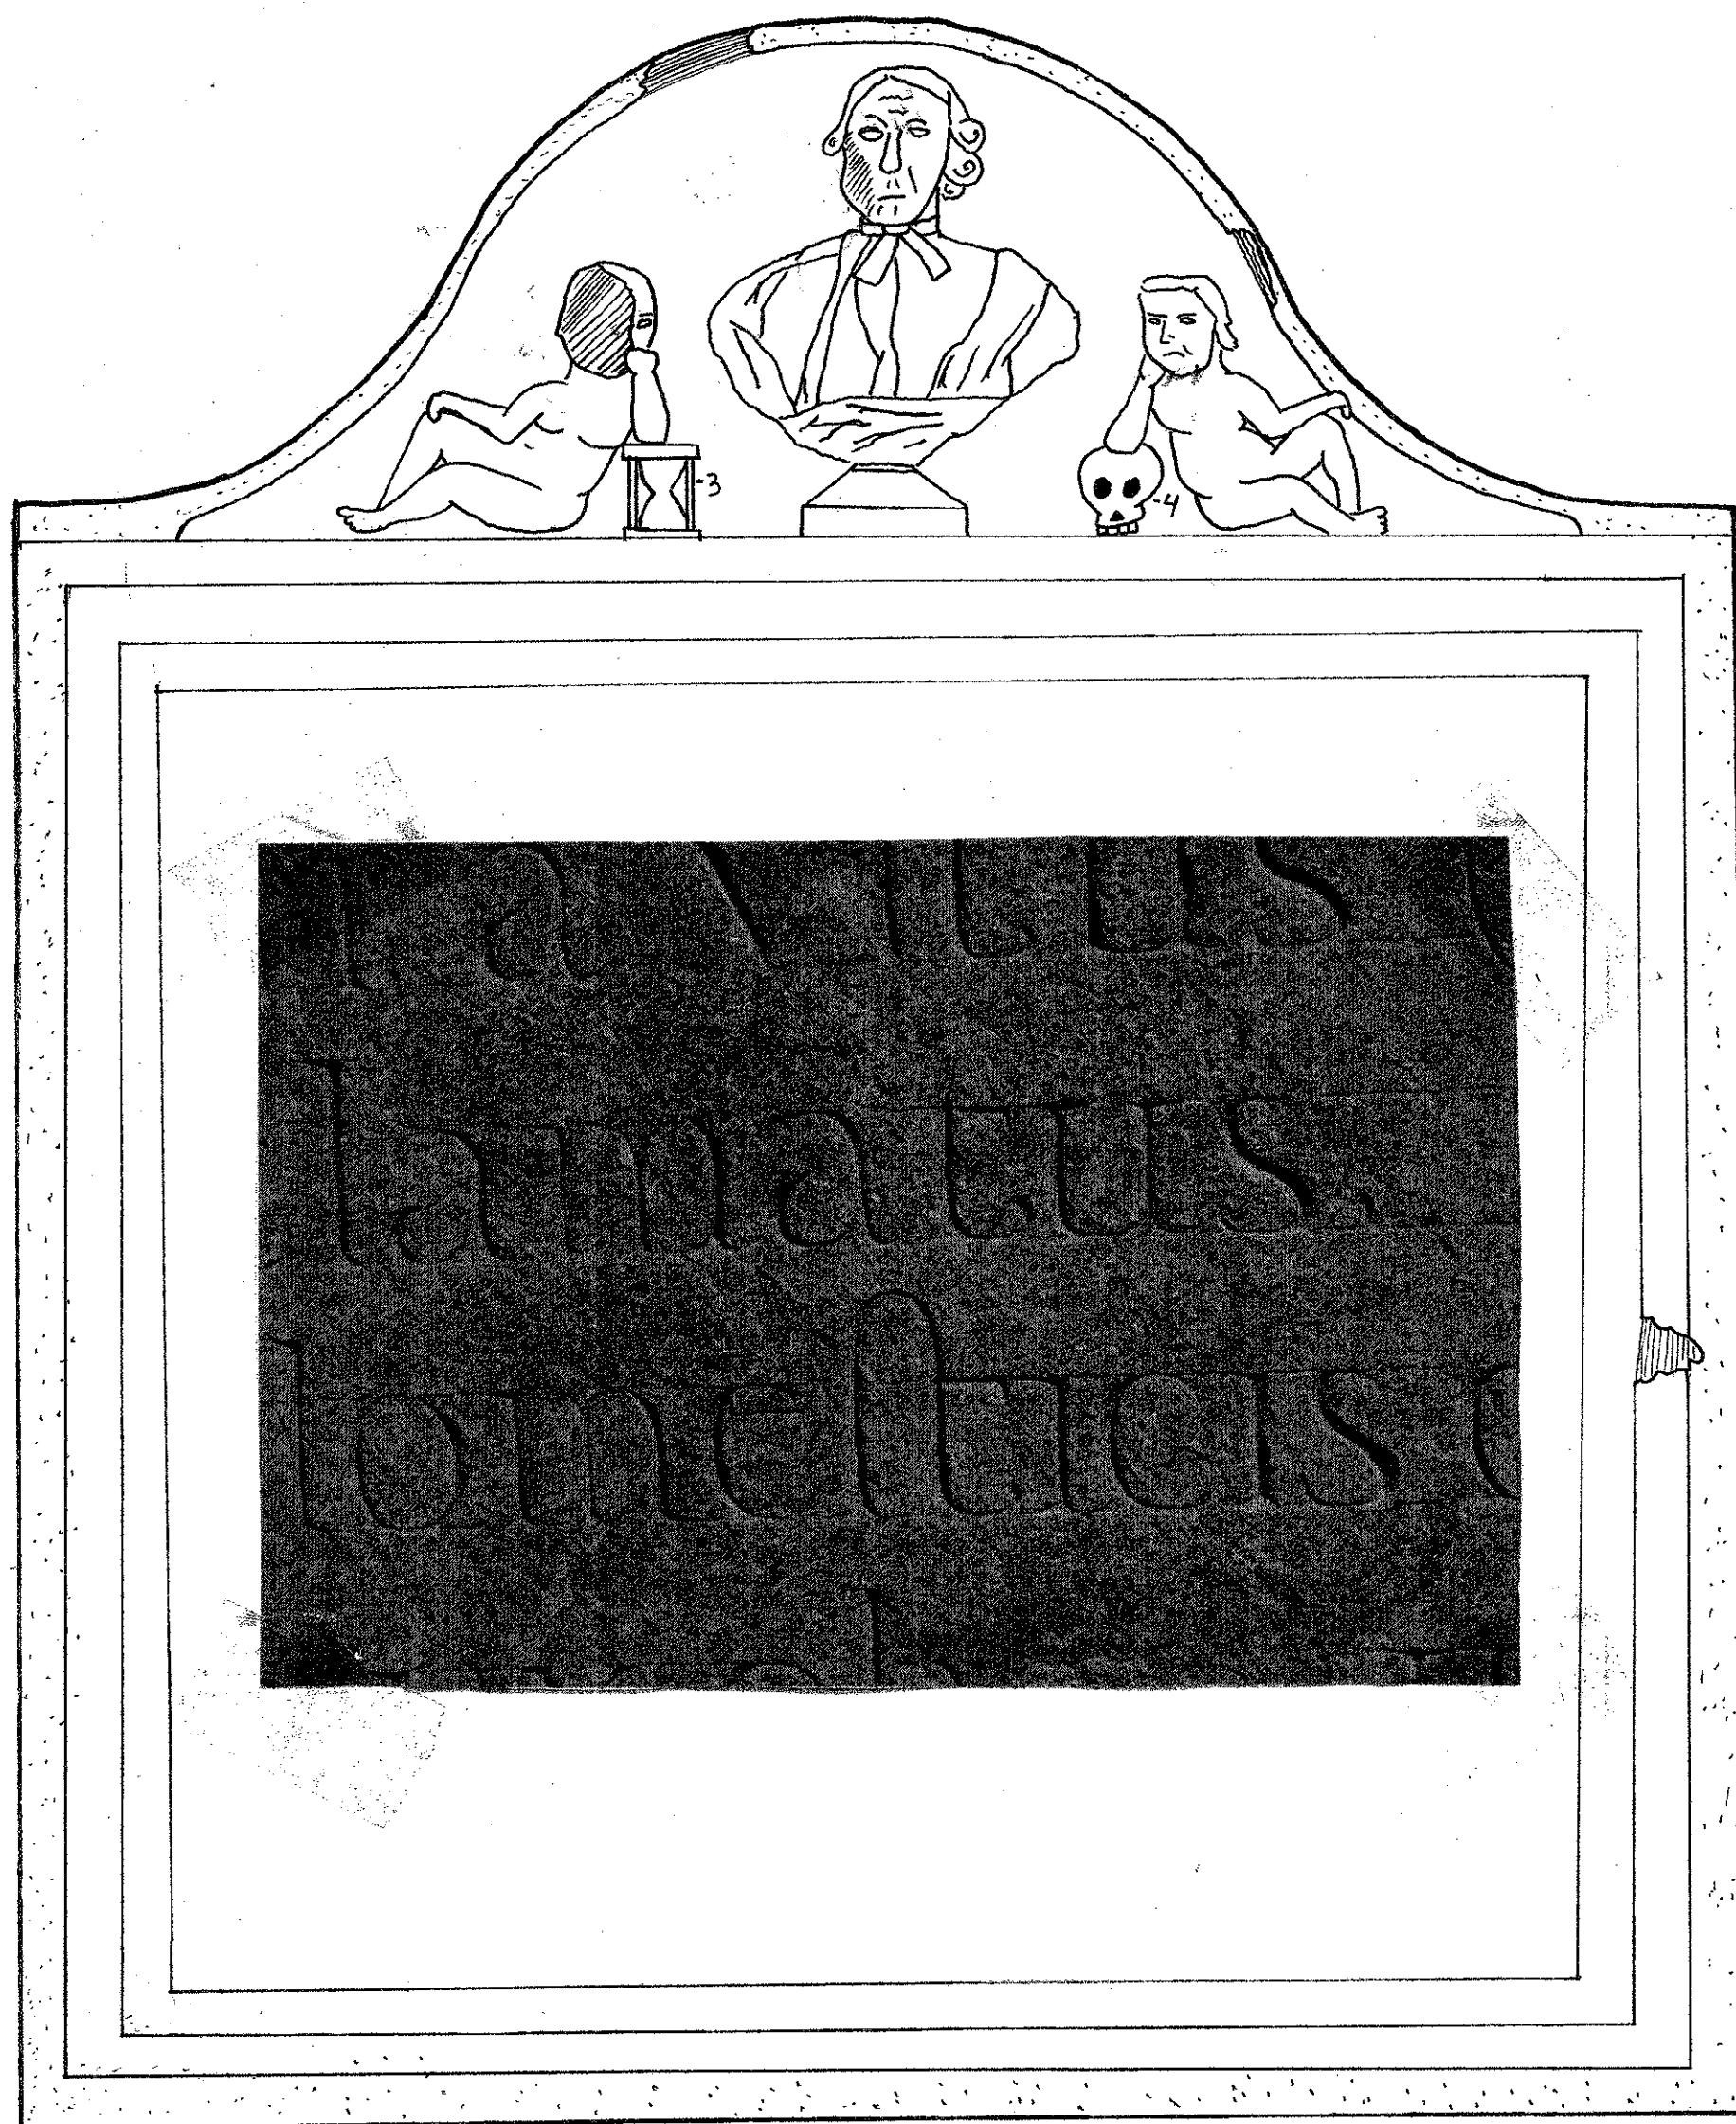
Front of Grave

- Notes For additional information see proposal
1. Marks probably caused by picture washing or weather.
  2. 2' down the grave it is  $\frac{5}{8}$ " out of plumb.
  3. Hour glass is the symbol of the passage of life.
  4. Skull is symbol of death or sin.
  5. Stippling marks show where grave stone poorly carved for the last 100 years.
