| JAMES LIPHUS WARD<br>SC RLA | | <b>GLEBE STREET RESIDENCES</b> | |
| COLLEGE OF CHARLESTON<br>HPCP 299-SPRING 2010<br>HISTORIC PRESERVATION &<br>COMMUNITY PLANNING | | DRAWING TITLE:<br><b>14 GLEBE STREET</b><br><b>Floor Plan</b><br>DRAWING PREPARED BY (TEAM/INDIVIDUAL):<br><b>TEAM: Galtor Frick Voneshatz</b> | |

| JAMES LIPPHUS WARD<br>SC RLA | | GLEBE STREET RESIDENCES | |
| COLLEGE OF CHARLESTON<br>HPCP 209-SPRING 2010 | | DRAWING TITLE:<br>14 GLEBE ST<br>ELEVATIONS | |

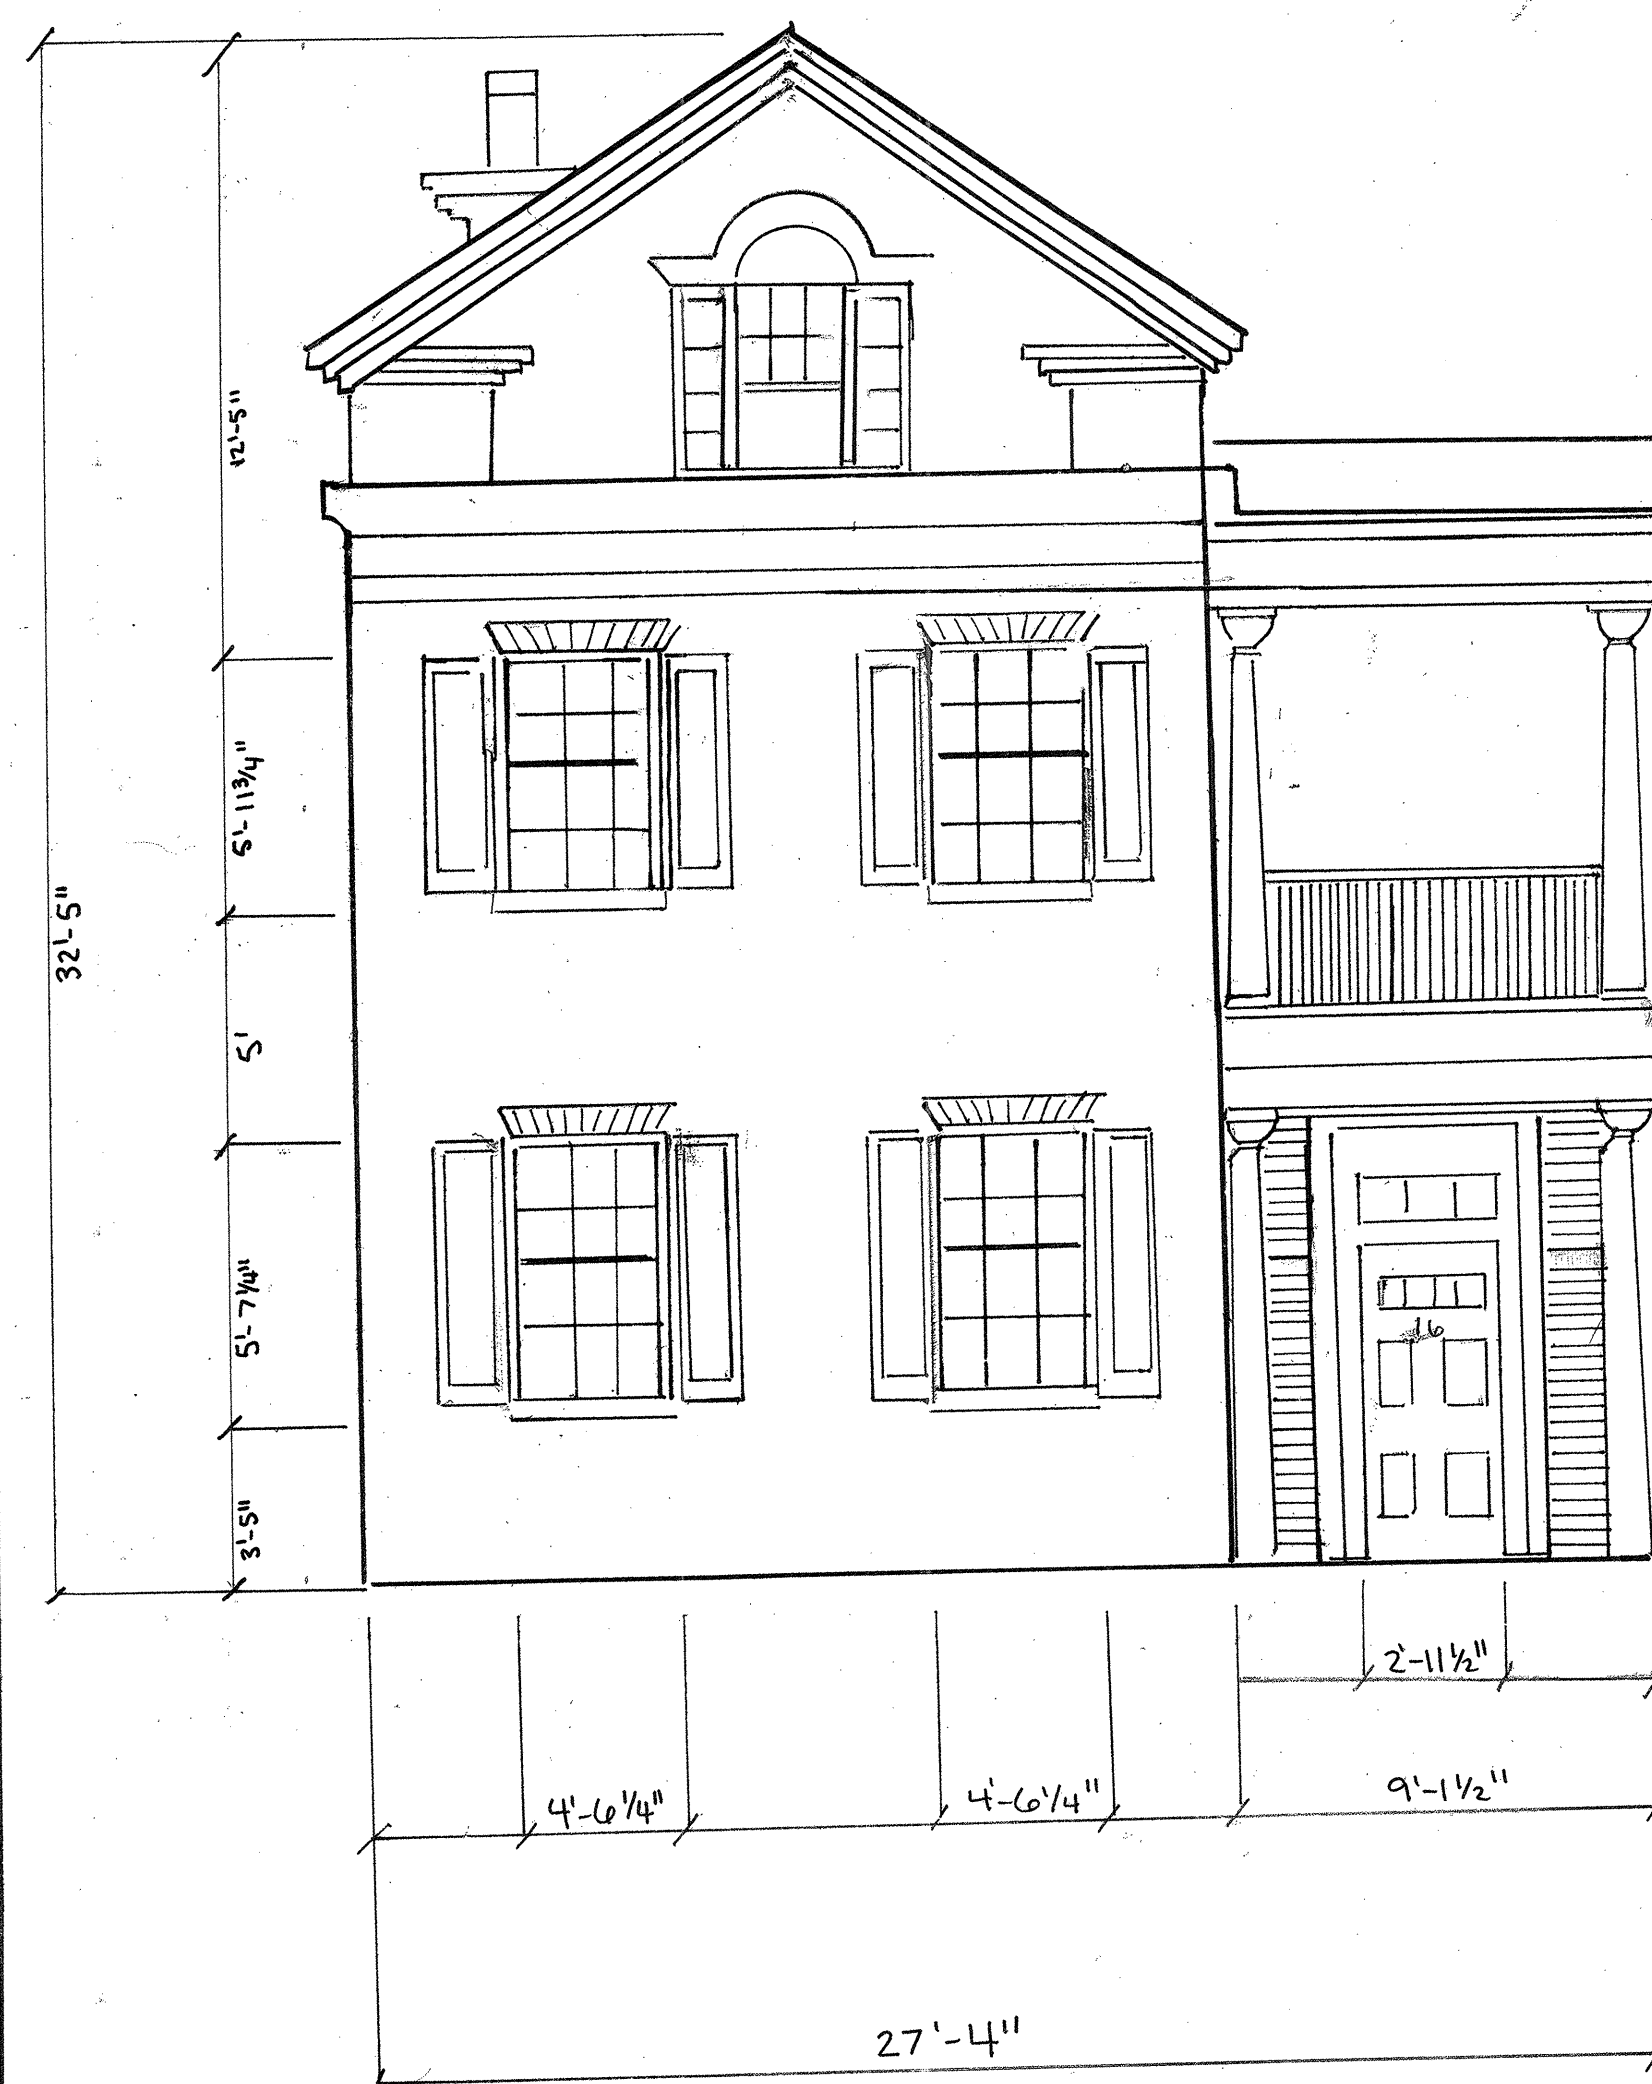
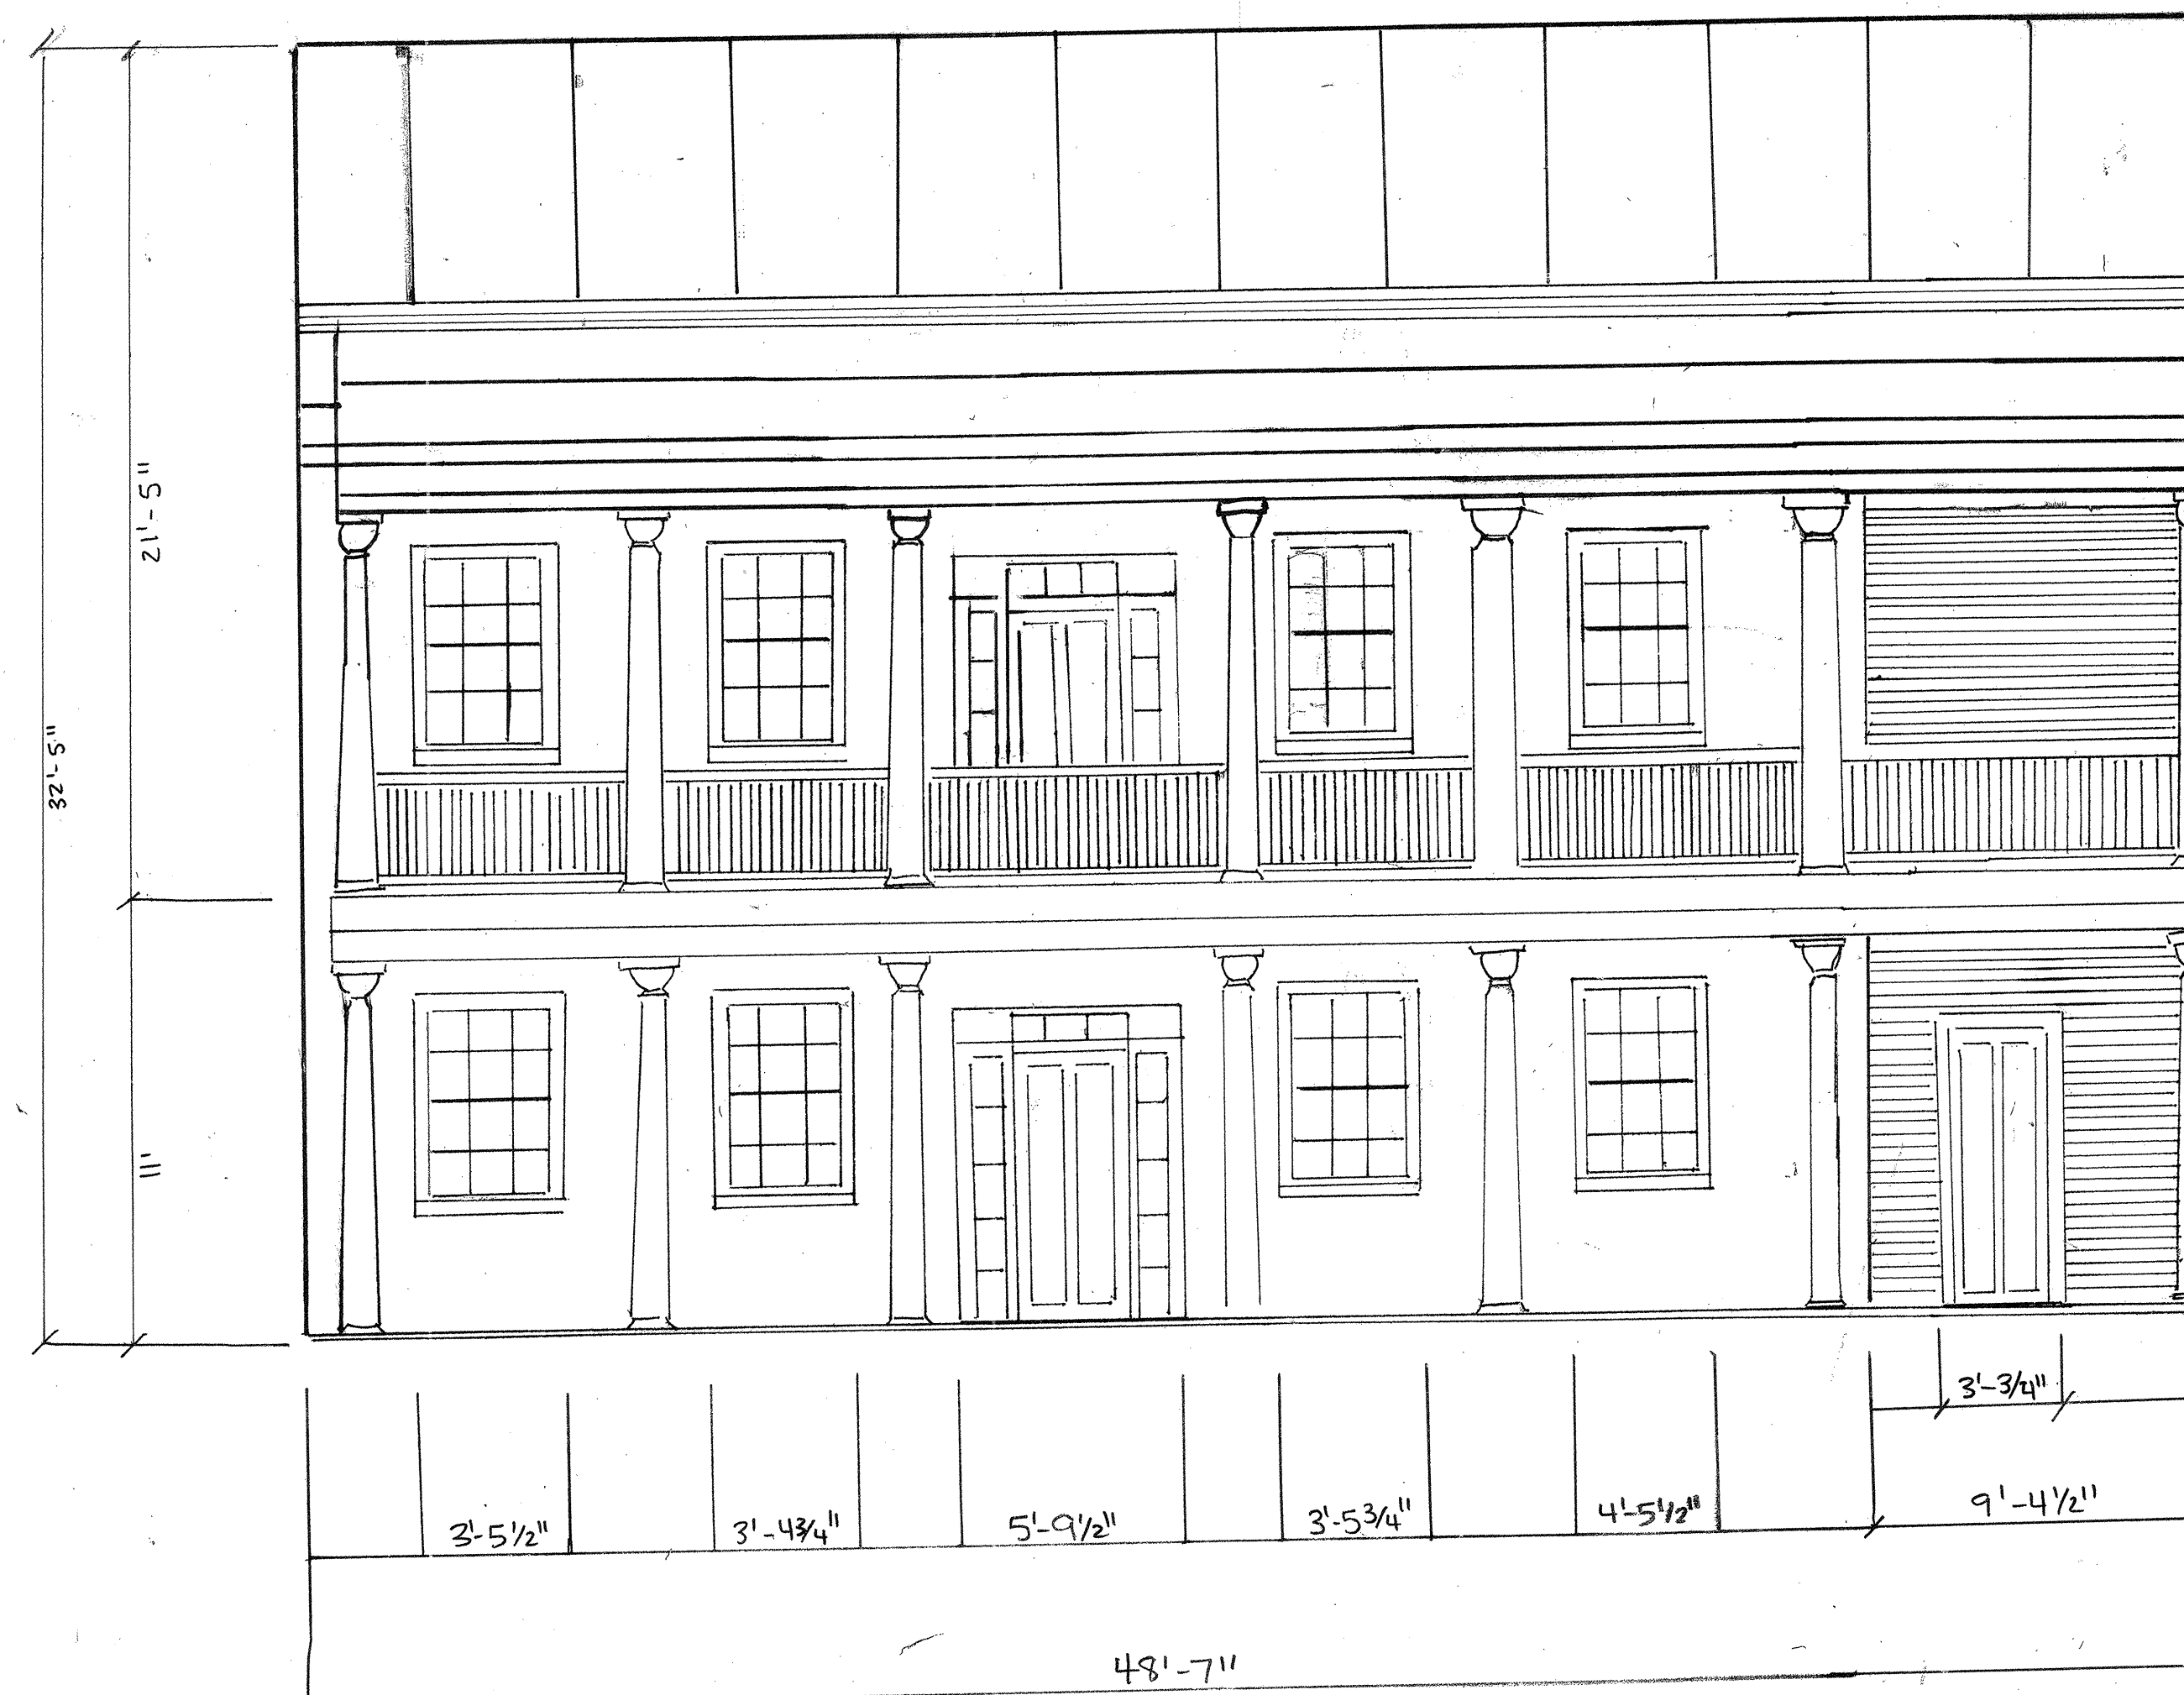
EAST ELEVATION

- COLUMNS HAVE WOOD ROT AT BASE
- FRONT OF HOUSE BRICK IS LAID IN A BELGIUM STYLE
- DOORS MAYBE ORIGINAL AND HAVE MANY LAYERS OF PAINT
- WINDOWS ARE MOST LIKELY NOT ORIGINAL SINCE THEY HAVE LARGER PANES OF GLASS
- RAILINGS ARE 1" WIDE

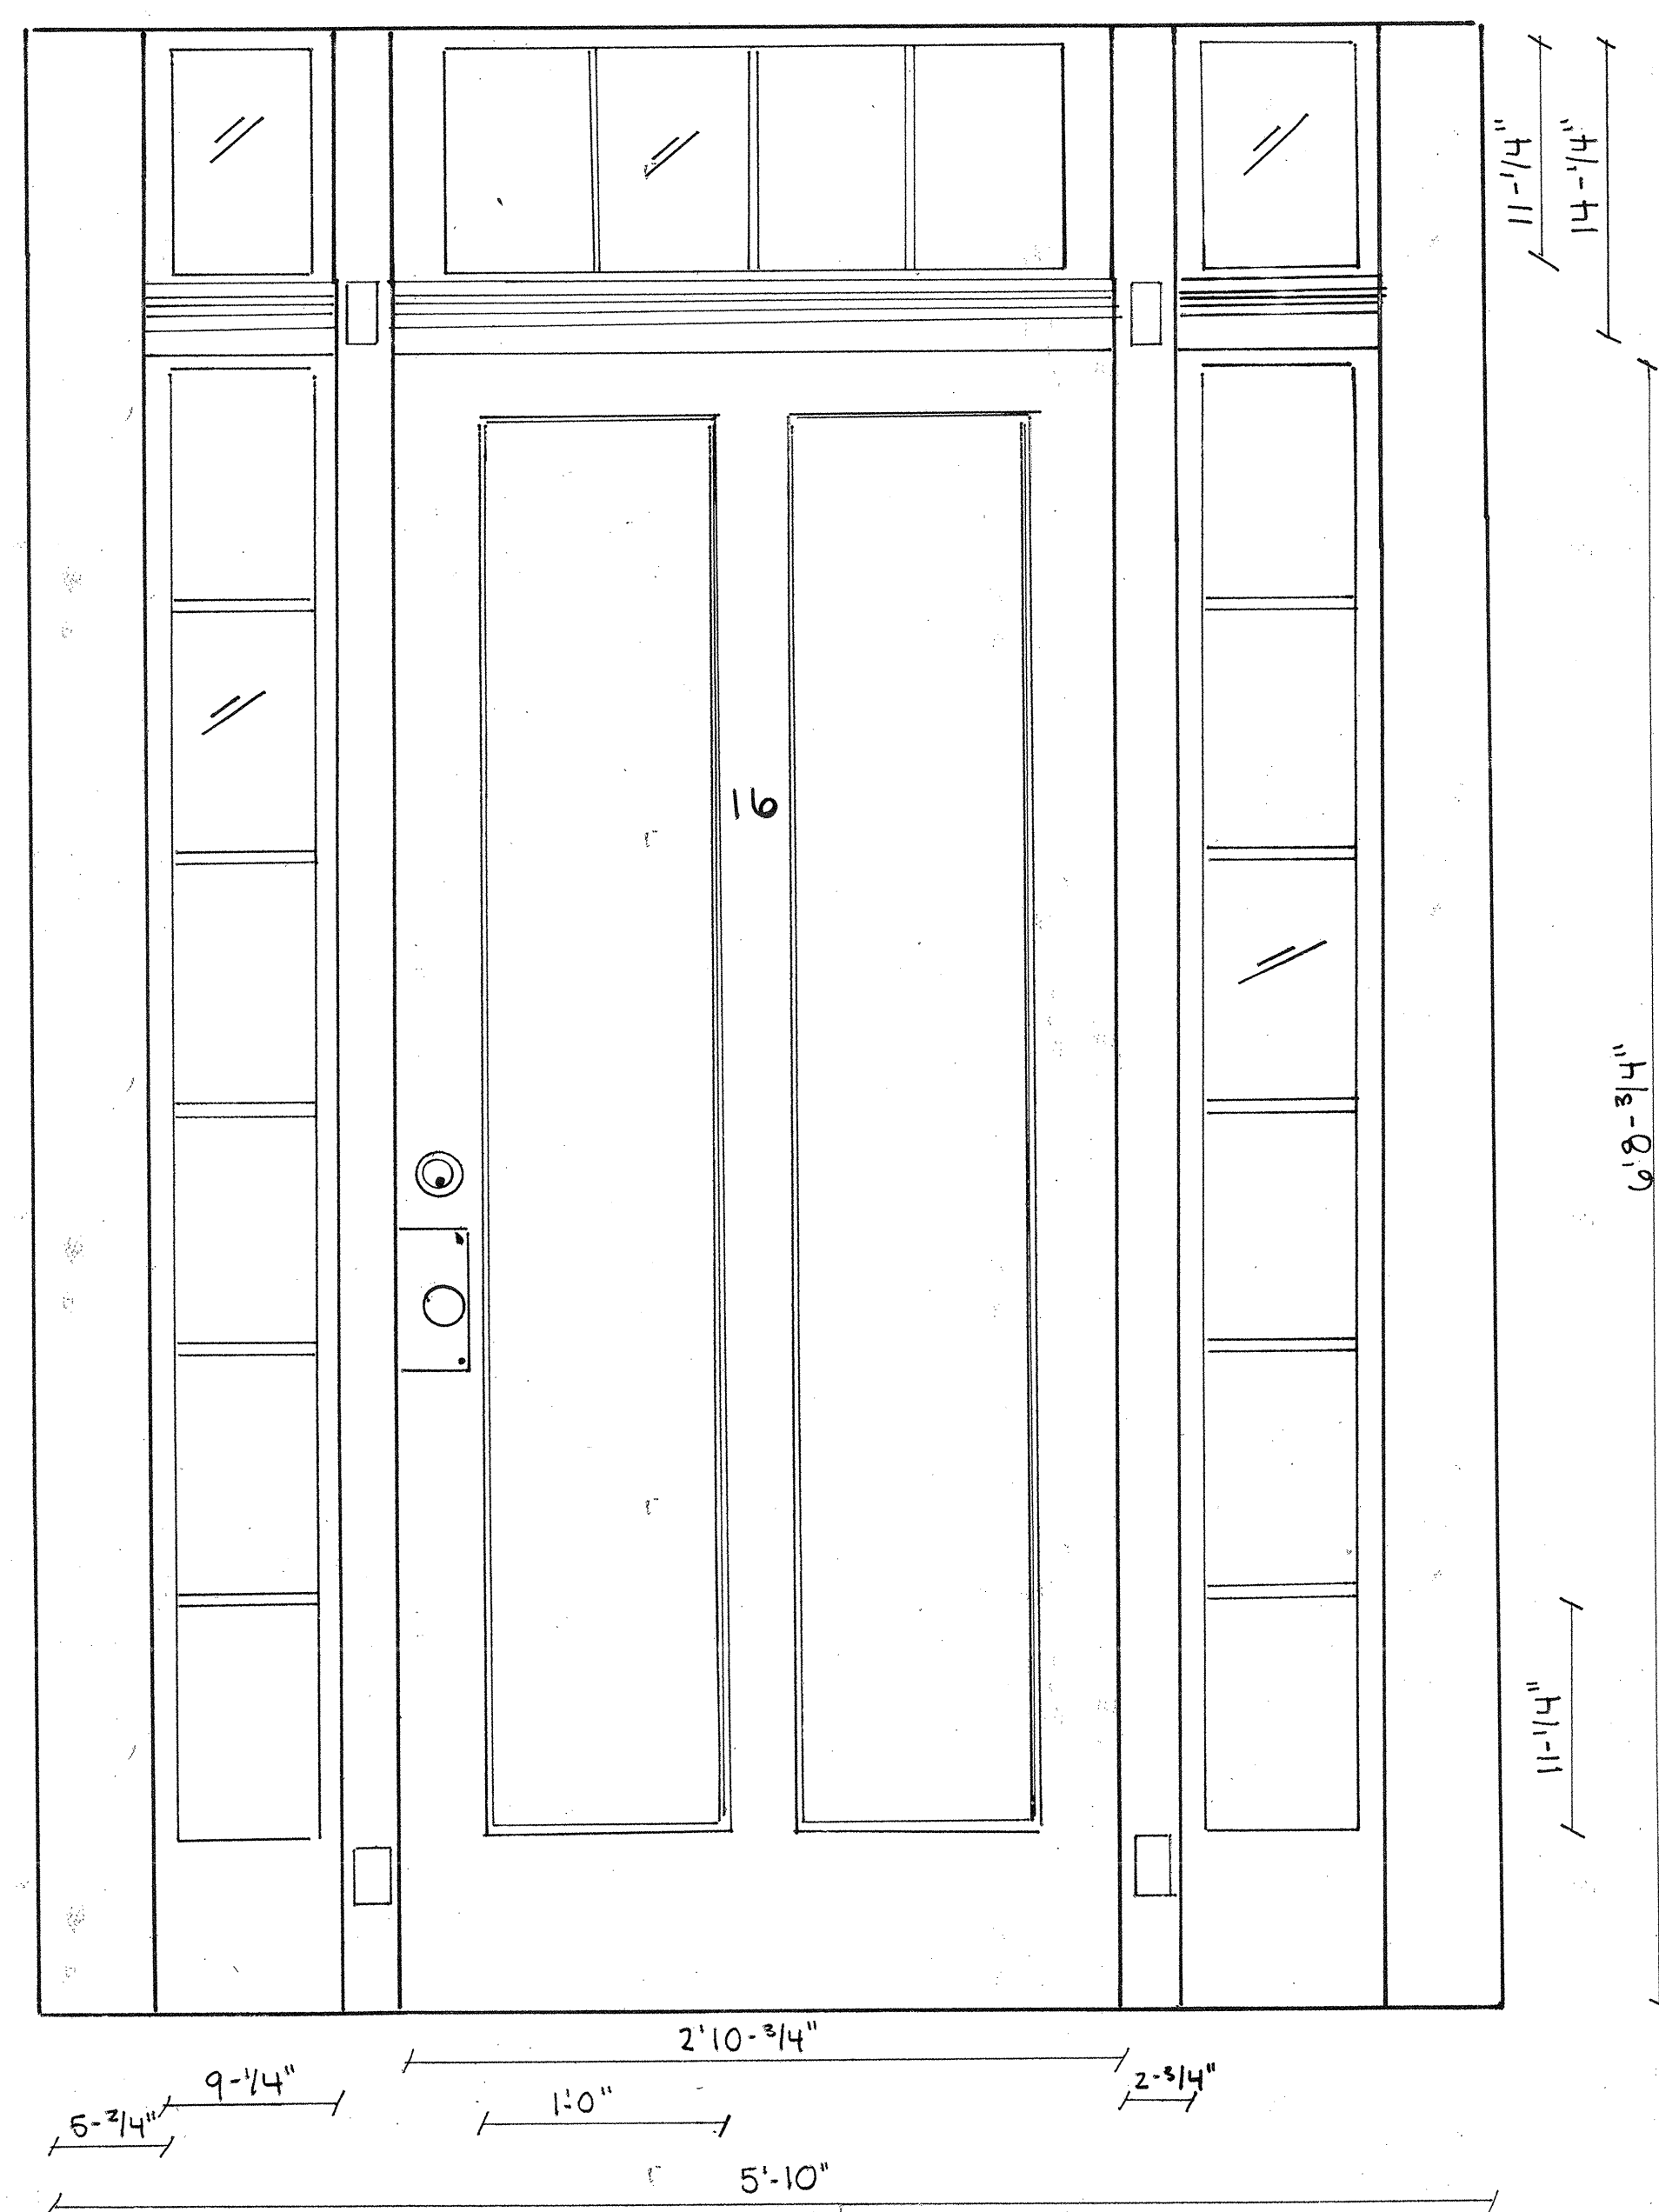
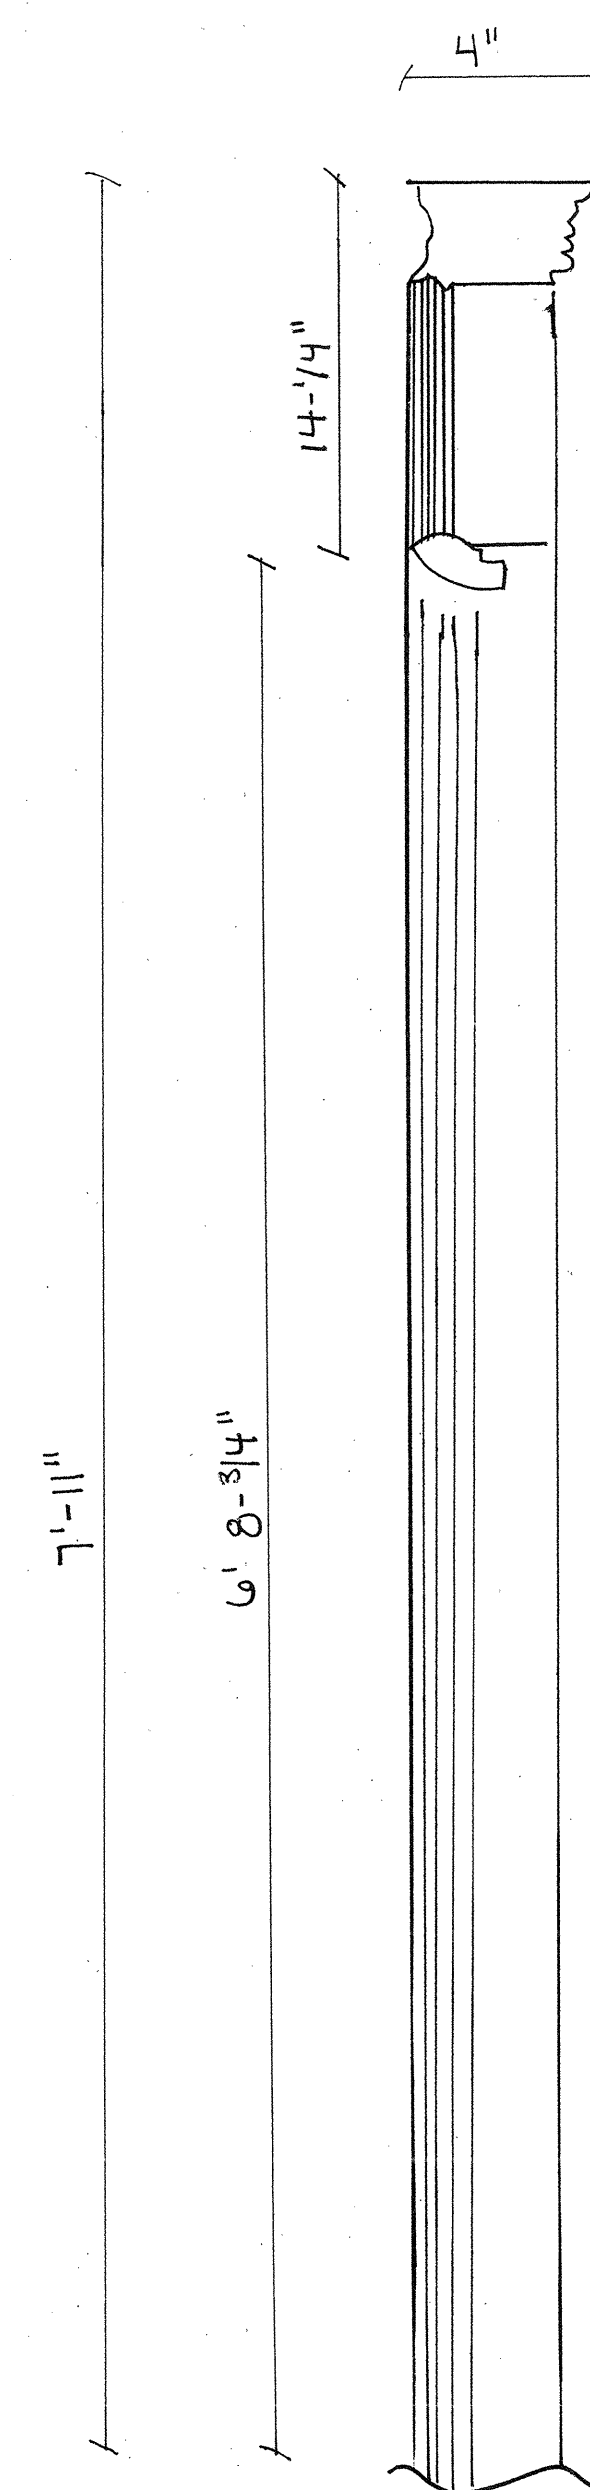
NORTH FRONT DOOR

1. SECTION CUT THROUGH HEAD AND SILL AT TRANSOM LIGHT
2. DOOR IS LIKELY ORIGINAL
3. EVIDENCE OF REMOVAL OF SCREEN DOOR - NOT ORIGINAL TO HOUSE
4. DAMAGE AROUND DOOR HARDWARE DUE TO NEW AND POORLY INSTALLED LOCK AND KNOB
5. PRESENCE OF OLD ORIGINAL GLASS IN SOME OF THE SIDELIGHTS AS WELL AS NEWER GLASS
6. SIDELIGHTS ARE SET BACK 7"

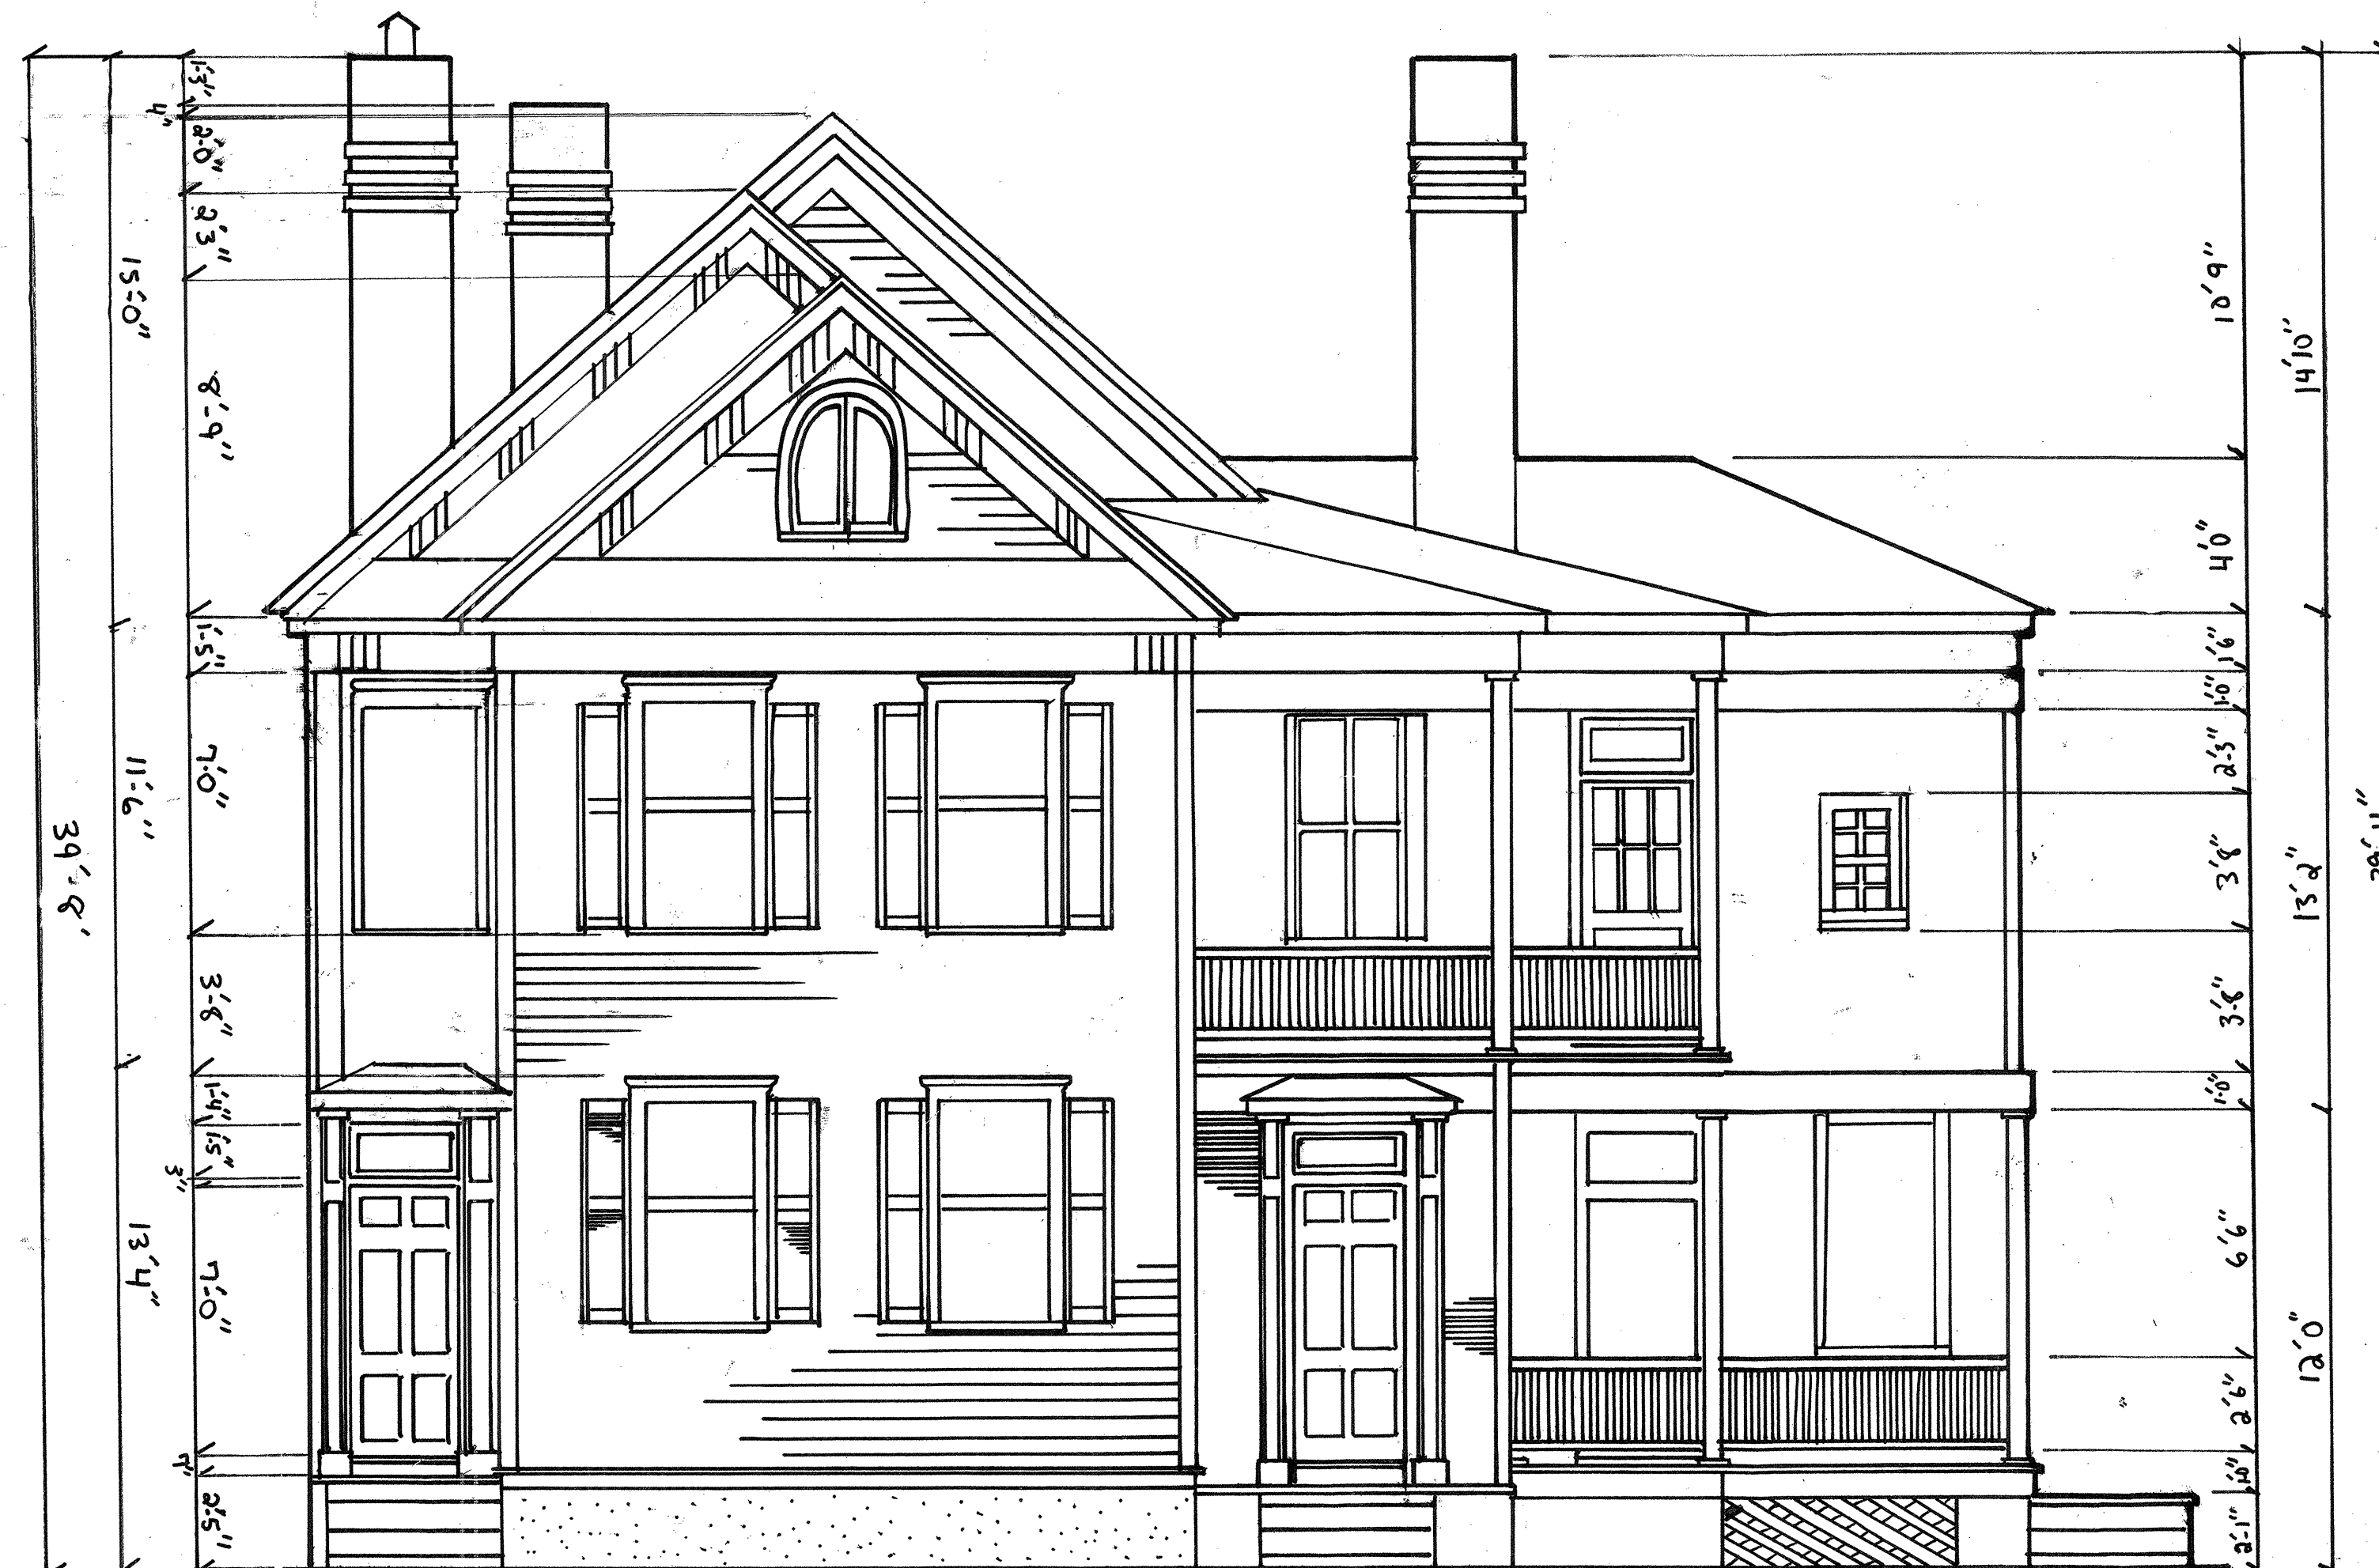
FRONT ELEVATION

SHUTTERS NOT ORIGINAL, NAILED ON  
 BUILDING NOT SQUARE  
 OUTSIDE OF BUILDING CLAPBOARD SIDING  
 SOME SIDING IS ROTTED, SEVERAL COATS OF  
 PAINT  
 UNIQUE SET OF SHUTTERS ON TOP PORTICO  
 ROOF IS STANDING SEAM METAL PAINTED  
 RED  
 BRICK AND MORTAR ON CHIMNEYS ARE IN  
 NEED OF REPAIR  
 FRONT PORCH FLOORING NOT LEVEL, COULD  
 BE AN ADDITION  
 ROOF MEASUREMENTS ESTIMATED FROM  
 SCALED PHOTO  
 BUILDING HEIGHT OBTAINED FROM COUNTING  
 INDIVIDUAL SIDING PLANKS  
 CHIMNEY HEIGHT OBTAINED FROM COUNTING  
 INDIVIDUAL BRICKS  
 SEVERAL INDIVIDUAL MOULDING PIECES  
 NOT LEVEL
