| JAMES LIPHUS WARD<br>SC RLA | | <b>GLEBE STREET RESIDENCES</b> | |
| COLLEGE OF CHARLESTON<br>HPCP 299-SPRING 2010<br>HISTORIC PRESERVATION &<br>COMMUNITY PLANNING | | DRAWING TITLE:<br><b>14 GLEBE STREET</b><br><b>Floor Plan</b><br>DRAWING PREPARED BY (TEAM/INDIVIDUAL):<br><b>TEAM: Galtor Frick Voneshatz</b> | |

| JAMES LIPPHUS WARD<br>SC RLA | | GLEBE STREET RESIDENCES | |
| COLLEGE OF CHARLESTON<br>HPCP 209-SPRING 2010 | | DRAWING TITLE:<br>14 GLEBE ST<br>ELEVATIONS | |

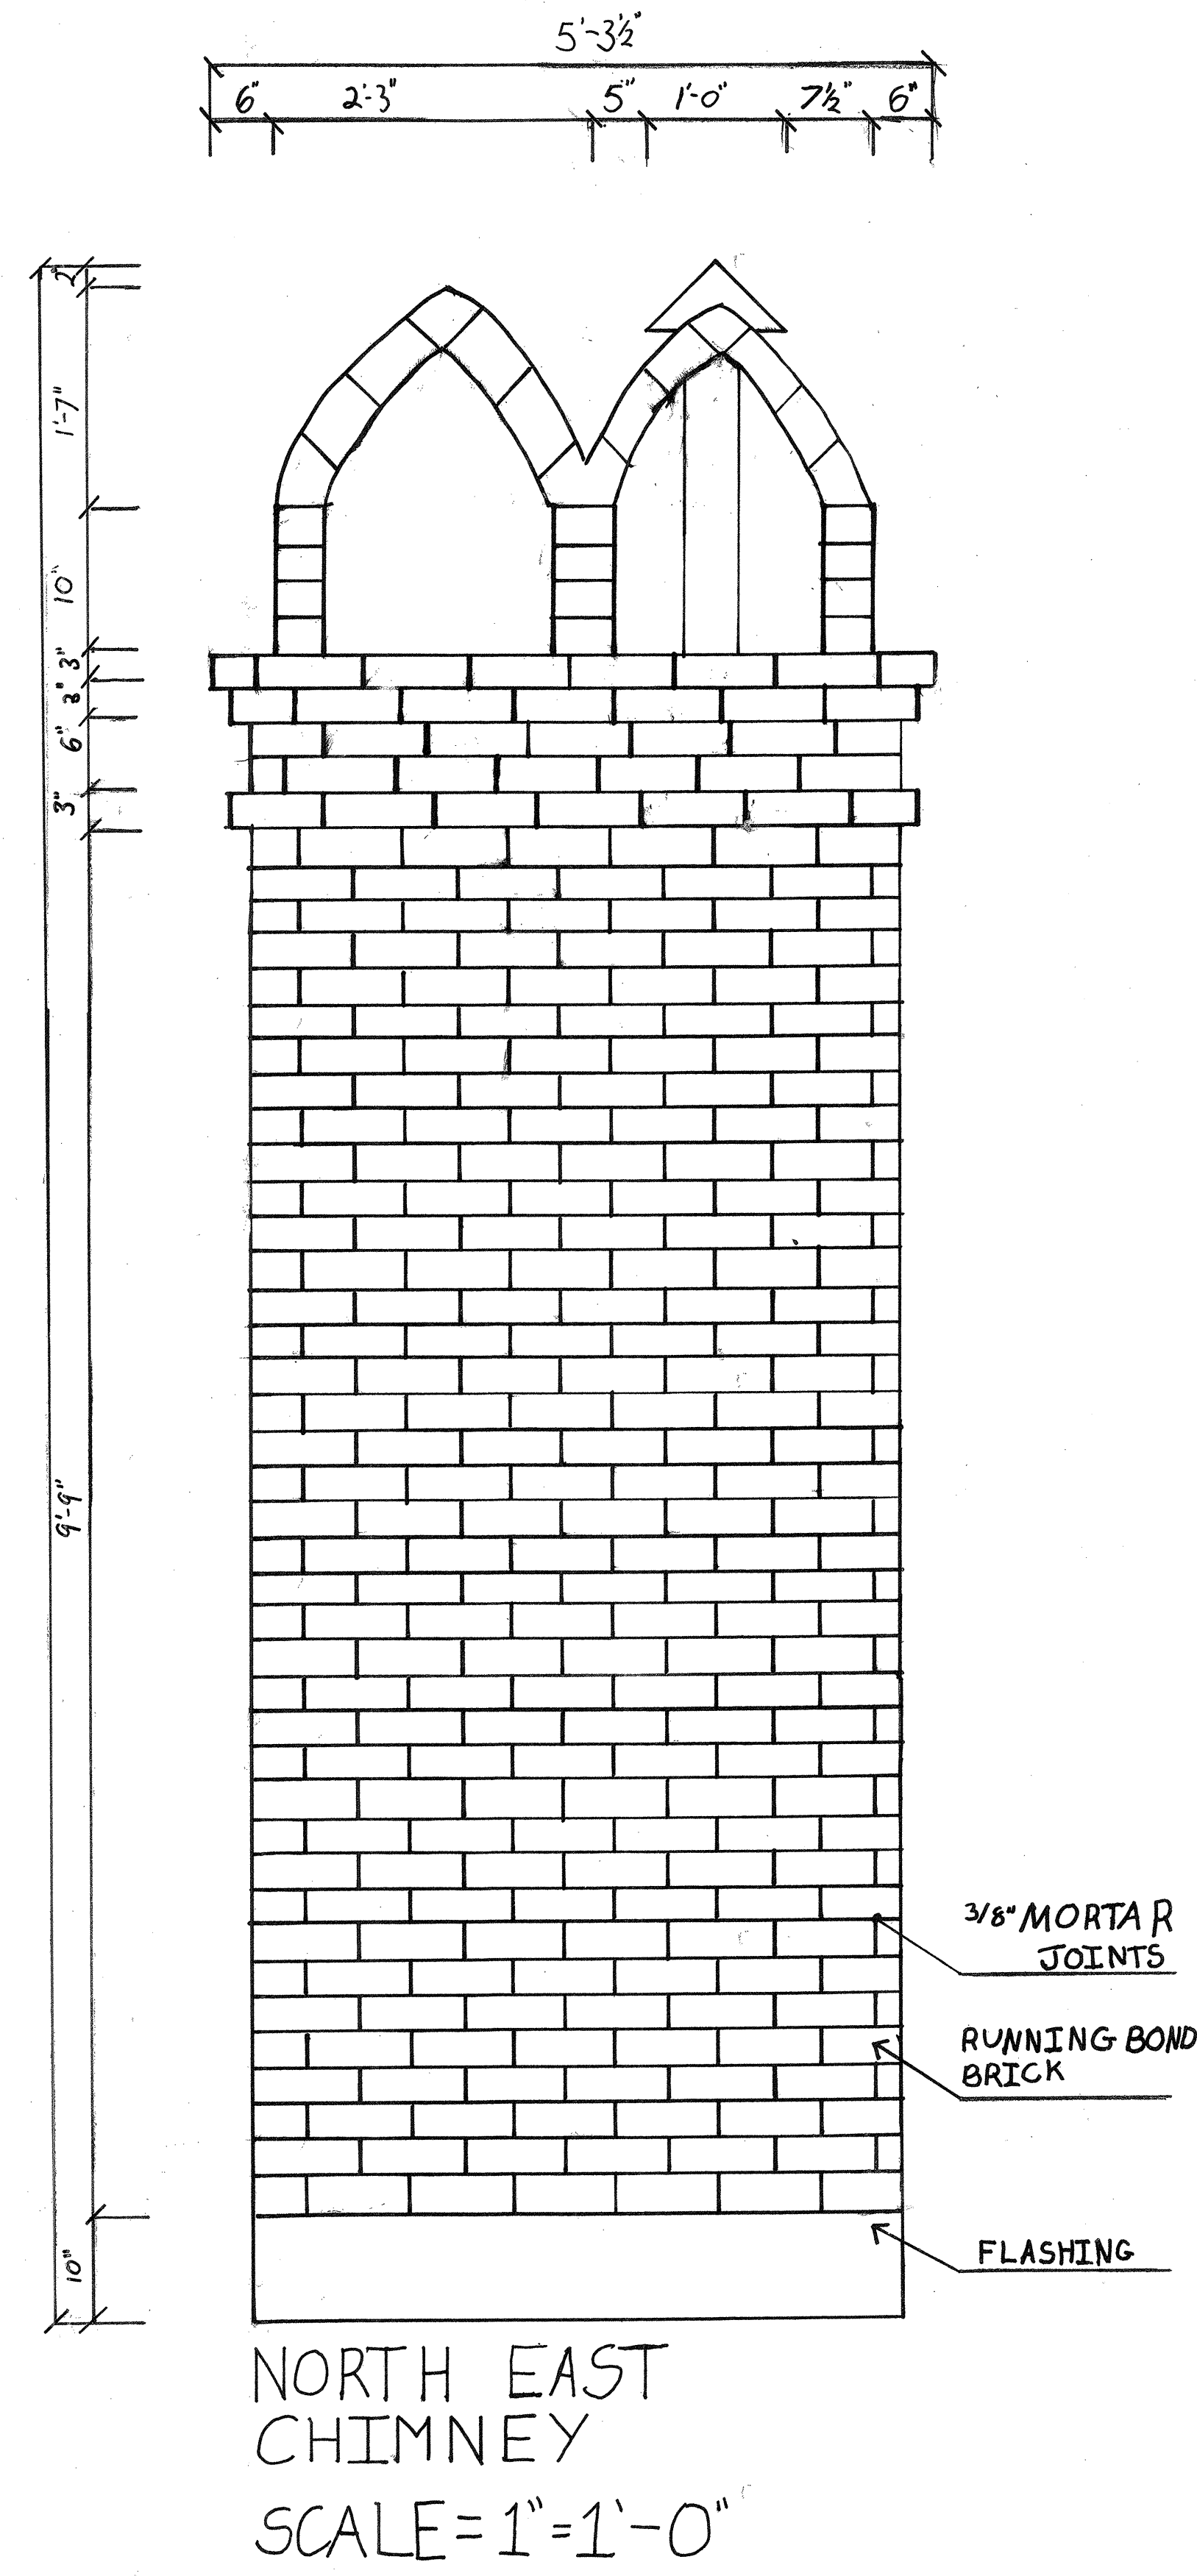
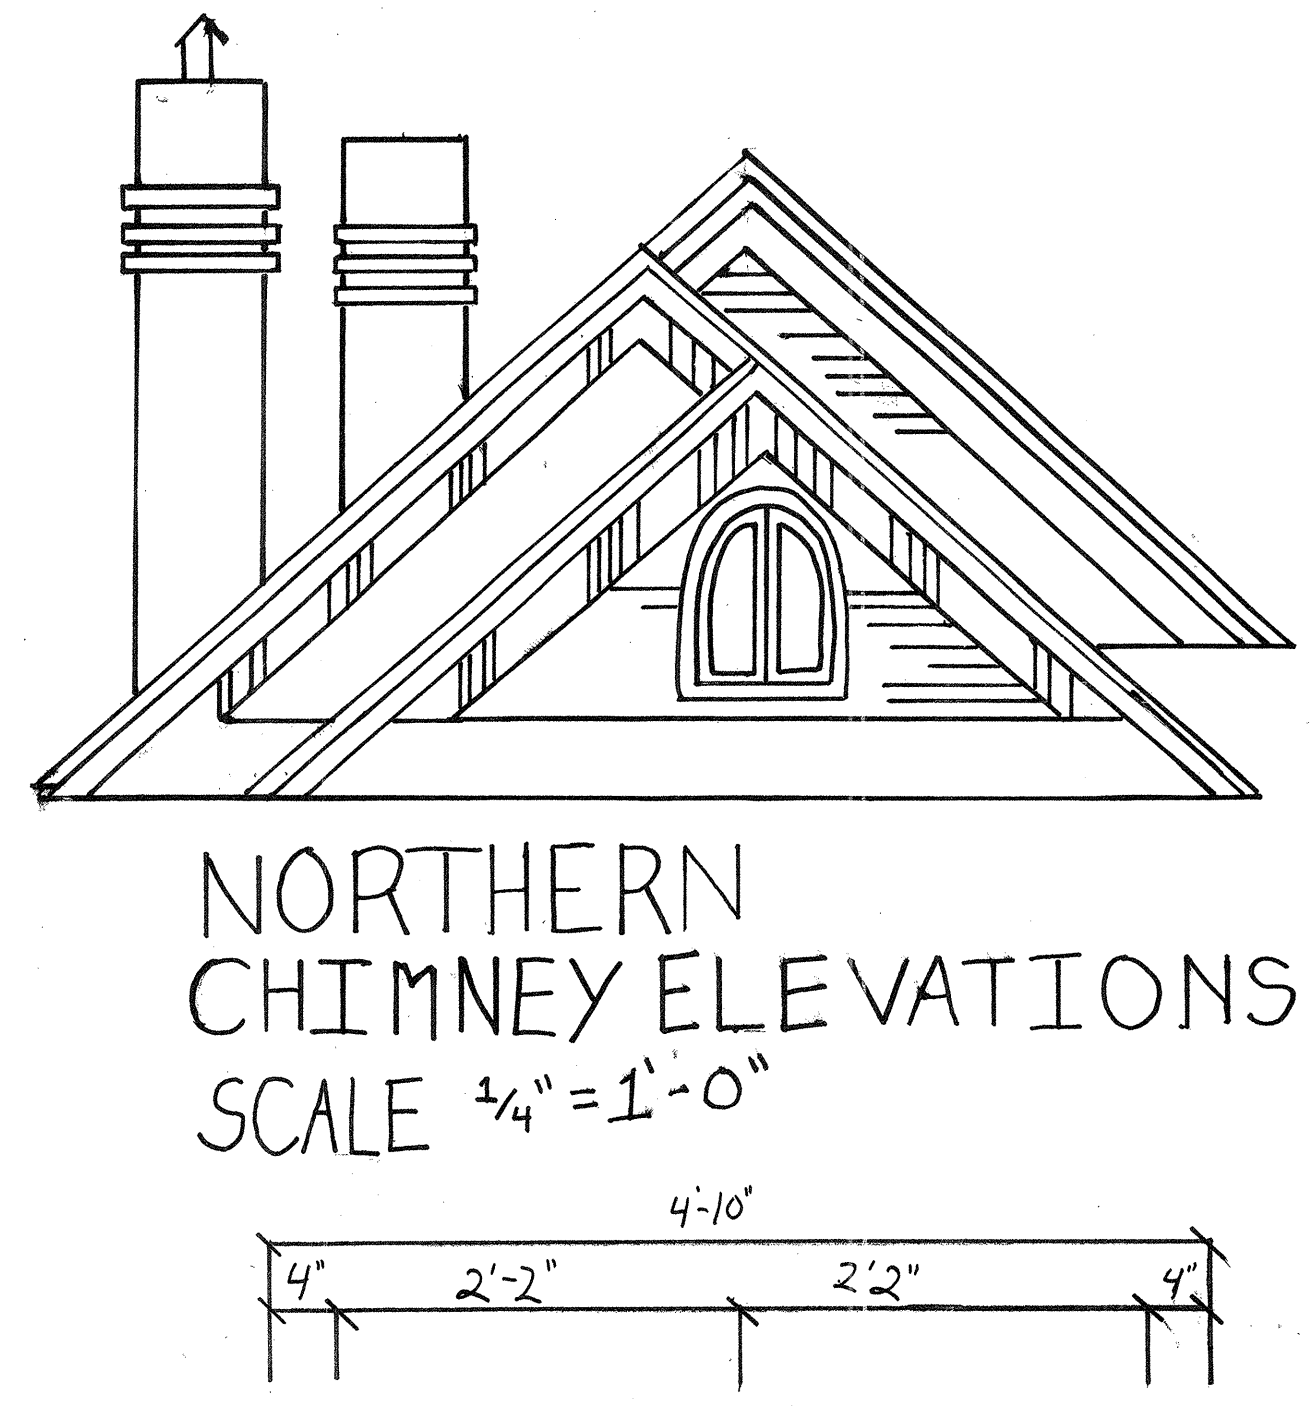
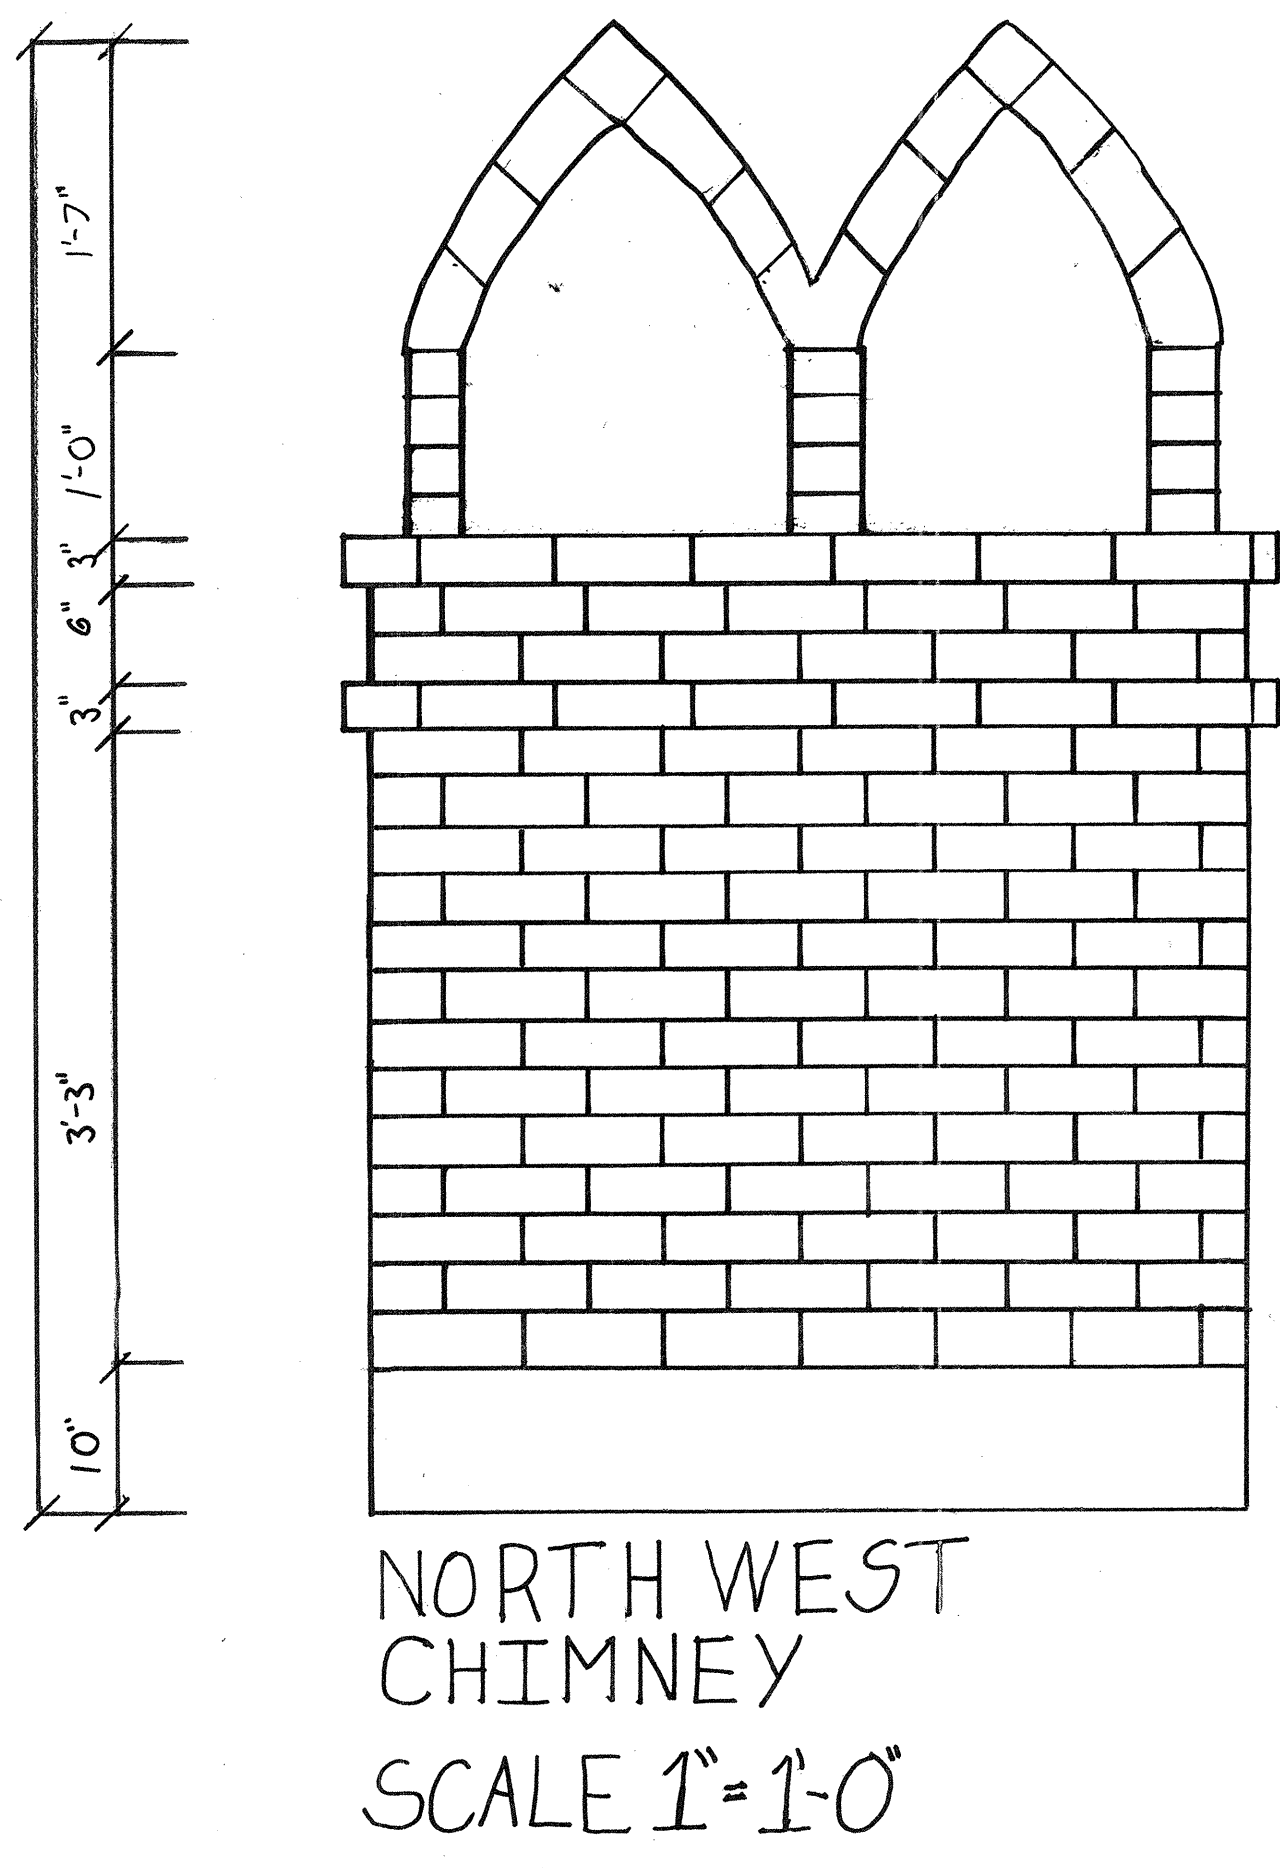
22 Glebe contains three chimneys; two identical chimneys stand at the northwest and southeast alignments and one taller stack at northeast. All three are interior brick chimneys. Brick arches adorn the caps of all three.

Investigation of the interior of 22 Glebe revealed all the fireplaces to be blocked off, as such, tests to find cracks (and potential fire hazards) in the chimney are less pressing. Many inspections of the freestanding part of the columns can be done visually, aided with binoculars, such as examinations for cracks and potential failing of the mortar. Rot underneath the roof-sheathing boards as seen from the attic is a sign of deterioration in the base flashing of the chimney. Unfortunately, access to the chimney was unavailable, so checking for such rot was not possible. If visual inspection reveals leaning in the pillar, different procedures may be employed, depending on severity of the case. For slightly leaning chimneys, a metal collar may be installed. For a more advanced lean, an iron collar may provide tension in the wrong areas, thus doing more harm than good. For any case more severe, the other option is deconstructing and repairing. When taking this route, it is important to note that chimneys often contribute to the historical character of the structure, as such, many documentations should be made throughout the procedure. With these notes, the chimney can be reconstructed in the most accurate. It is often encouraged to save as many original bricks as possible. Inspection of 22 Glebe showed no need for any of these procedures as the freestanding columns showed no lean.

Chimney caps were not often included in eighteenth and early nineteenth century architecture. 22 Glebe was constructed around 1905, as such, the chimney caps may not be original. Added later potentially for the benefits of keeping the rain out and the increase of an updraft, these caps are in a compatible style with the use of brick arches.

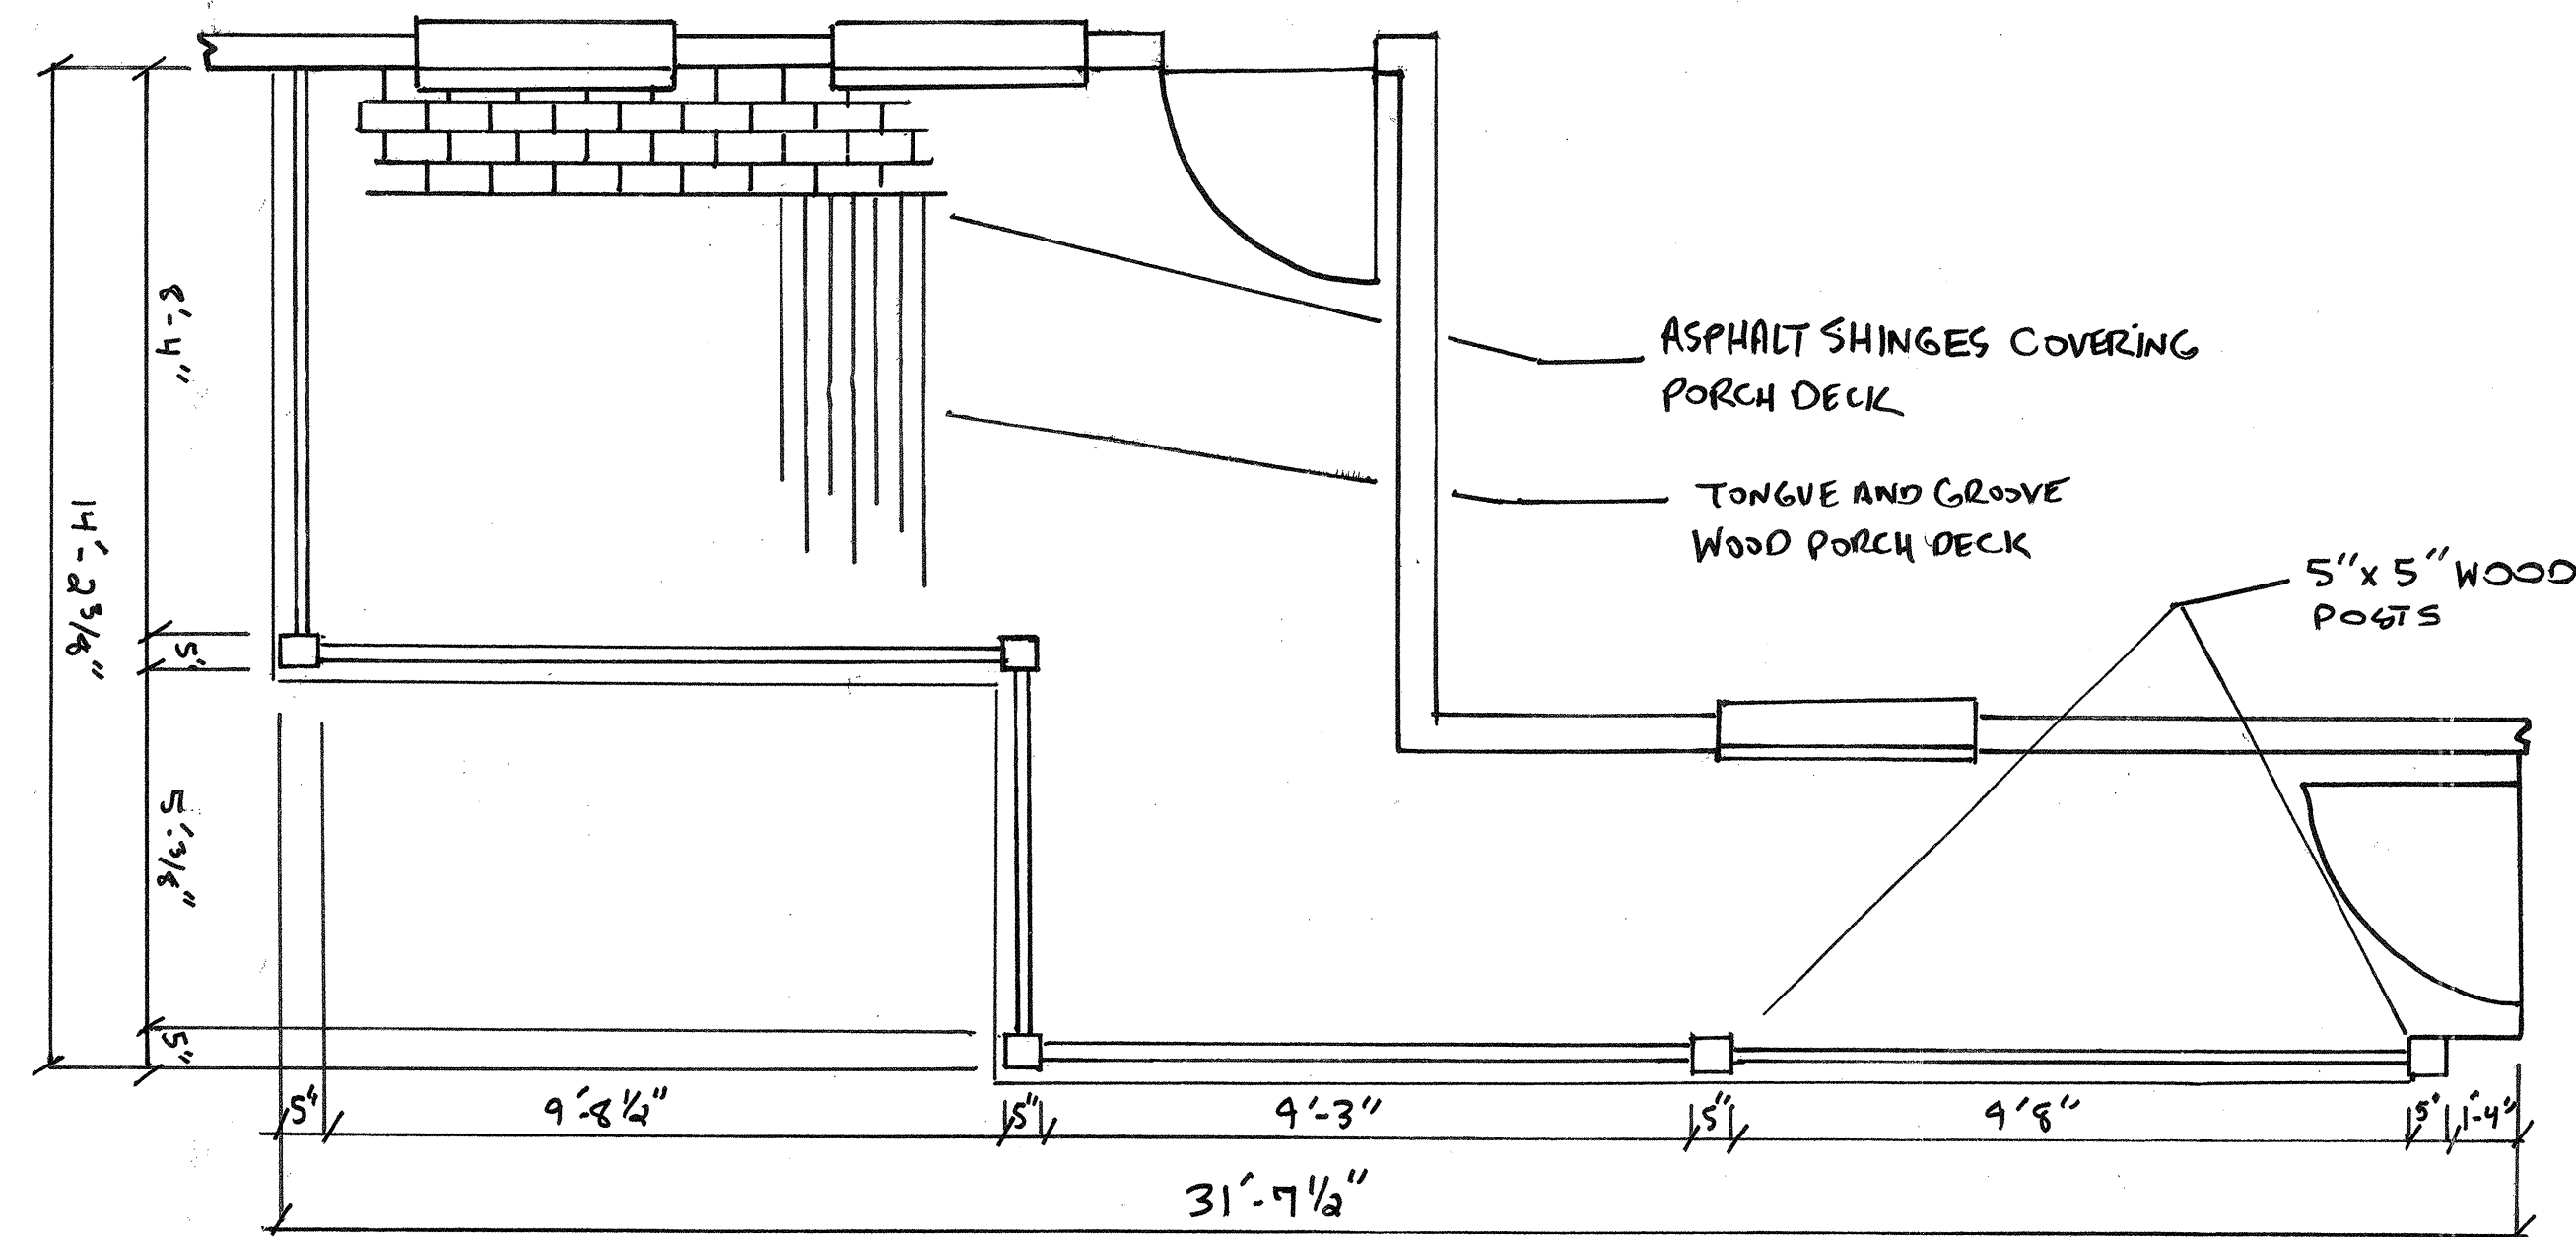
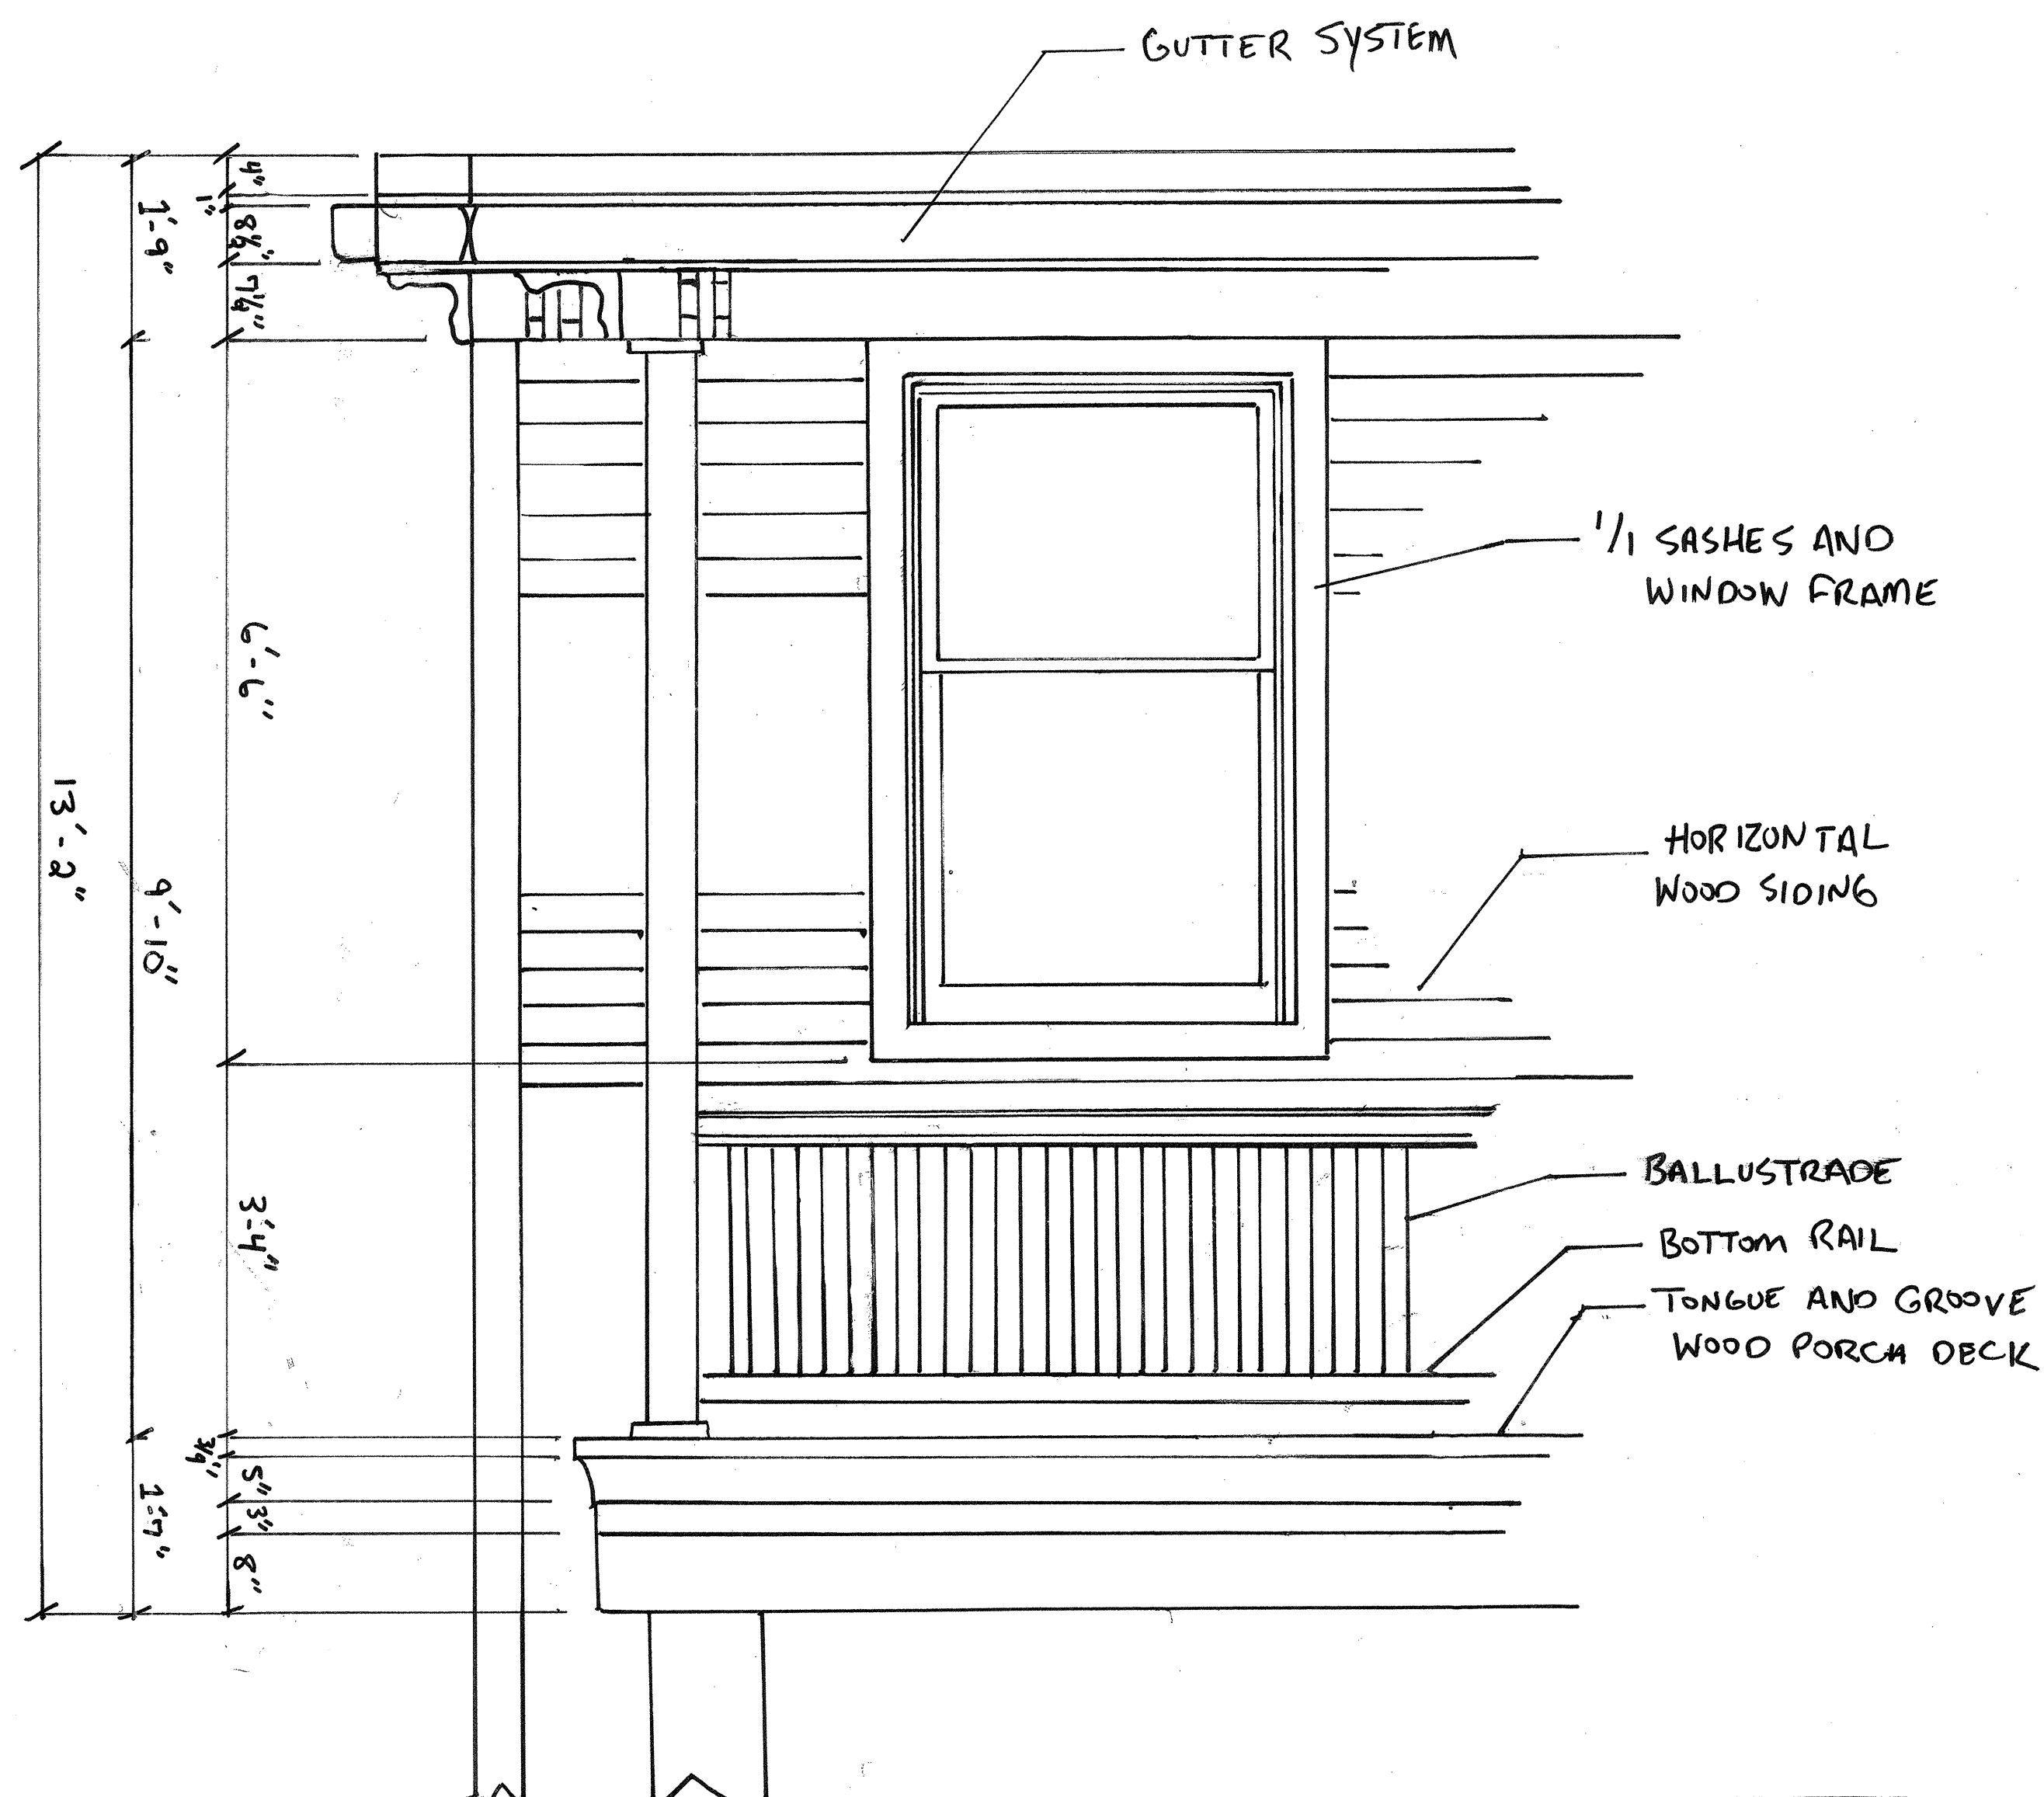
SIDE PORCH DETAIL 2ND FLOOR  
SCALE 3/4" = 1'

PORCH FLOOR IS AT AN ANGLE TO ALLOW FOR WATER RUNOFF

PORCH CEILING HAS WOOD BAT FROM WATER LEAK

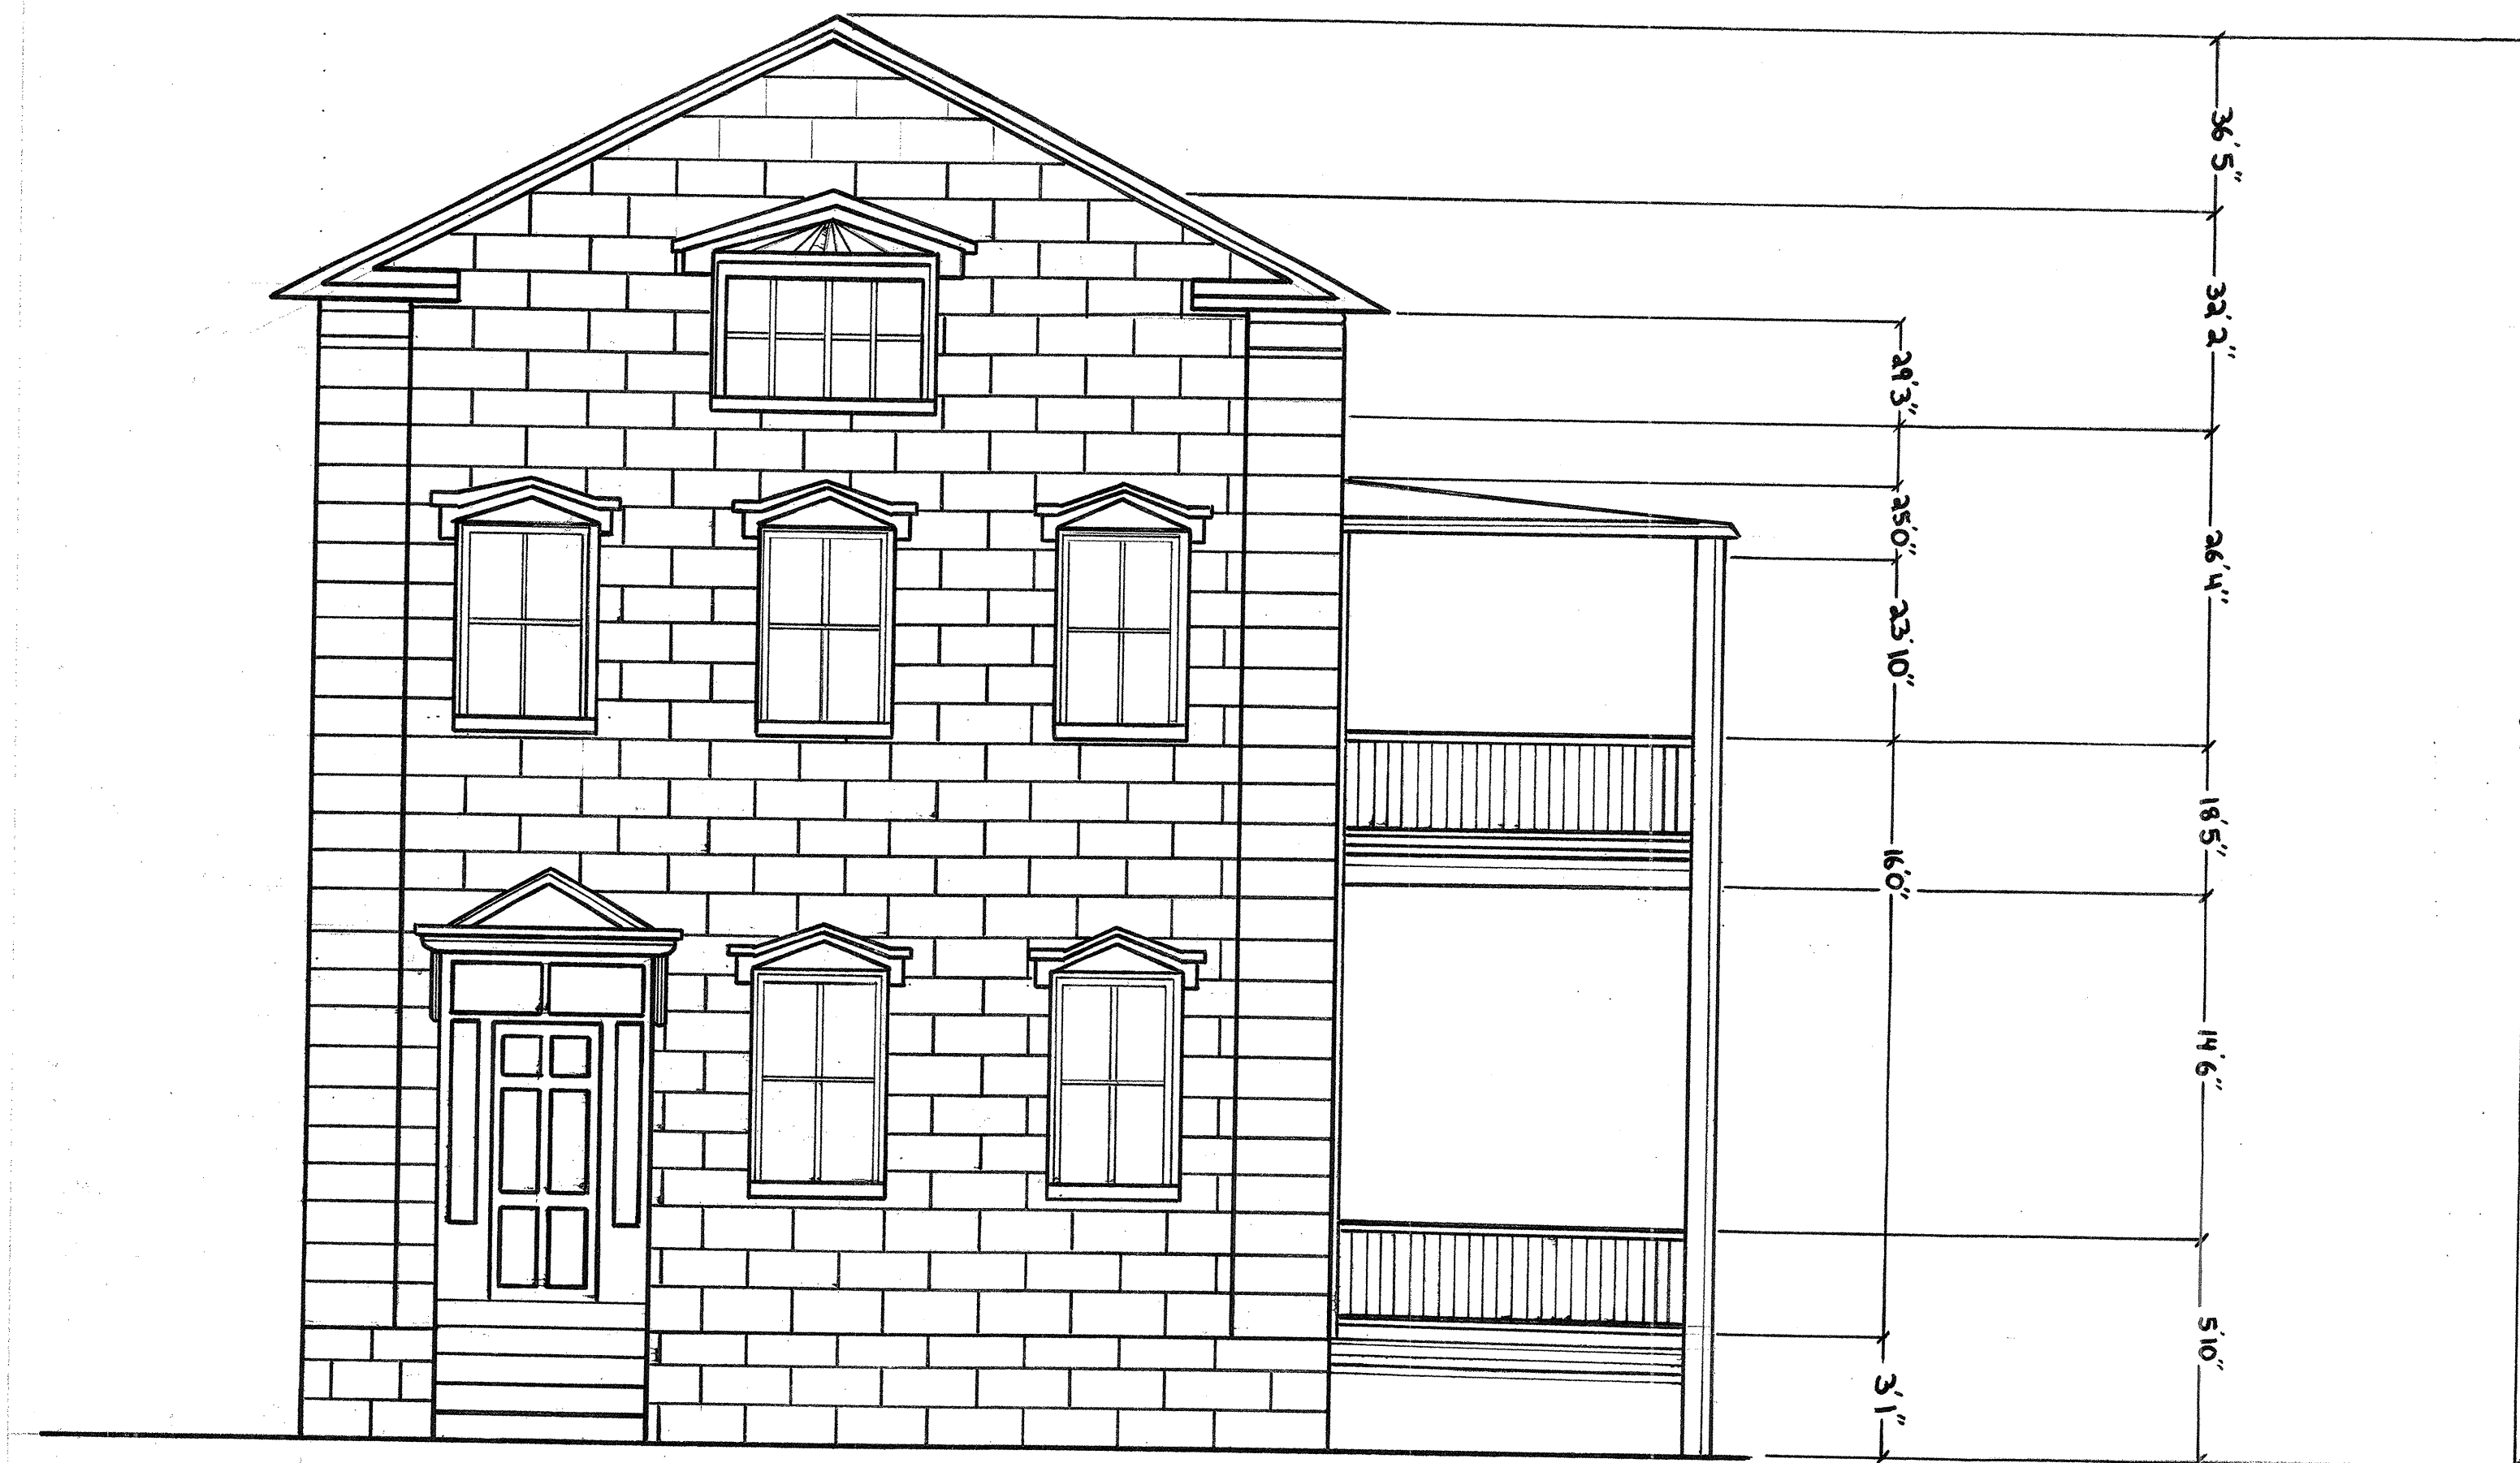
# WEST ELEVATION

NOTES:  
 ① STRUCTURE IS MASONRY COVERED IN STUCCO (POSSIBLY NATURAL CEMENT)  
 ② BUILT ON BRICK PIER FOUNDATION  
 ③ HVAC ARE LOCATED IN CRAWL SPACE  
 ④ ALL MEASUREMENTS FOR WINDOWS AND DOORS ARE FRAME TO FRAME  
 ⑤ ROOF CONSTRUCTION IS SLATE  
 ⑥ TOP OF ROOF IS LINED WITH TERRACOTTA  
 ⑦ SLATE SHINGLES ARE 9" TALL  
 ⑧ ROOF MEASURED BY SHINGLE COUNT  
 ⑨ ROOF HAS ISSUES WITH FLASHING AND IMPROPER INSTALLATION OF MATERIALS

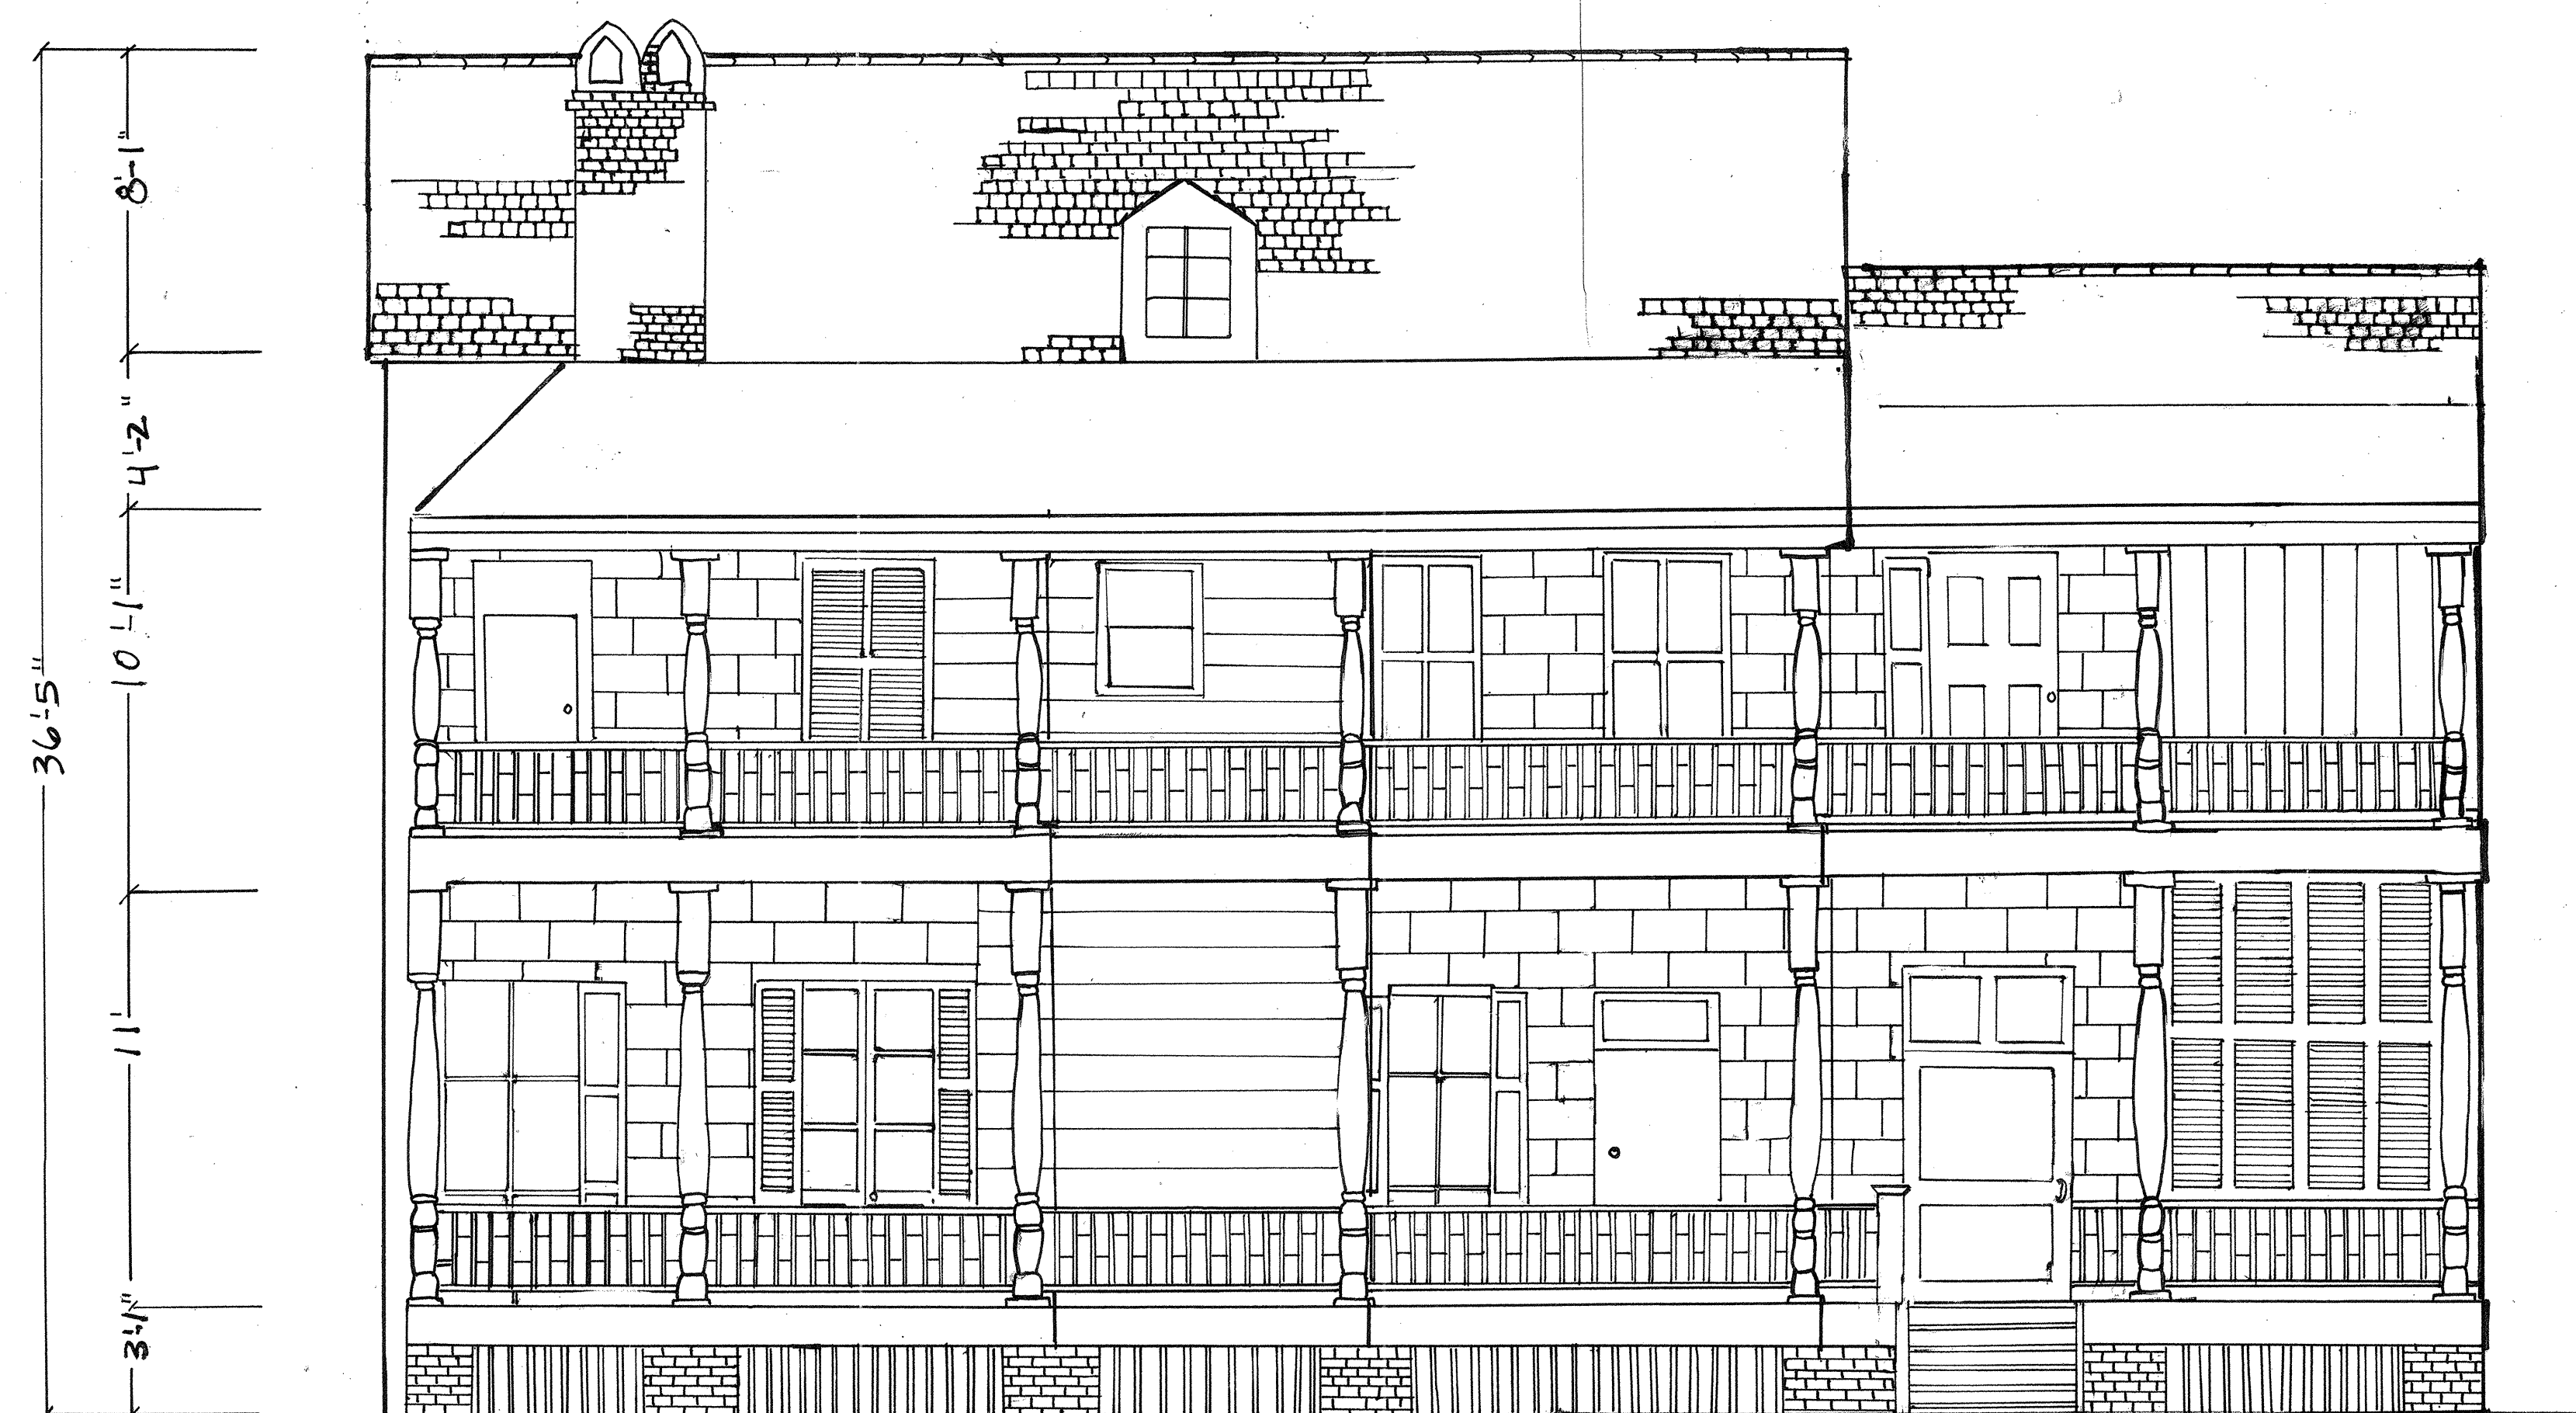
# SOUTH ELEVATION

NOTES:  
 1. STRUCTURE IS MASONRY COVERED IN STUCCO (POSSIBLY NATURAL CEMENT)  
 2. BUILT ON BRICK PIER FOUNDATION  
 3. HVAC ARE LOCATED IN CRAWL SPACE  
 4. ALL MEASUREMENTS FOR WINDOWS AND DOORS ARE FRAME TO FRAME  
 5. ROOF CONSTRUCTION IS SLATE  
 6. TOP OF ROOF IS LINED WITH TERRA COTTA  
 7. SLATE SHINGLES ARE 9" TALL  
 8. ROOF MEASURED BY SHINGLE COUNT  
 9. ROOF HAS ISSUES WITH FLASHING AND IMPROPER INSTALLATION OF MATERIALS
