| JAMES LIPHUS WARD<br>SC RLA | | <b>GLEBE STREET RESIDENCES</b> | |
| COLLEGE OF CHARLESTON<br>HPCP 299-SPRING 2010<br>HISTORIC PRESERVATION &<br>COMMUNITY PLANNING | | DRAWING TITLE:<br><b>14 GLEBE STREET</b><br><b>Floor Plan</b><br>DRAWING PREPARED BY (TEAM/INDIVIDUAL):<br><b>TEAM: Galtor Frick Voneshatz</b> | |

| JAMES LIPPHUS WARD<br>SC RLA | | GLEBE STREET RESIDENCES | |
| COLLEGE OF CHARLESTON<br>HPCP 209-SPRING 2010 | | DRAWING TITLE:<br>14 GLEBE ST<br>ELEVATIONS | |

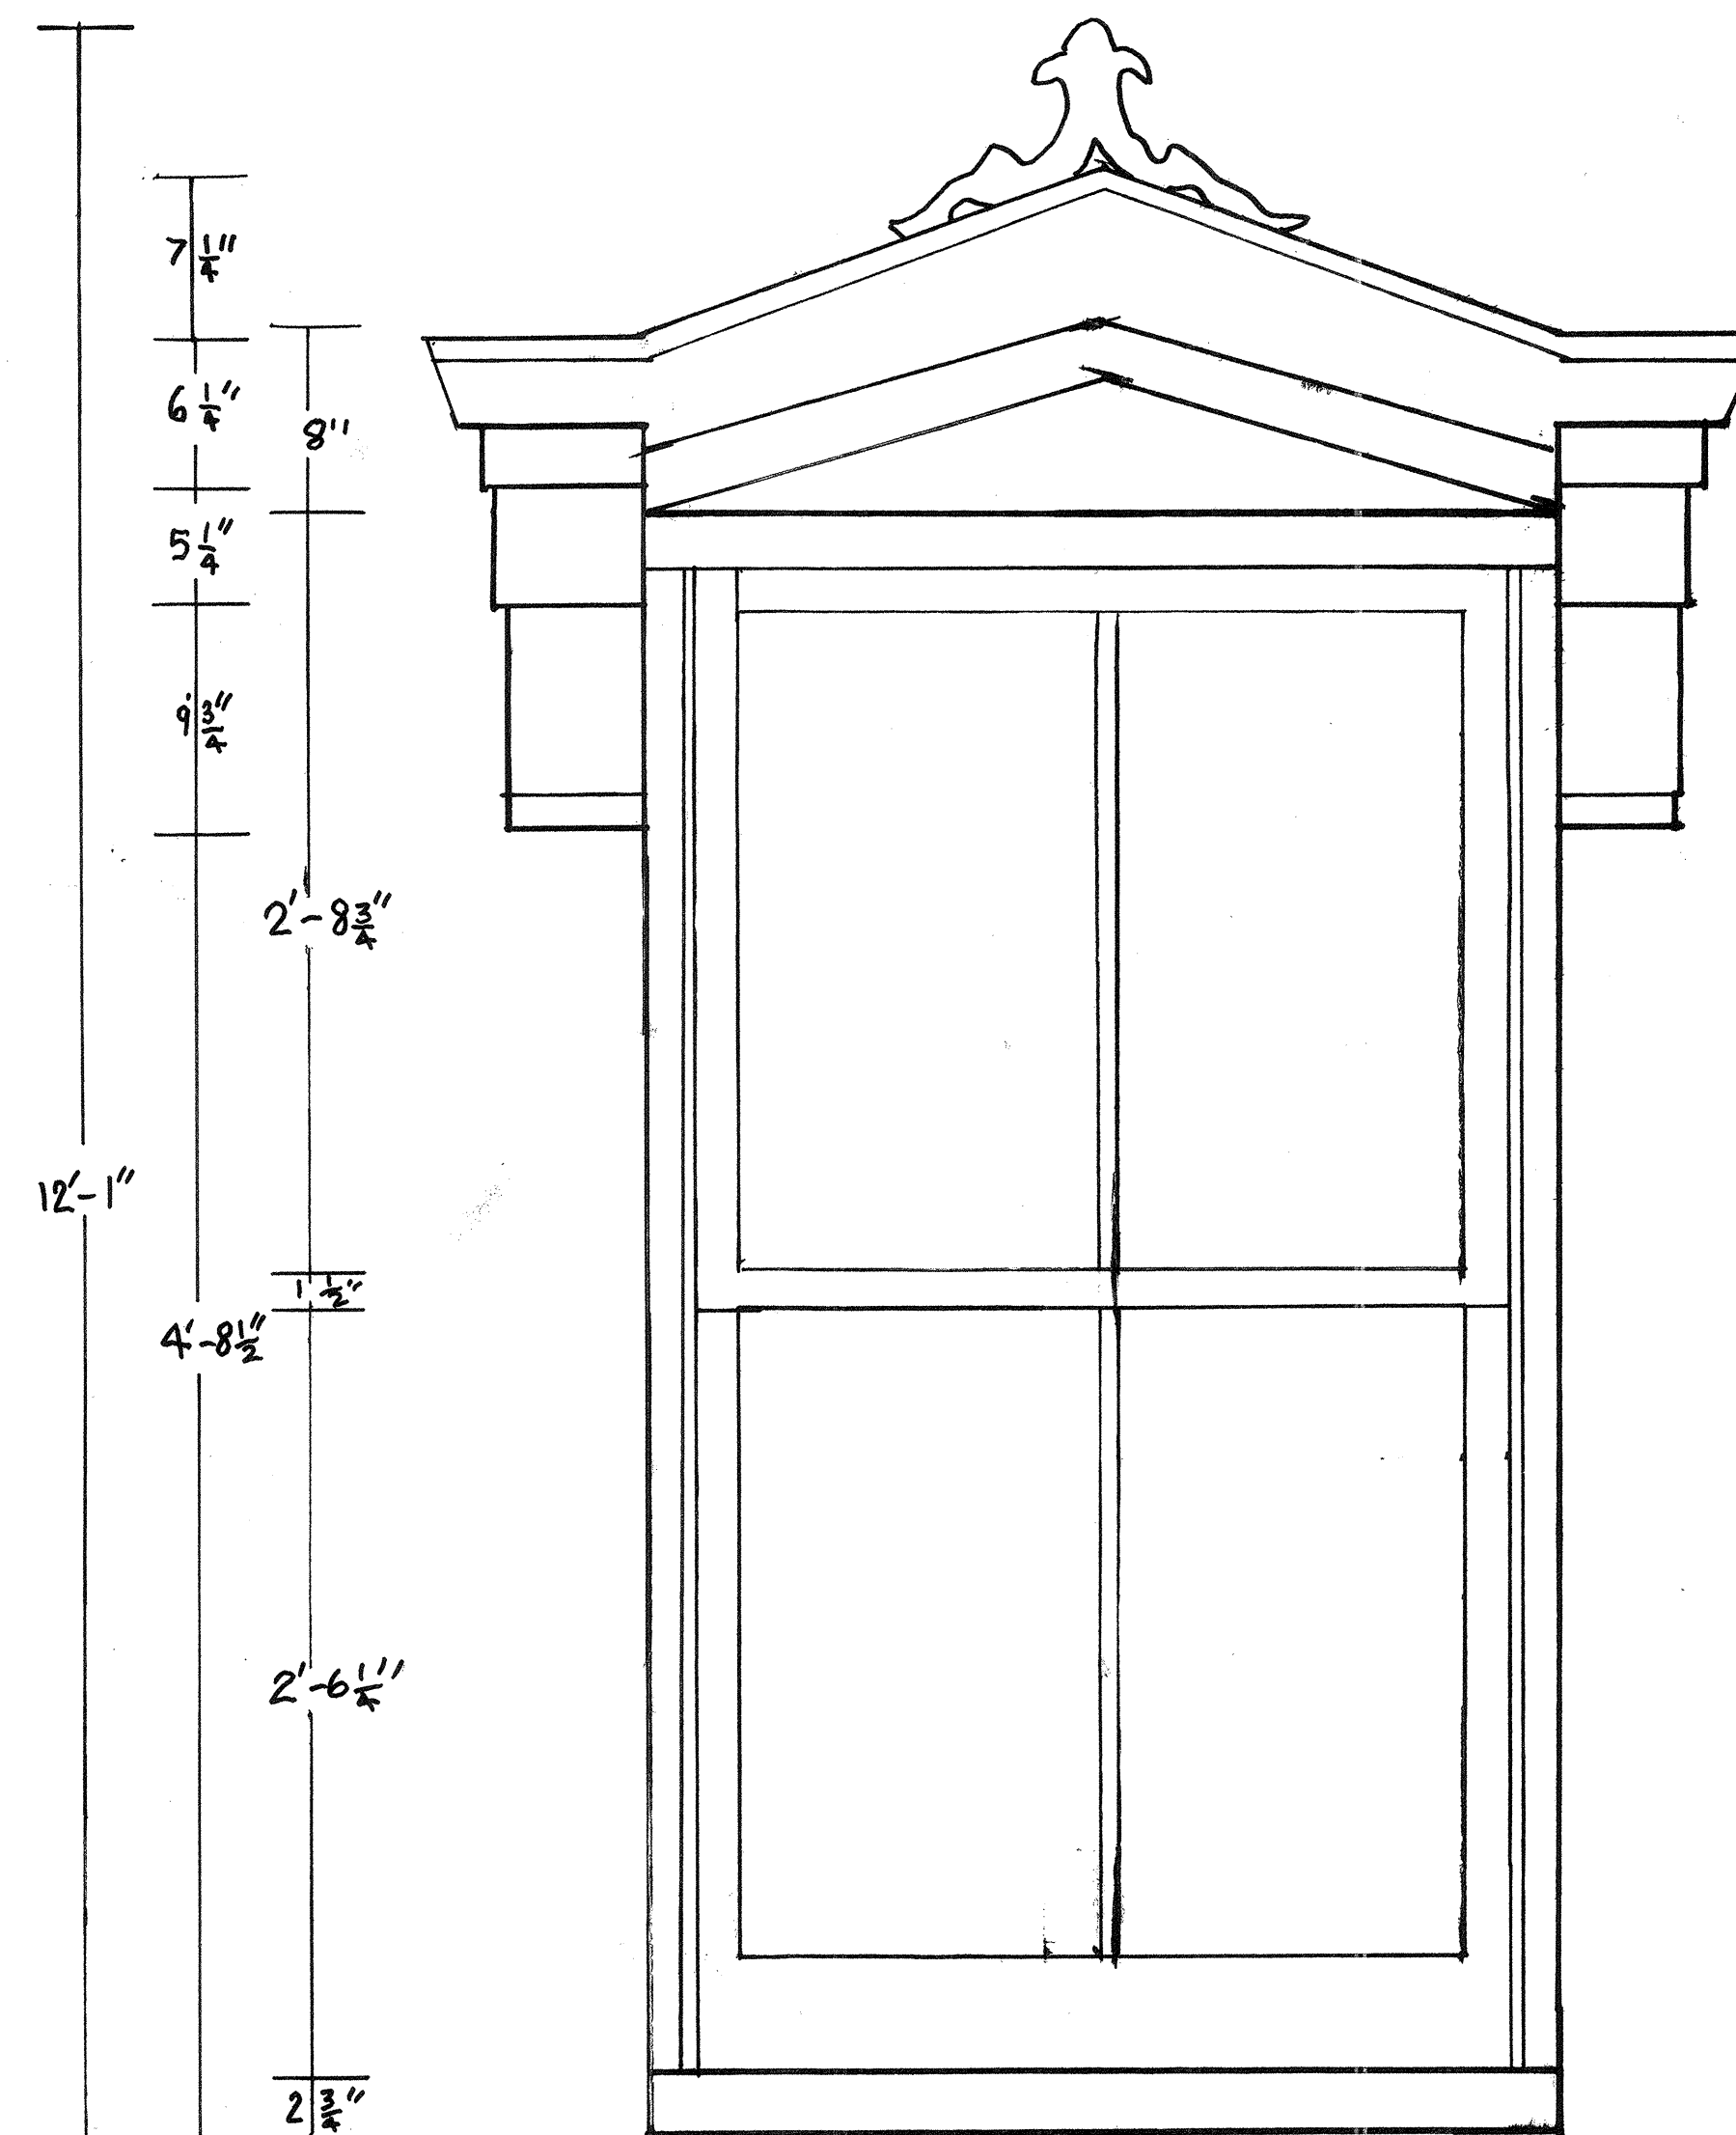
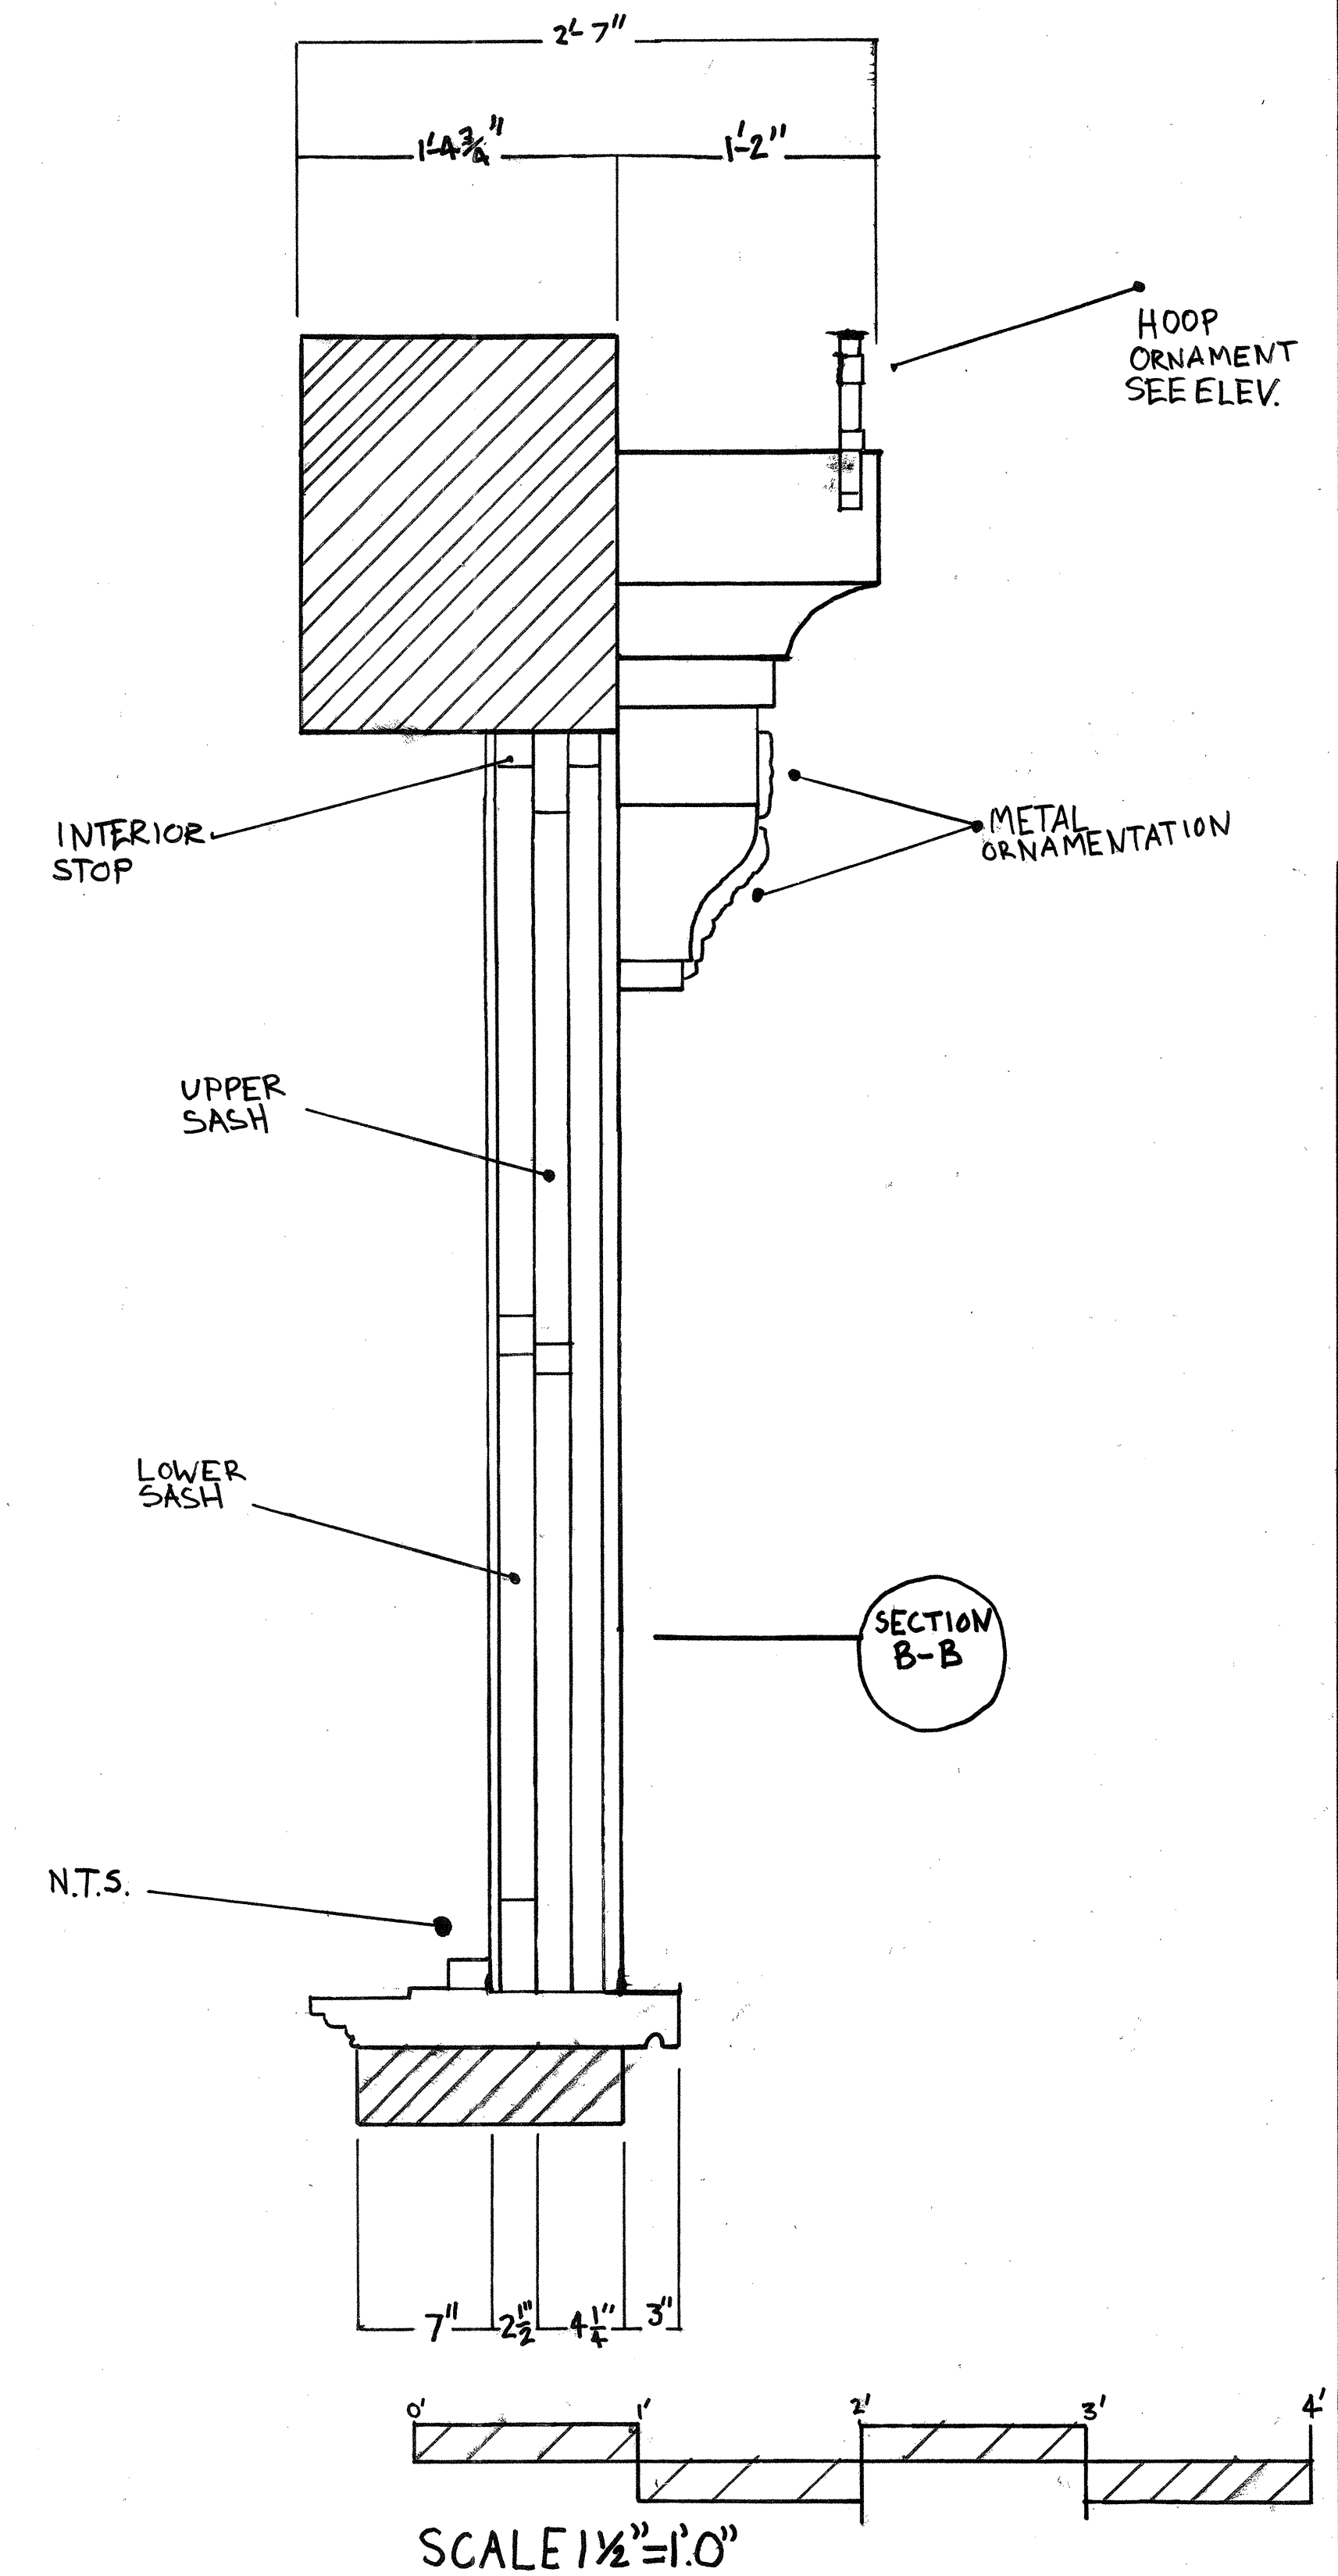
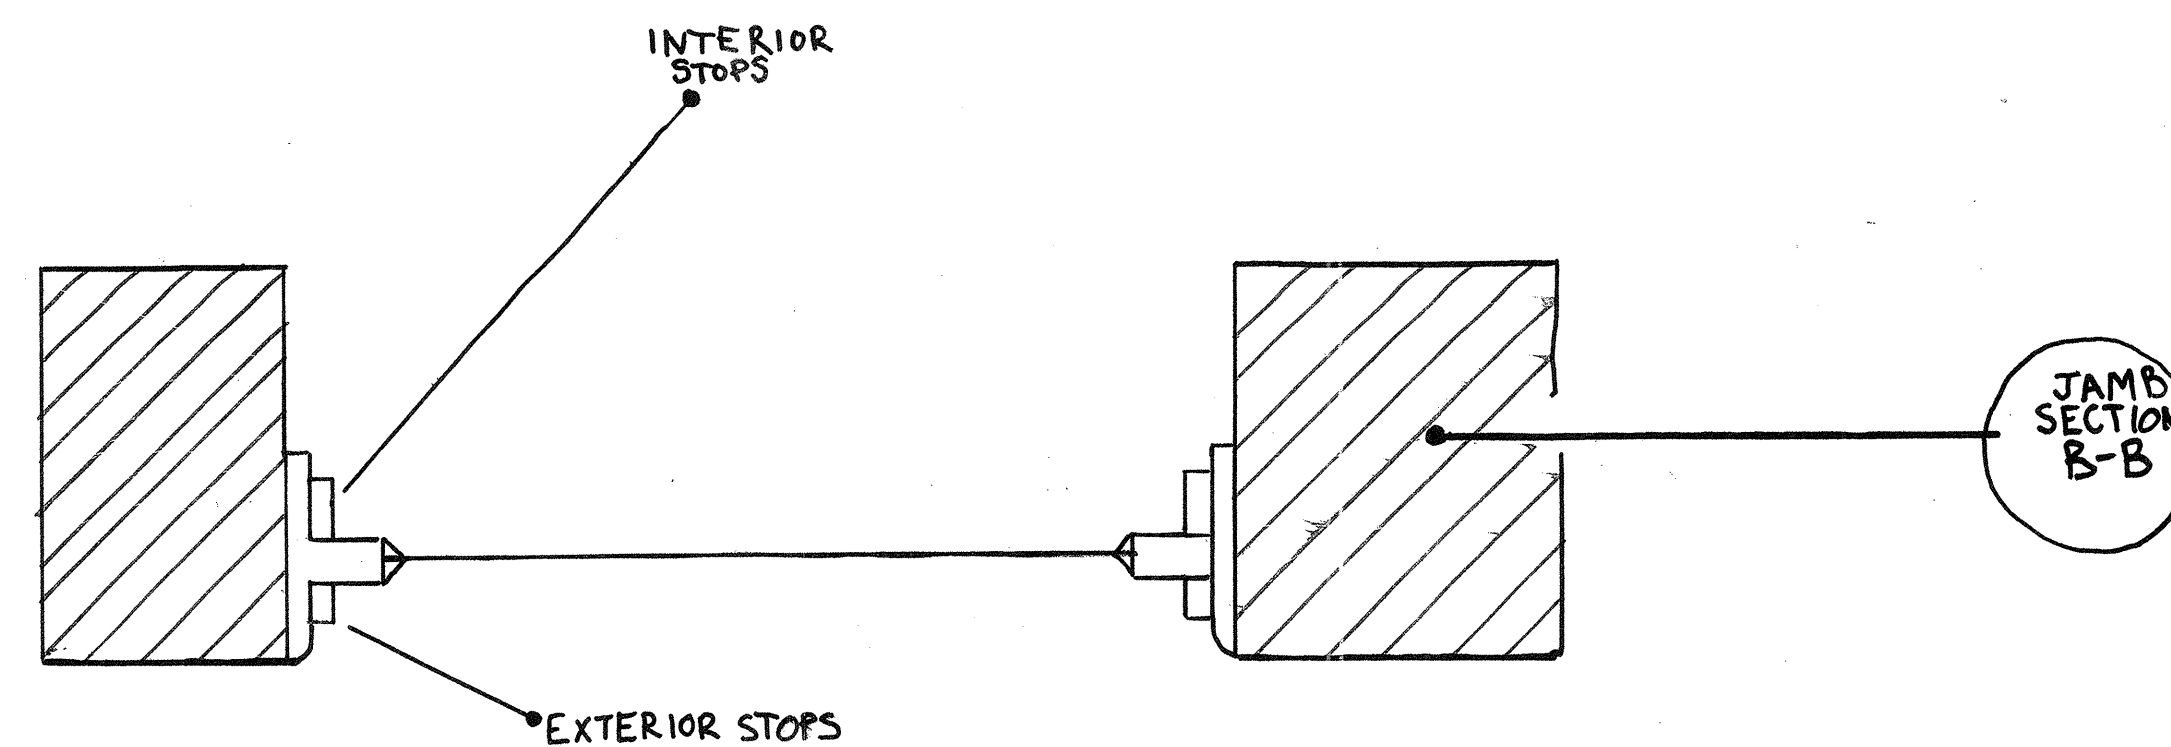
- The principle issue regarding the windows on 26 Glebe Street is the lack of maintenance due to neglect.
- To bring historic wooden windows to like new condition usually requires:

- And of course, some repainting consistent to the style of the structure
- Mildew is growing on some of the exterior window moldings, this issue can be solved by simply wiping off mildew with bleach. (Note: always test the surface before using cleaners so there is not further damage done). One can tell it is mildew, as opposed to dirt, because mildew will come off with bleach and dirt will become mud.

- The ornamentation on top of some moldings have been mutilated or fallen off. The moldings should be replaced by duplicating one of the existing ones and making new historically accurate metal moldings.

- Some level of interior or exterior paint removal.
  - Removal and repair of sash, including re-glazing if necessary
  - Repairs to the frame
  - Repairs to the weather stripping and reinstallation of the sash

- The appropriate weather stripping should be added to the window after maintenance to retrofit the structure to reduce air infiltration. Appropriate contemporary weather-stripping should be considered an integral part of the repair process to windows.

- Consider adding a modern quality storm window to provide insulation between the frames for better energy efficiency.

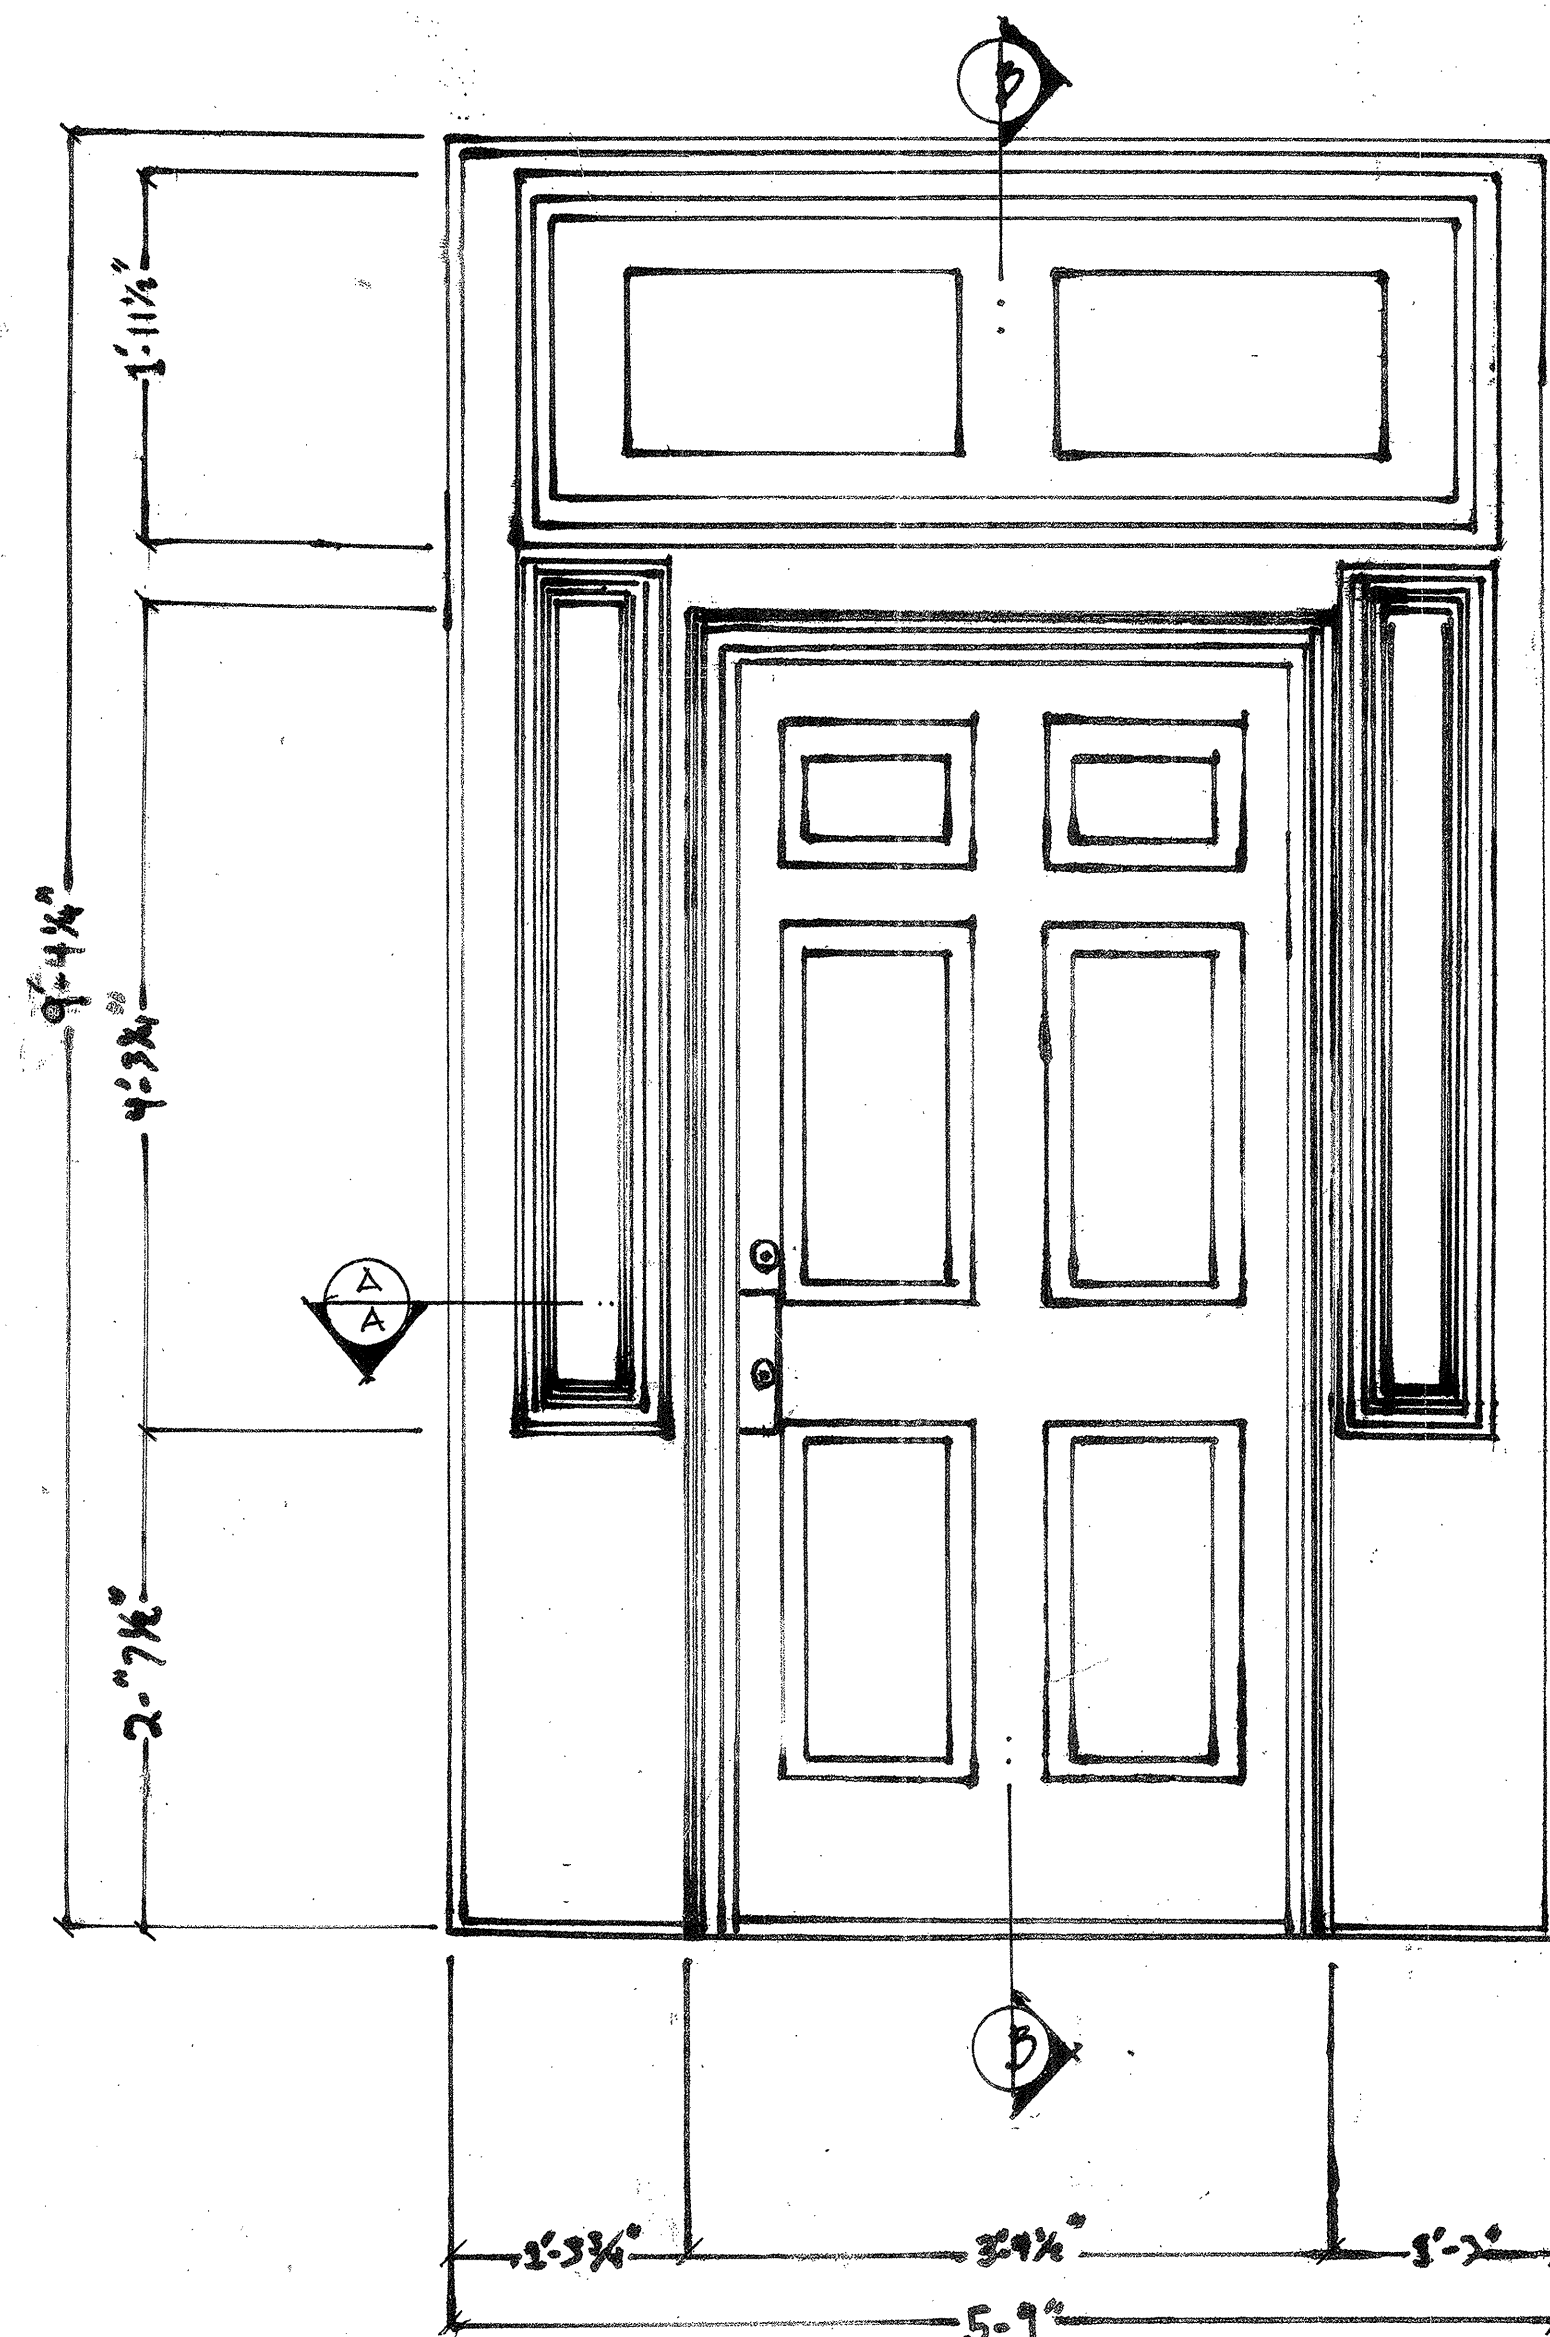
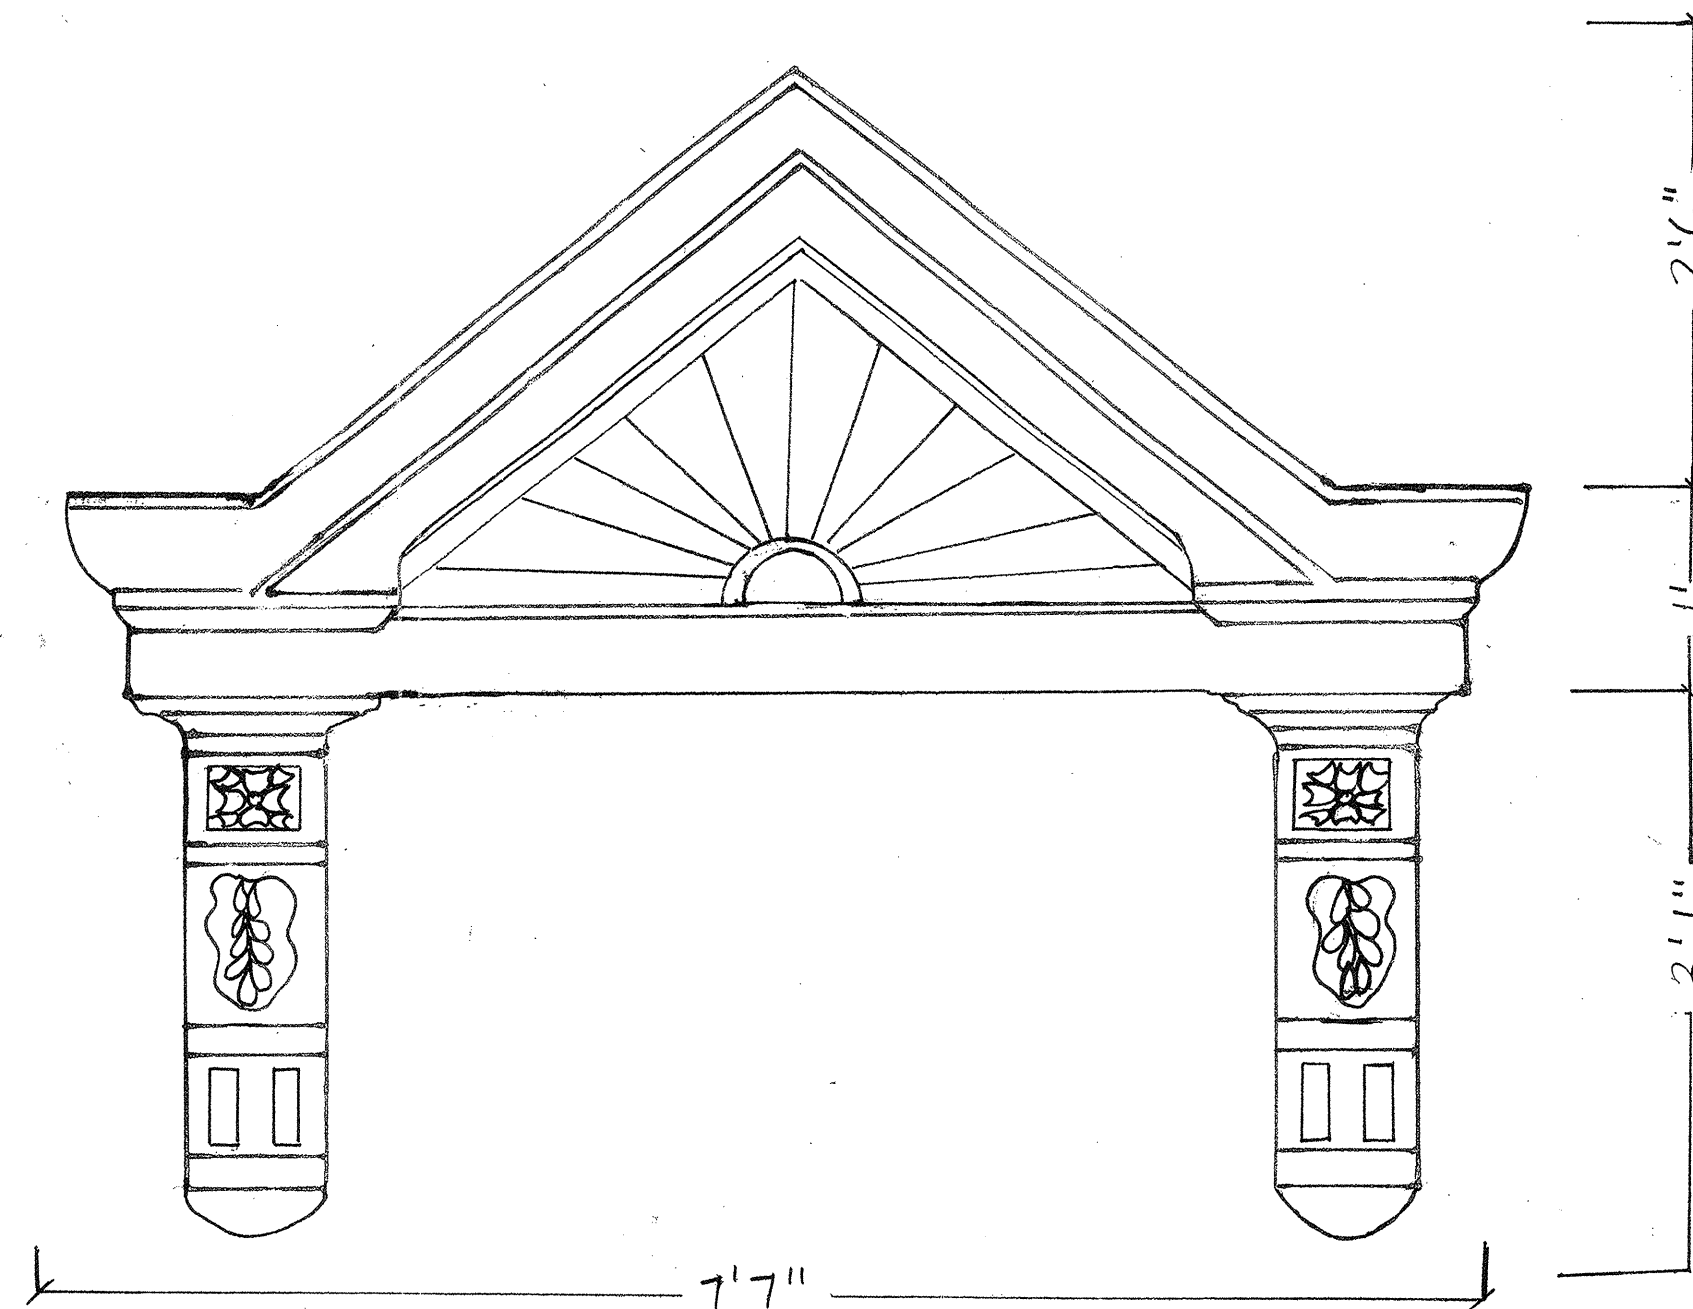
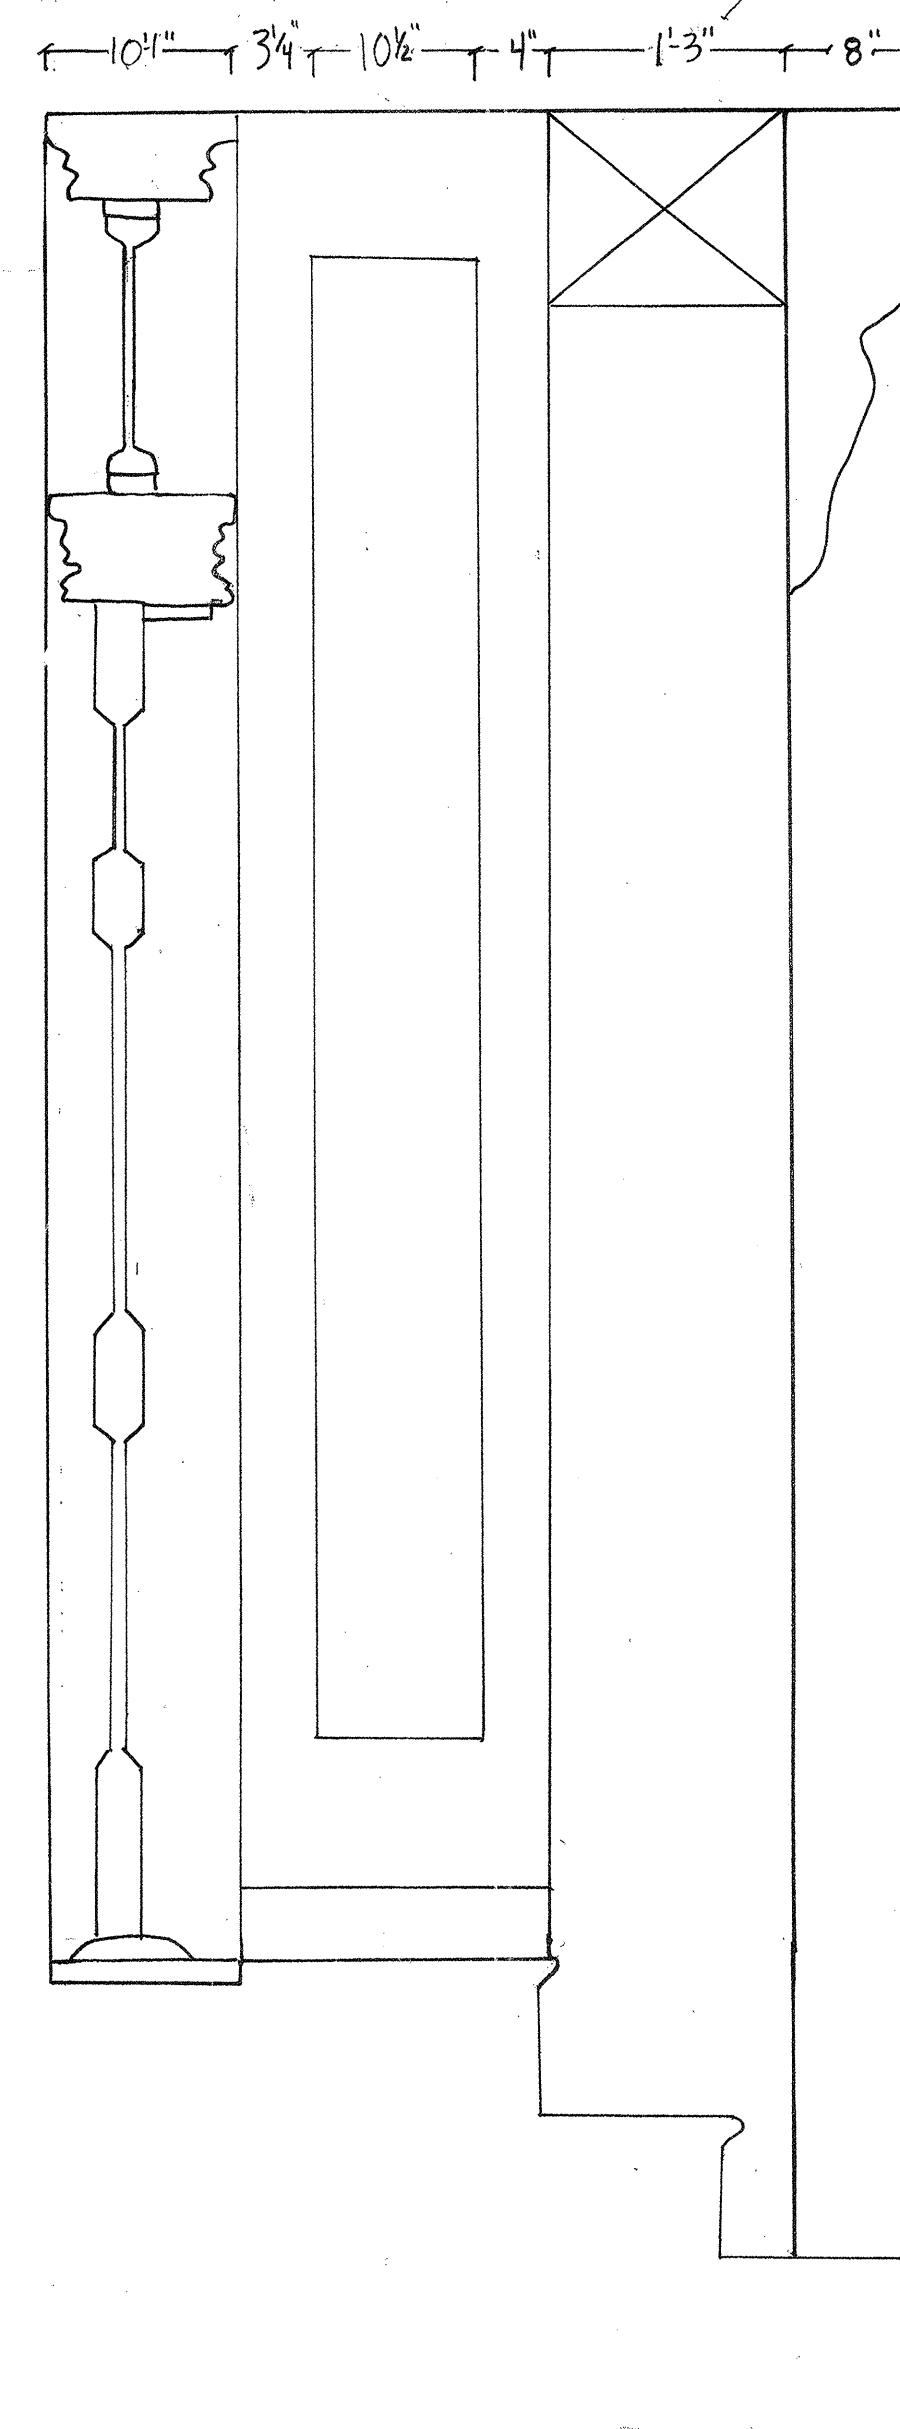
NOTES:  
 ① THE ORIGINAL DOOR HAS BEEN REMOVED AND REPLACED BY A GENERIC DOOR.  
 ② CURRENT DOOR HAS BEEN RECESSED DEEPER INTO LOGGIA.  
 ③ THE GLASS ETCHING OVER THE DOOR IS ORIGINAL.  
 ④ STEPS ARE MARBLE.  
 ⑤ MARBLE IS CHIPPED AND CRACKING.  
 ⑥ CRACKING SHOULD BE STABILIZED TO PREVENT FURTHER DAMAGE.  
 ⑦ THE MOLDINGS AND HARDWARE ARE NOT ORIGINAL.
