HABS OUTLINE

The Redeemer Presbyterian Church and Fellowship Hall (HABS number)  
Location: 43 Wentworth Street, Charleston, SC 29401  
Present Owner: Holy Spirit Evangelical Lutheran Church  
Present Use: 43 Wentworth Street is used for its own church services and programs.  
Significance: The 43 Wentworth Street annex is currently undergoing the legal process of possibly being converted into a residential site. The Redeemer Presbyterian Church congregation is hoping to halt this process, and as a result this HABS report acts in part as a rescue preservation plan.

# Redeemer Episcopal Church and Annex

DOCUMENTARY DRAWINGS  
College of Charleston  
Program in Historic Preservation and Community Planning

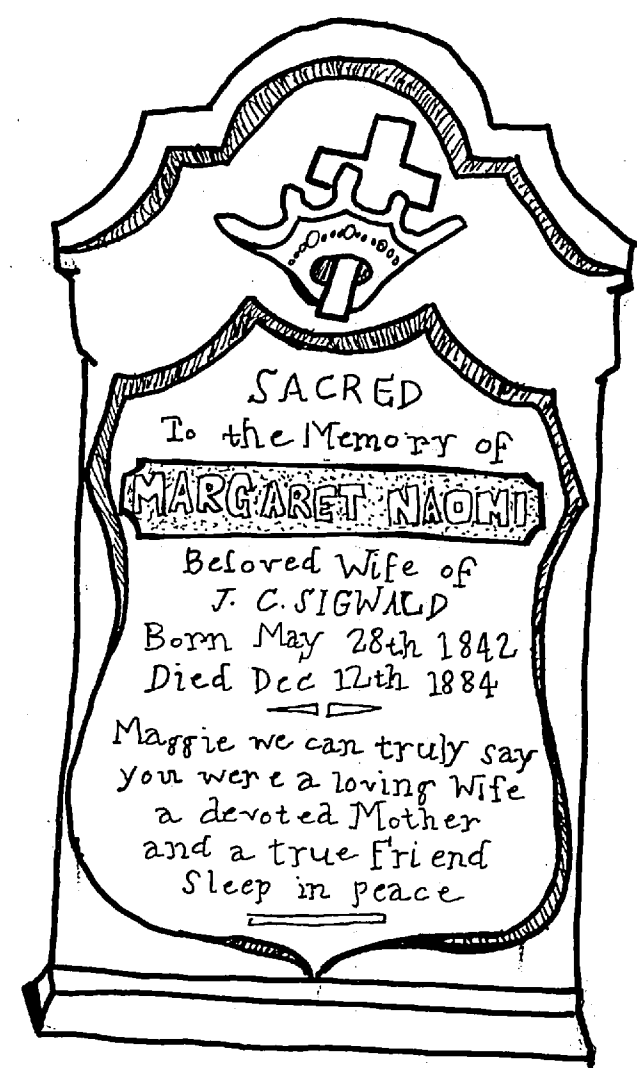
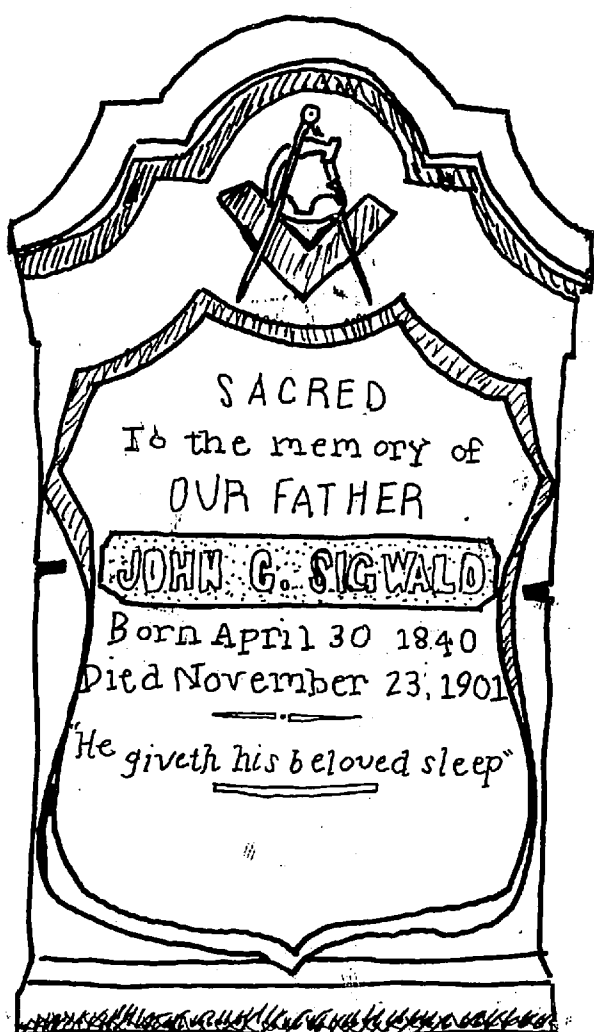
DETAIL OF GRAVESTONES  
43 WENTWORTH

As previously mentioned, most of these headstones have been sandblasted. Unfortunately, this degrades their beauty and demolishes future types of preservation. Sandblasted headstones feel grainy to the touch, and are more prone to chipping. Sandblasting was most likely a former attempt to clean, or touch up the headstone. However, there are now techniques listed on websites like these<sup>3</sup>, which designate the correct way to clean and preserve headstones.

First, the abrasive method of cleaning is damaging to the aesthetic quality of the marker. Secondly, methods like sandblasting alter the material it is "treating" leaving it susceptible to the elements. The headstones at 43 Wentworth are most likely limestone and are therefore more porous, softer, and chemically sensitive than other types of stone. The result of abrasive cleaning on this type of stone, as previously mentioned, eliminates the patina or "quarry crust" that is created by the movement of moisture towards the outer edge of the surface, thereby causing a natural barrier of protection to the material. In addition, sandblasting increases water permeability to the porous stone or can expose and enlarge existing cracks on the surface where water can enter and become damaging to the headstone. Should methods such as these continue to be used in the cleaning of historic headstones we may come upon a time when these artistic and handcrafted structure are merely a relic of the past.

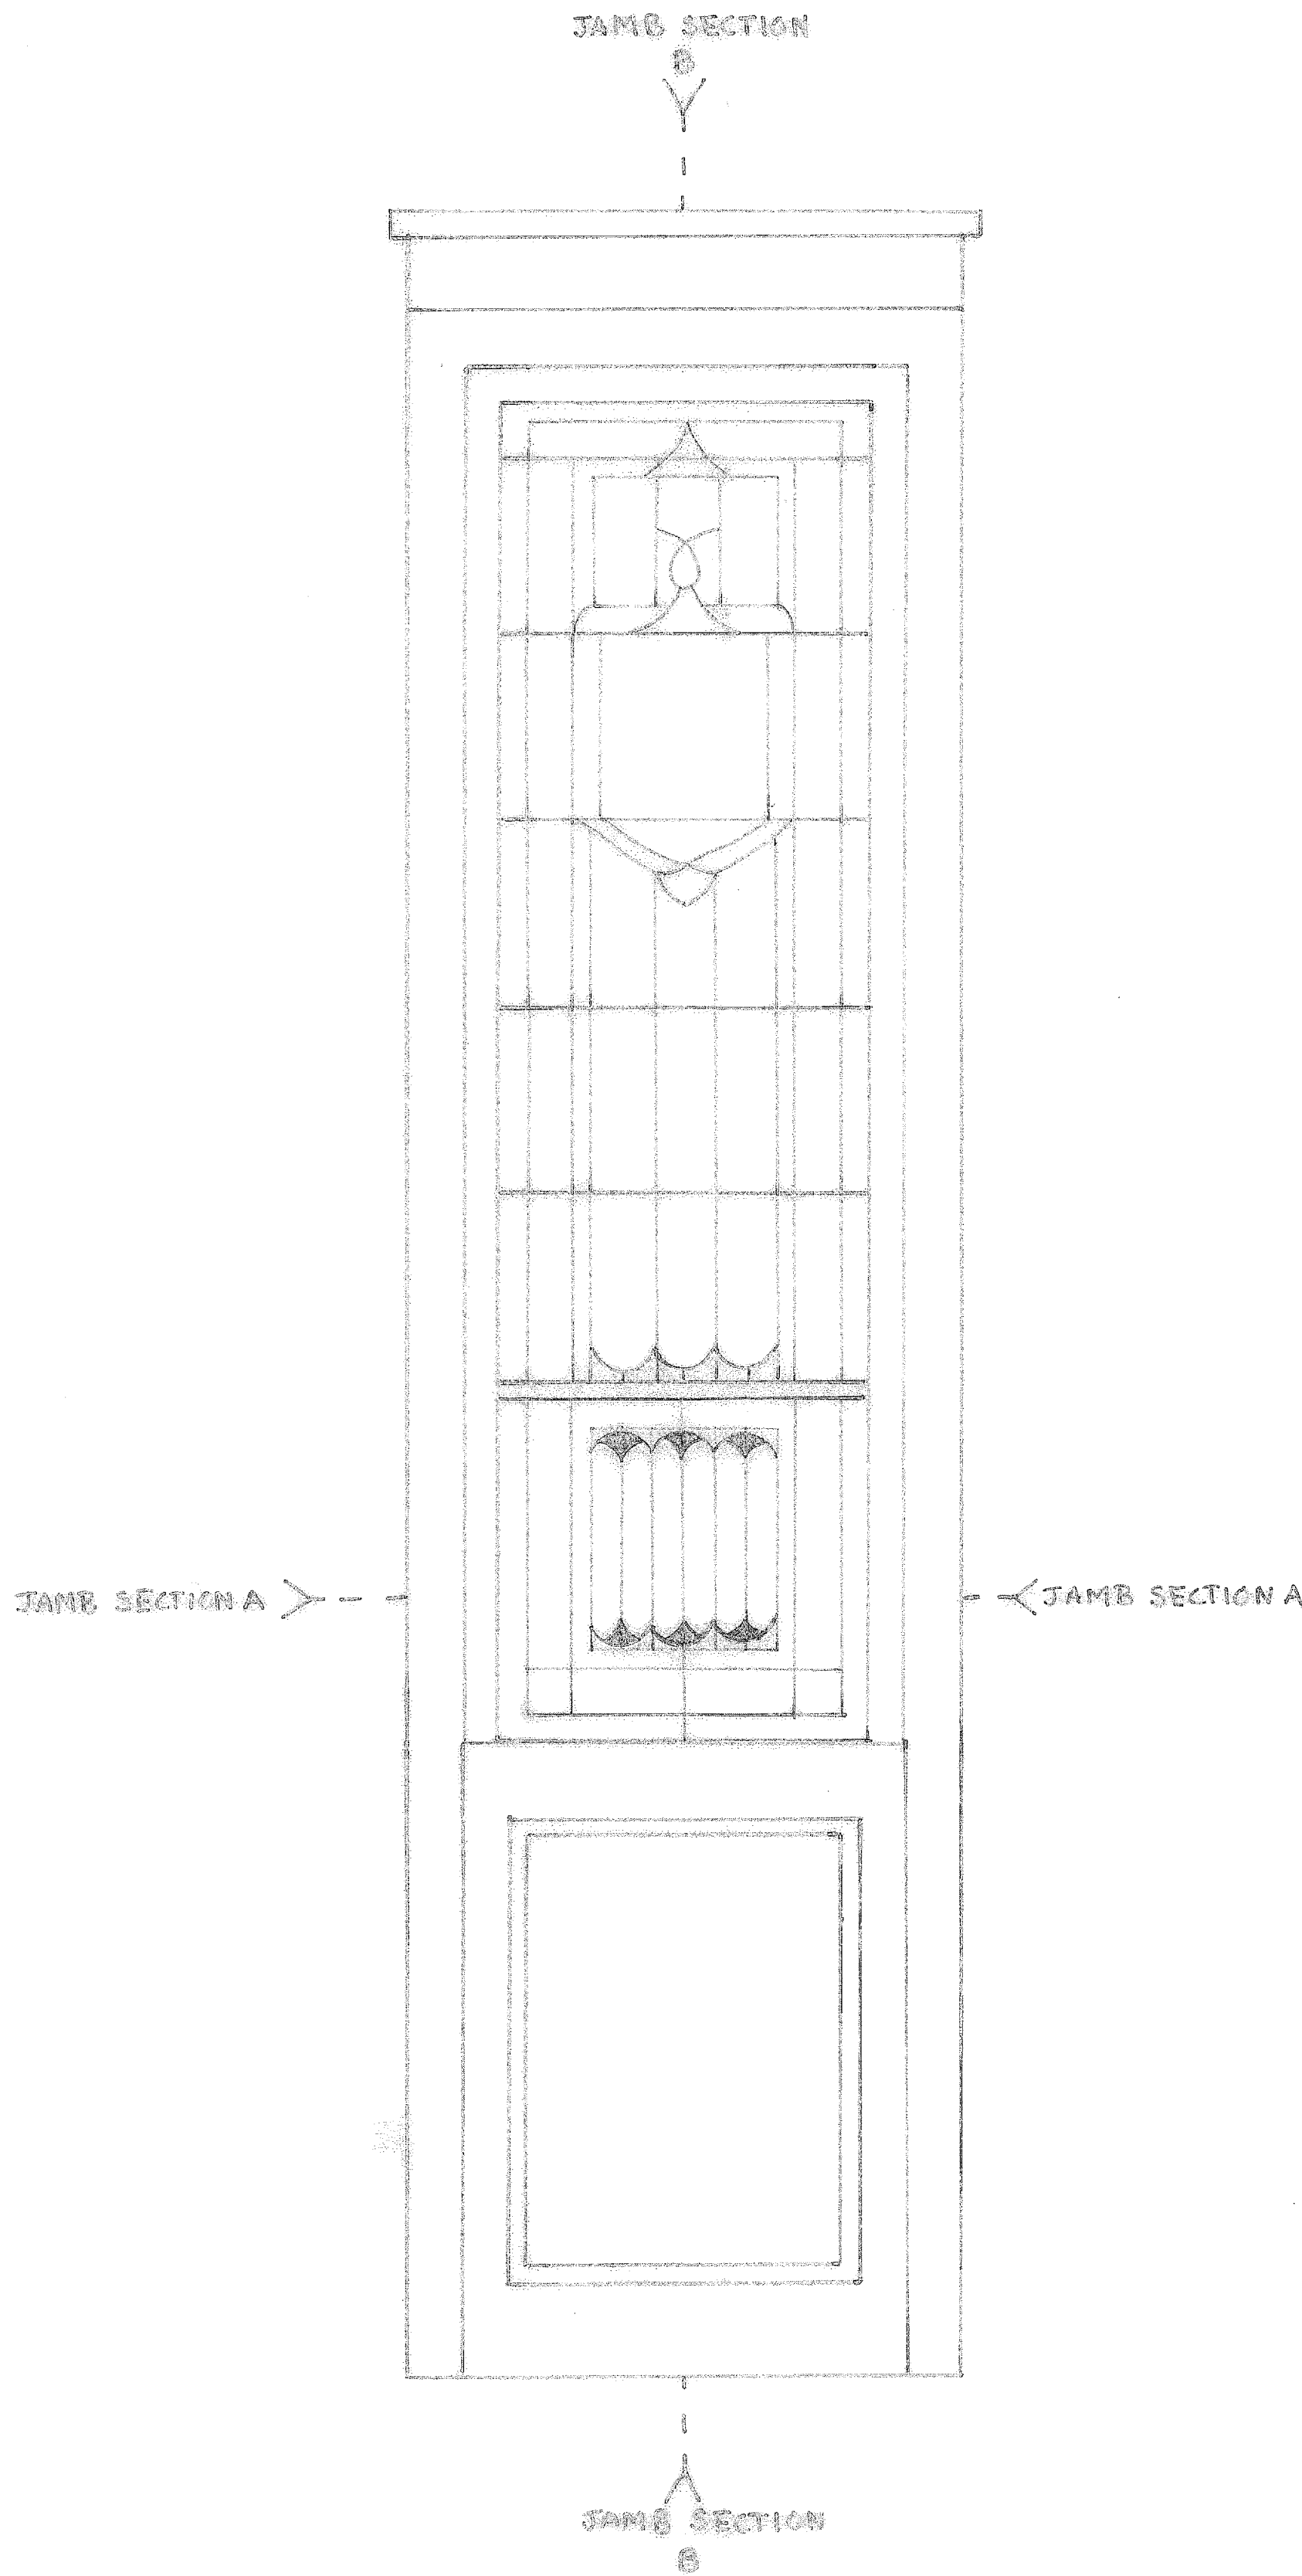
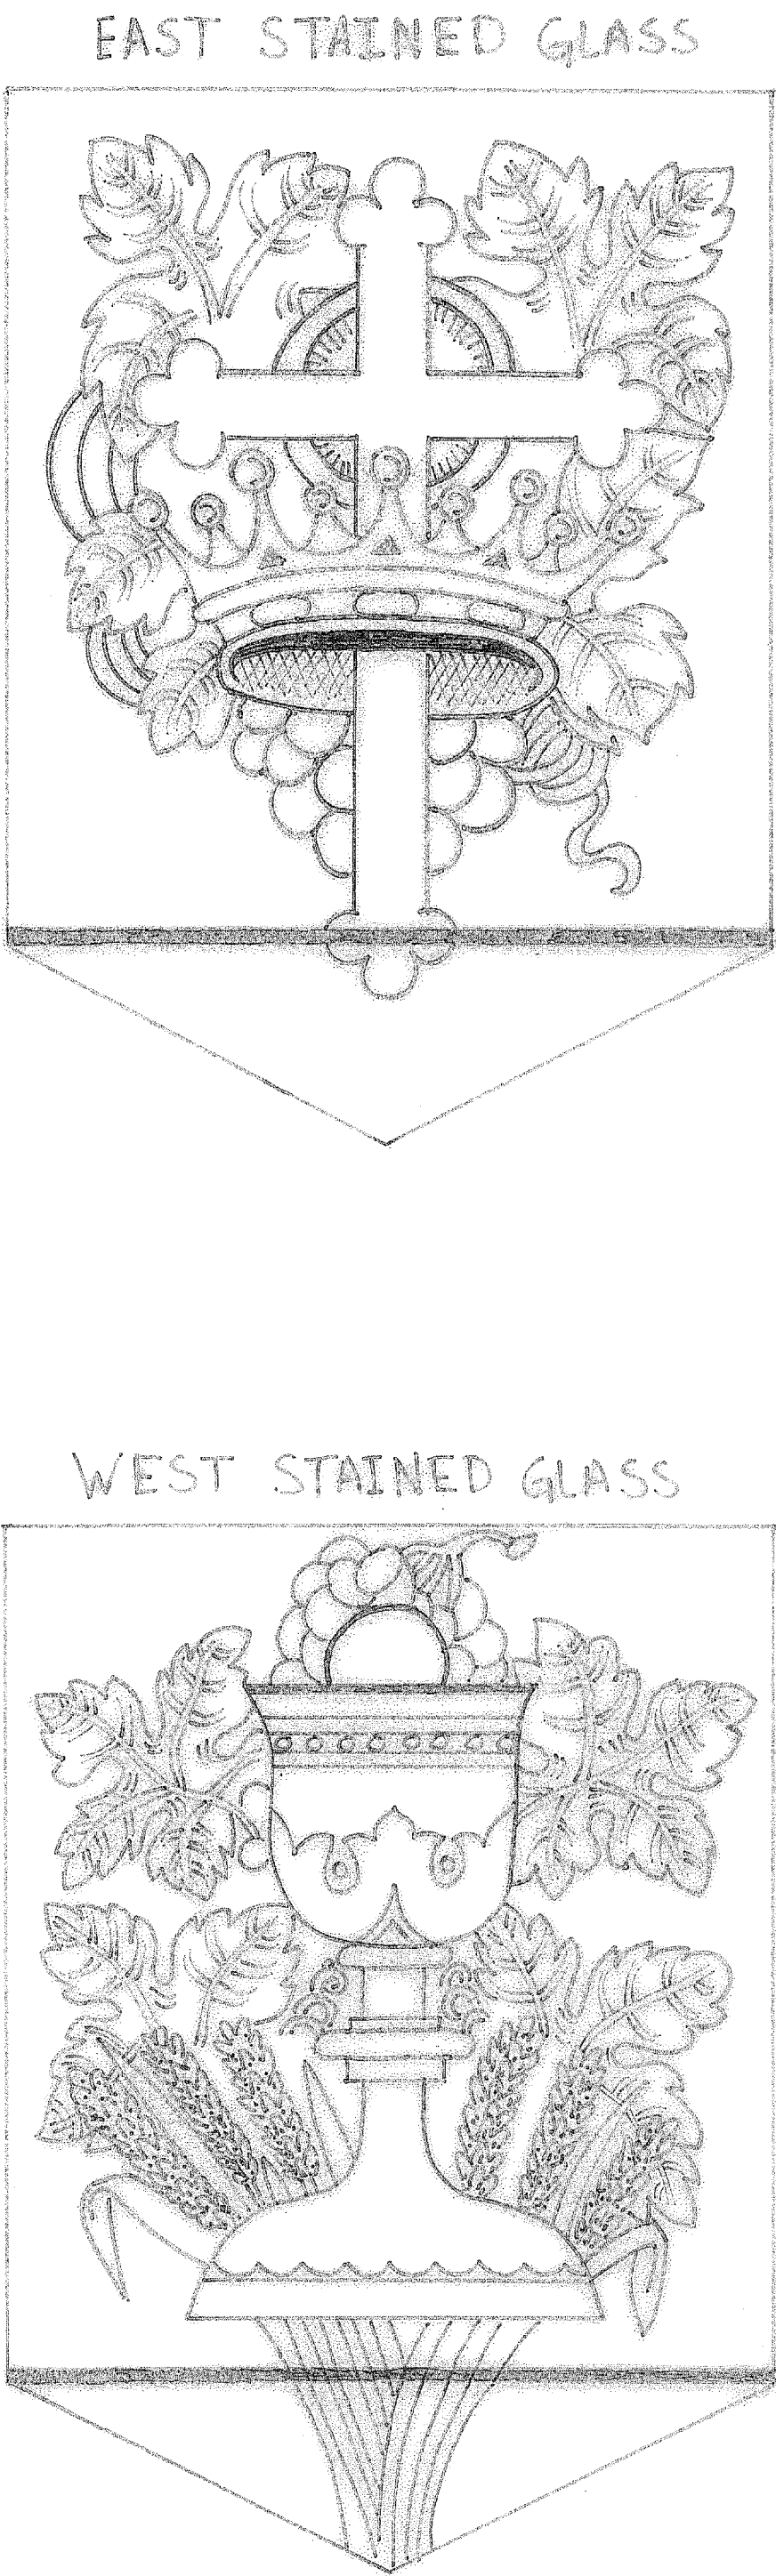
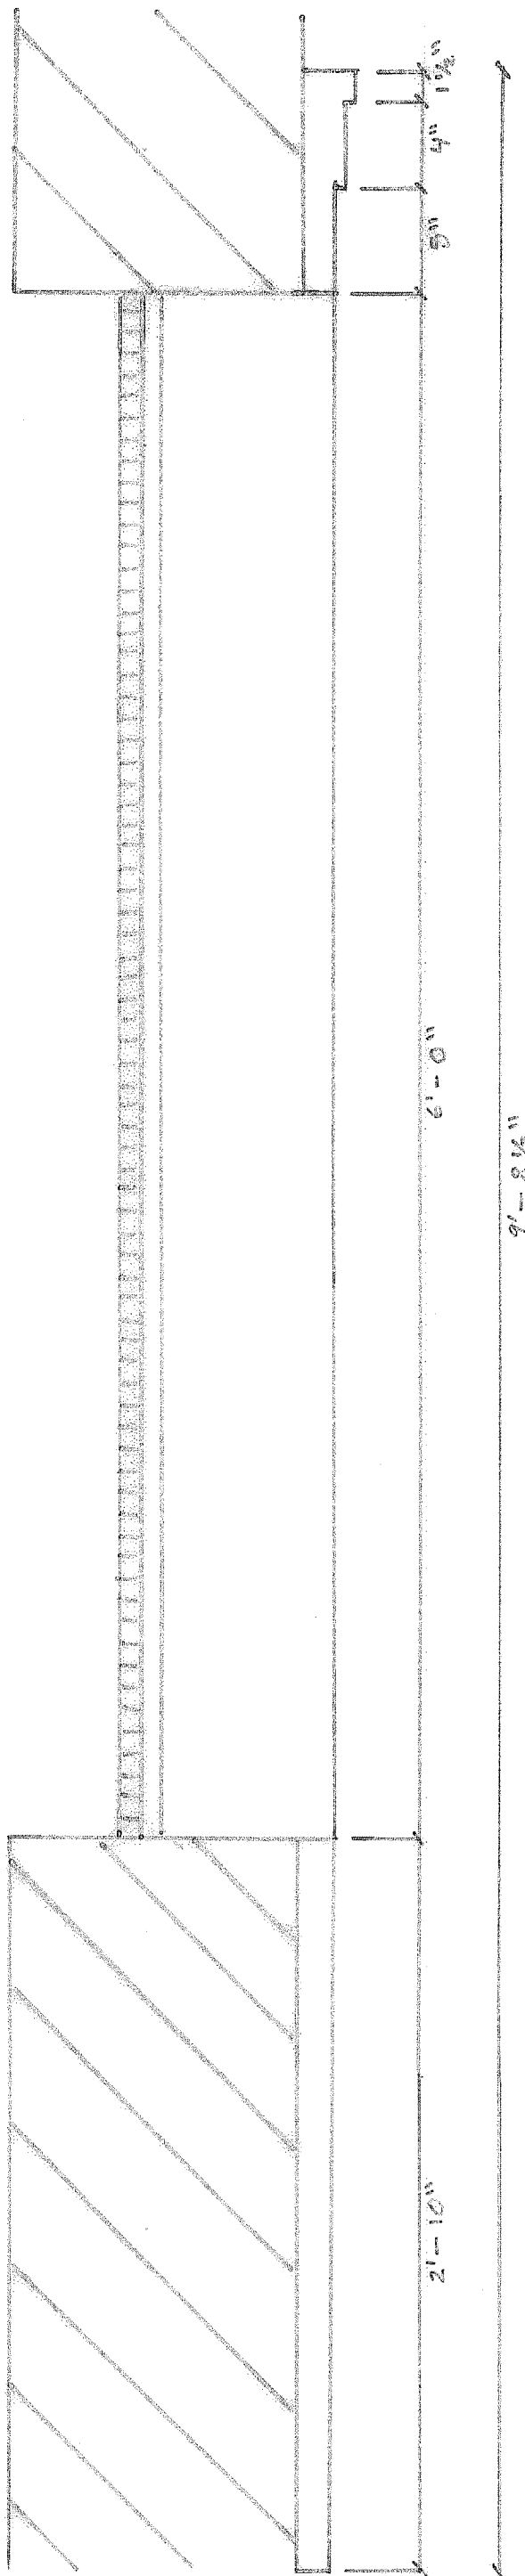
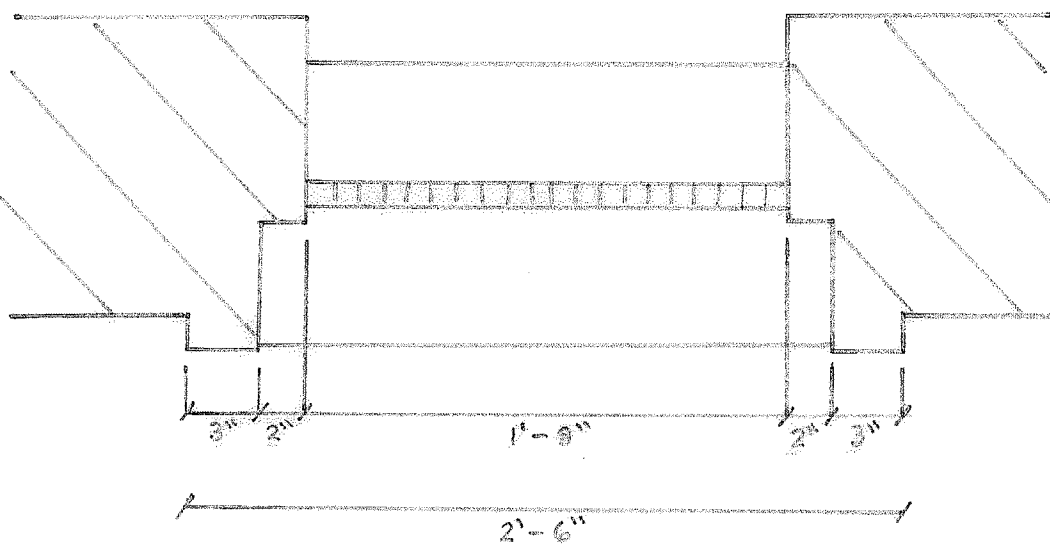
| HISTORIC PRESERVATION & COMMUNITY PLANNING | | DRAWING TITLE:<br>2. Second Floor Theater<br>Stained-Glass Windows | |

Each individual window needs to be photo documented. Also some kind of imprint of the design should be done. Re-leading needs to be taken place for these windows. For some reason, I do not know when or why, the middle stained glass window was taken out and now just a Plexiglas sheet separates the inside and outside of the building. A professional that can take care of the glass, which is the most important part of the windows, should do the re-leading. The old lead should be taken away to leave just the individual pieces of glass. If any are broken they should be fixed with an epoxy resin. After putting the design back together, new lead should be soldered together. Also, some kind of cement should be affixed to the glass so a watertight seal is created between the glass and lead. The excess cement should be brushed away to show the glass. When reinstalling the stained glass a sheet of Plexiglas should be put on the outside of the stained glass to protect it and to help insulate the building.

| NOTES: | |
|---|--|
| ◦ MIDDLE AND LARGEST STAINED GLASS WINDOW IN THE THEATER WAS REMOVED AND REPLACED WITH PLEXIGLAS. | |

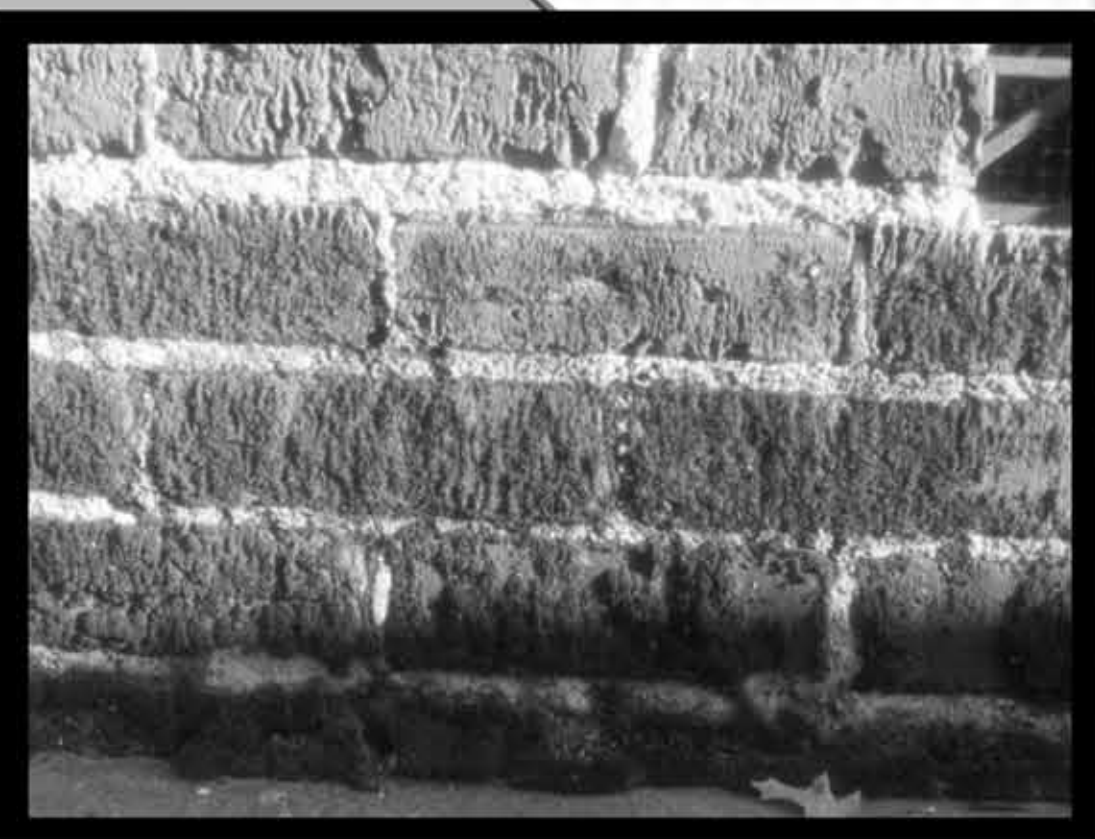
## Lichen

Along the bottom and around the areas were the wood and brick meet, there is lichen growing in abundance. The North Façade doesn't get much direct sunlight because of its orientation and with the trees that line the areas, it is shady and cool. There also may be an issue of water causing a dampness of the brick, in which case the solution would be to find the source of the dampness. To resolve the problem regarding the lichen one could soak the brick in water and with a cup of bleach and a bristle brush, scrub the excess lichen off the wall gently to restore the brick to its original state. Wetting the brick first before applying the bleach prevents the brick from absorbing the bleach, causing further damage.
