| JAMES L. WARD<br>ASSISTANT PROFESSOR<br><br>COLLEGE OF CHARLESTON<br>ARTH 299-001 FALL 2007<br><br>HISTORIC PRESERVATION &<br>COMMUNITY PLANNING | | LANCE HALL & ADDITION<br>MEETING STREET - CHARLESTON, SC | |
| ASSIGNMENT NO: 5 | | DRAWING TITLE:<br><b>FINAL SITE PLAN<br/>LANCE HALL &amp; ADDITION</b> | |
| DATE: 11.09.07 | | DRAWING PREPARED BY (TEAM/INDIVIDUAL):<br>G. BROWN, B. L'HULLIER, A. MILLER, P. REED | |

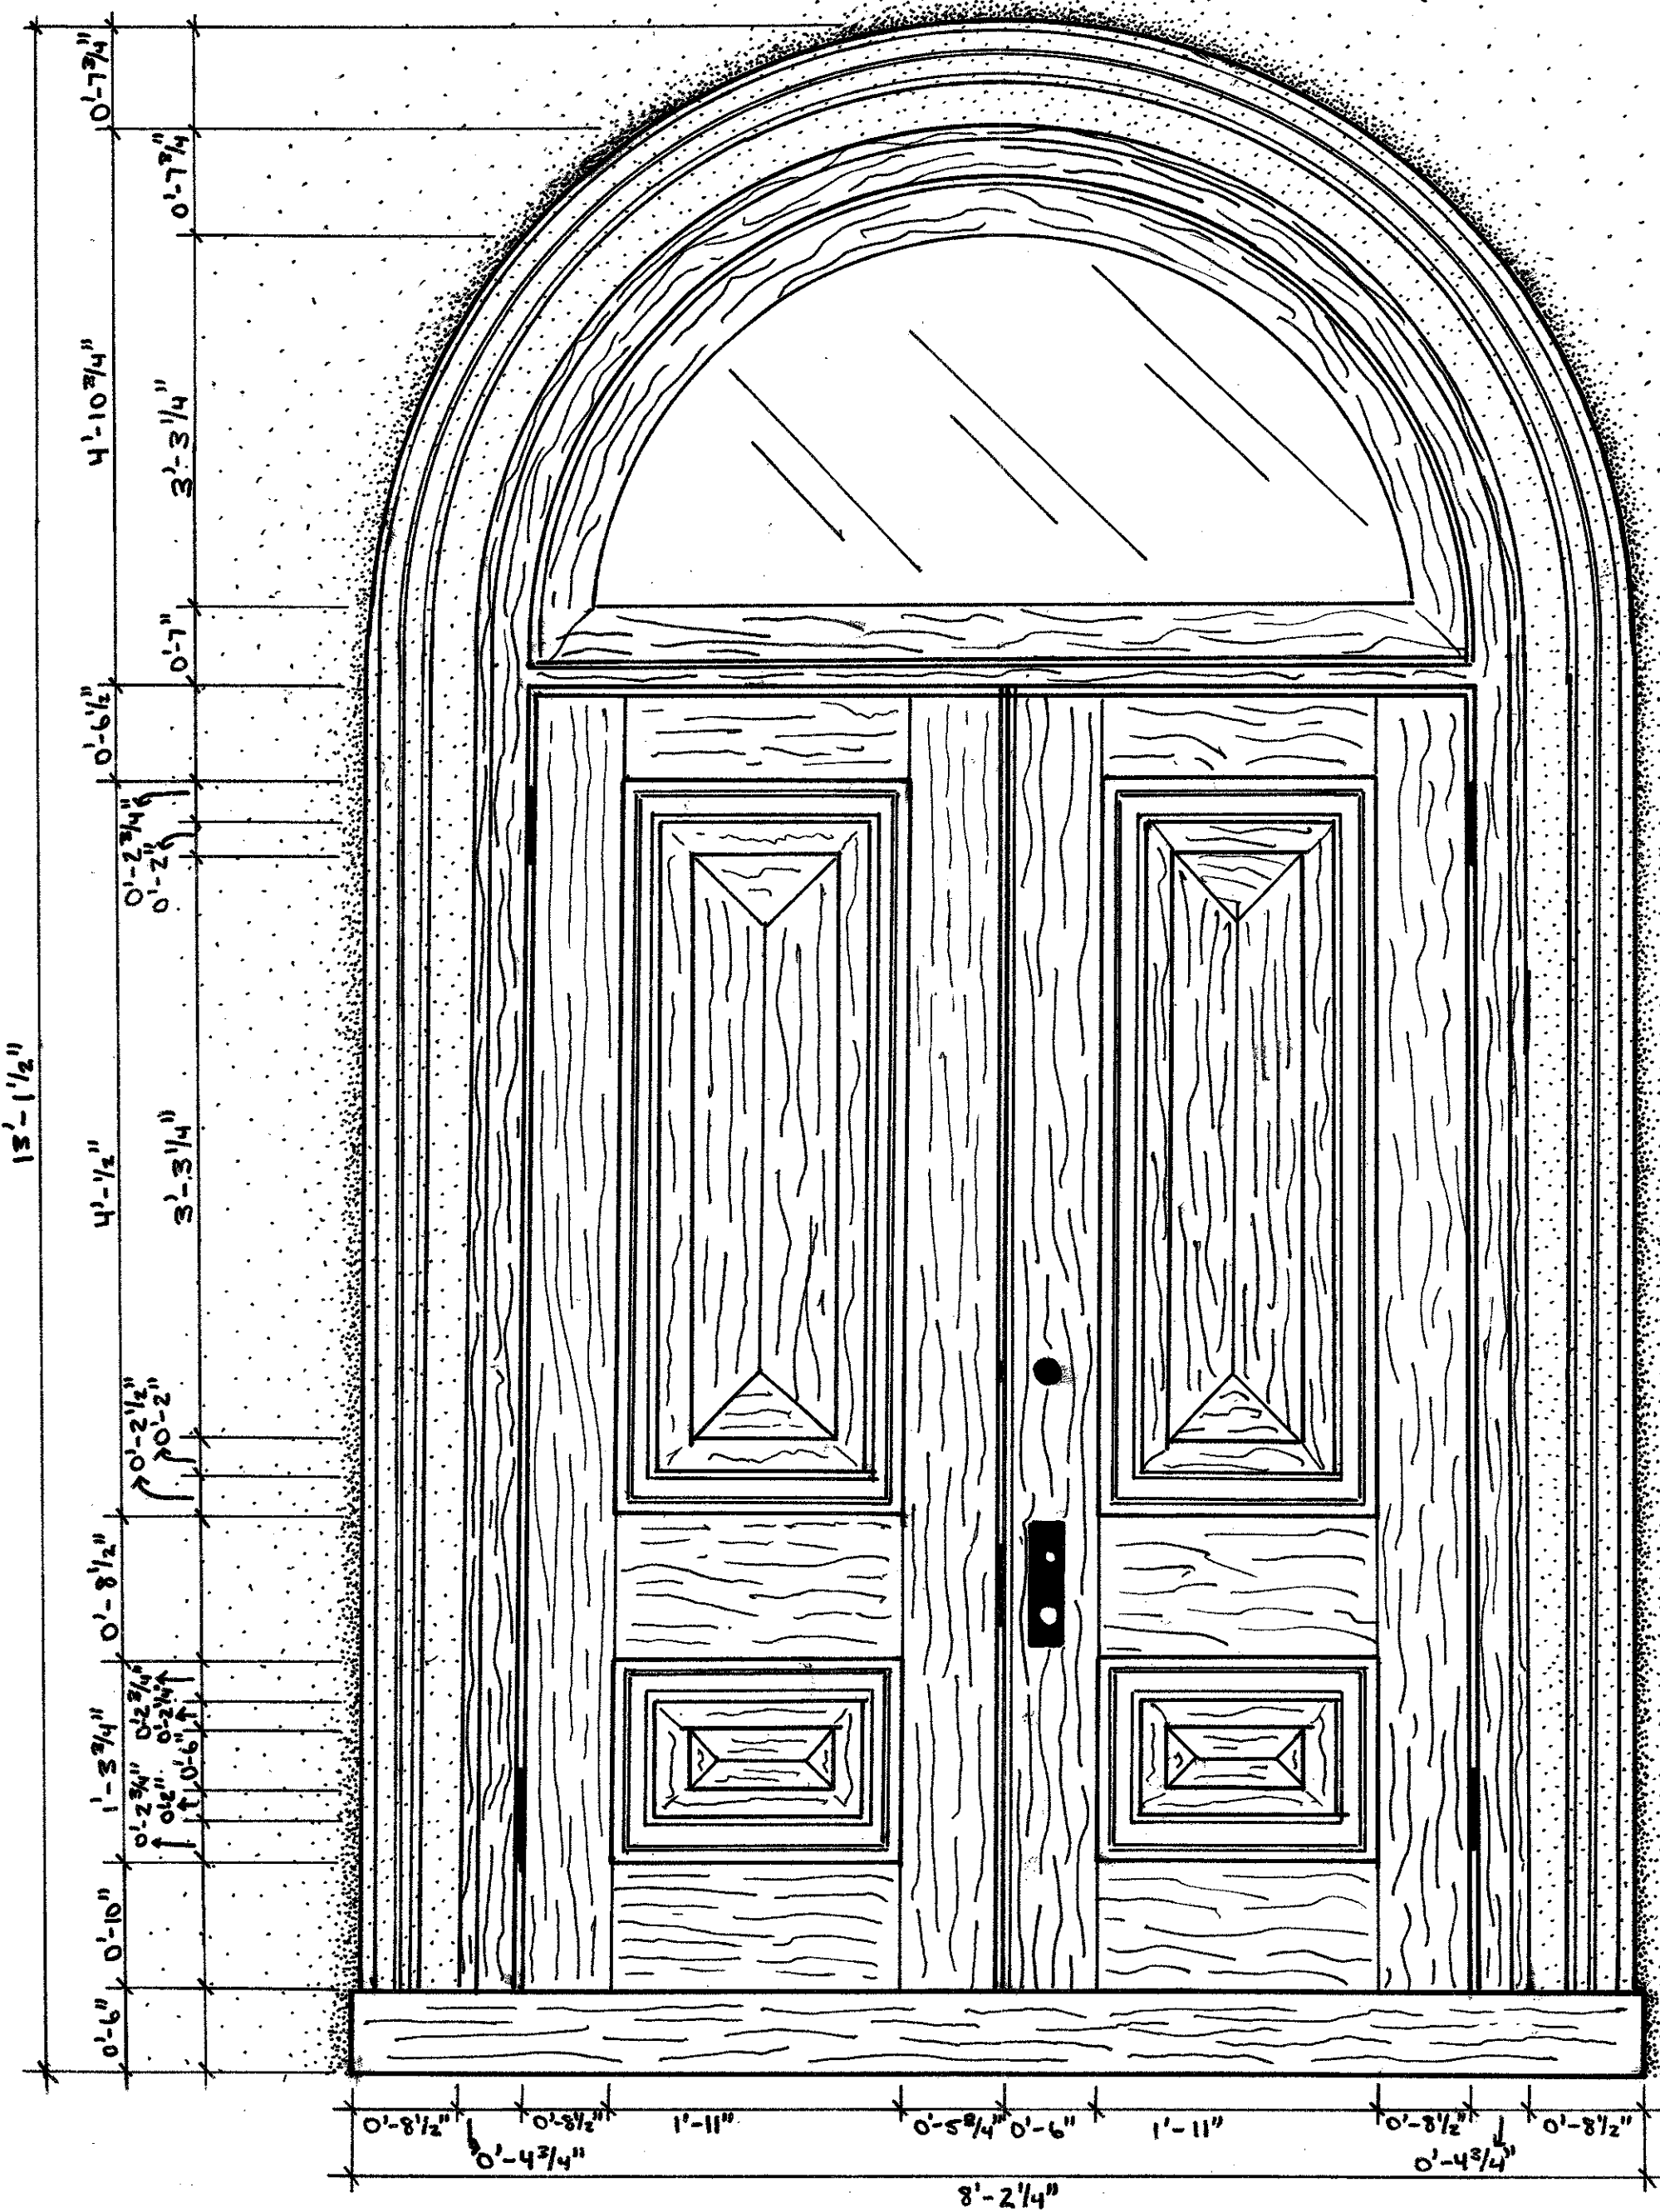
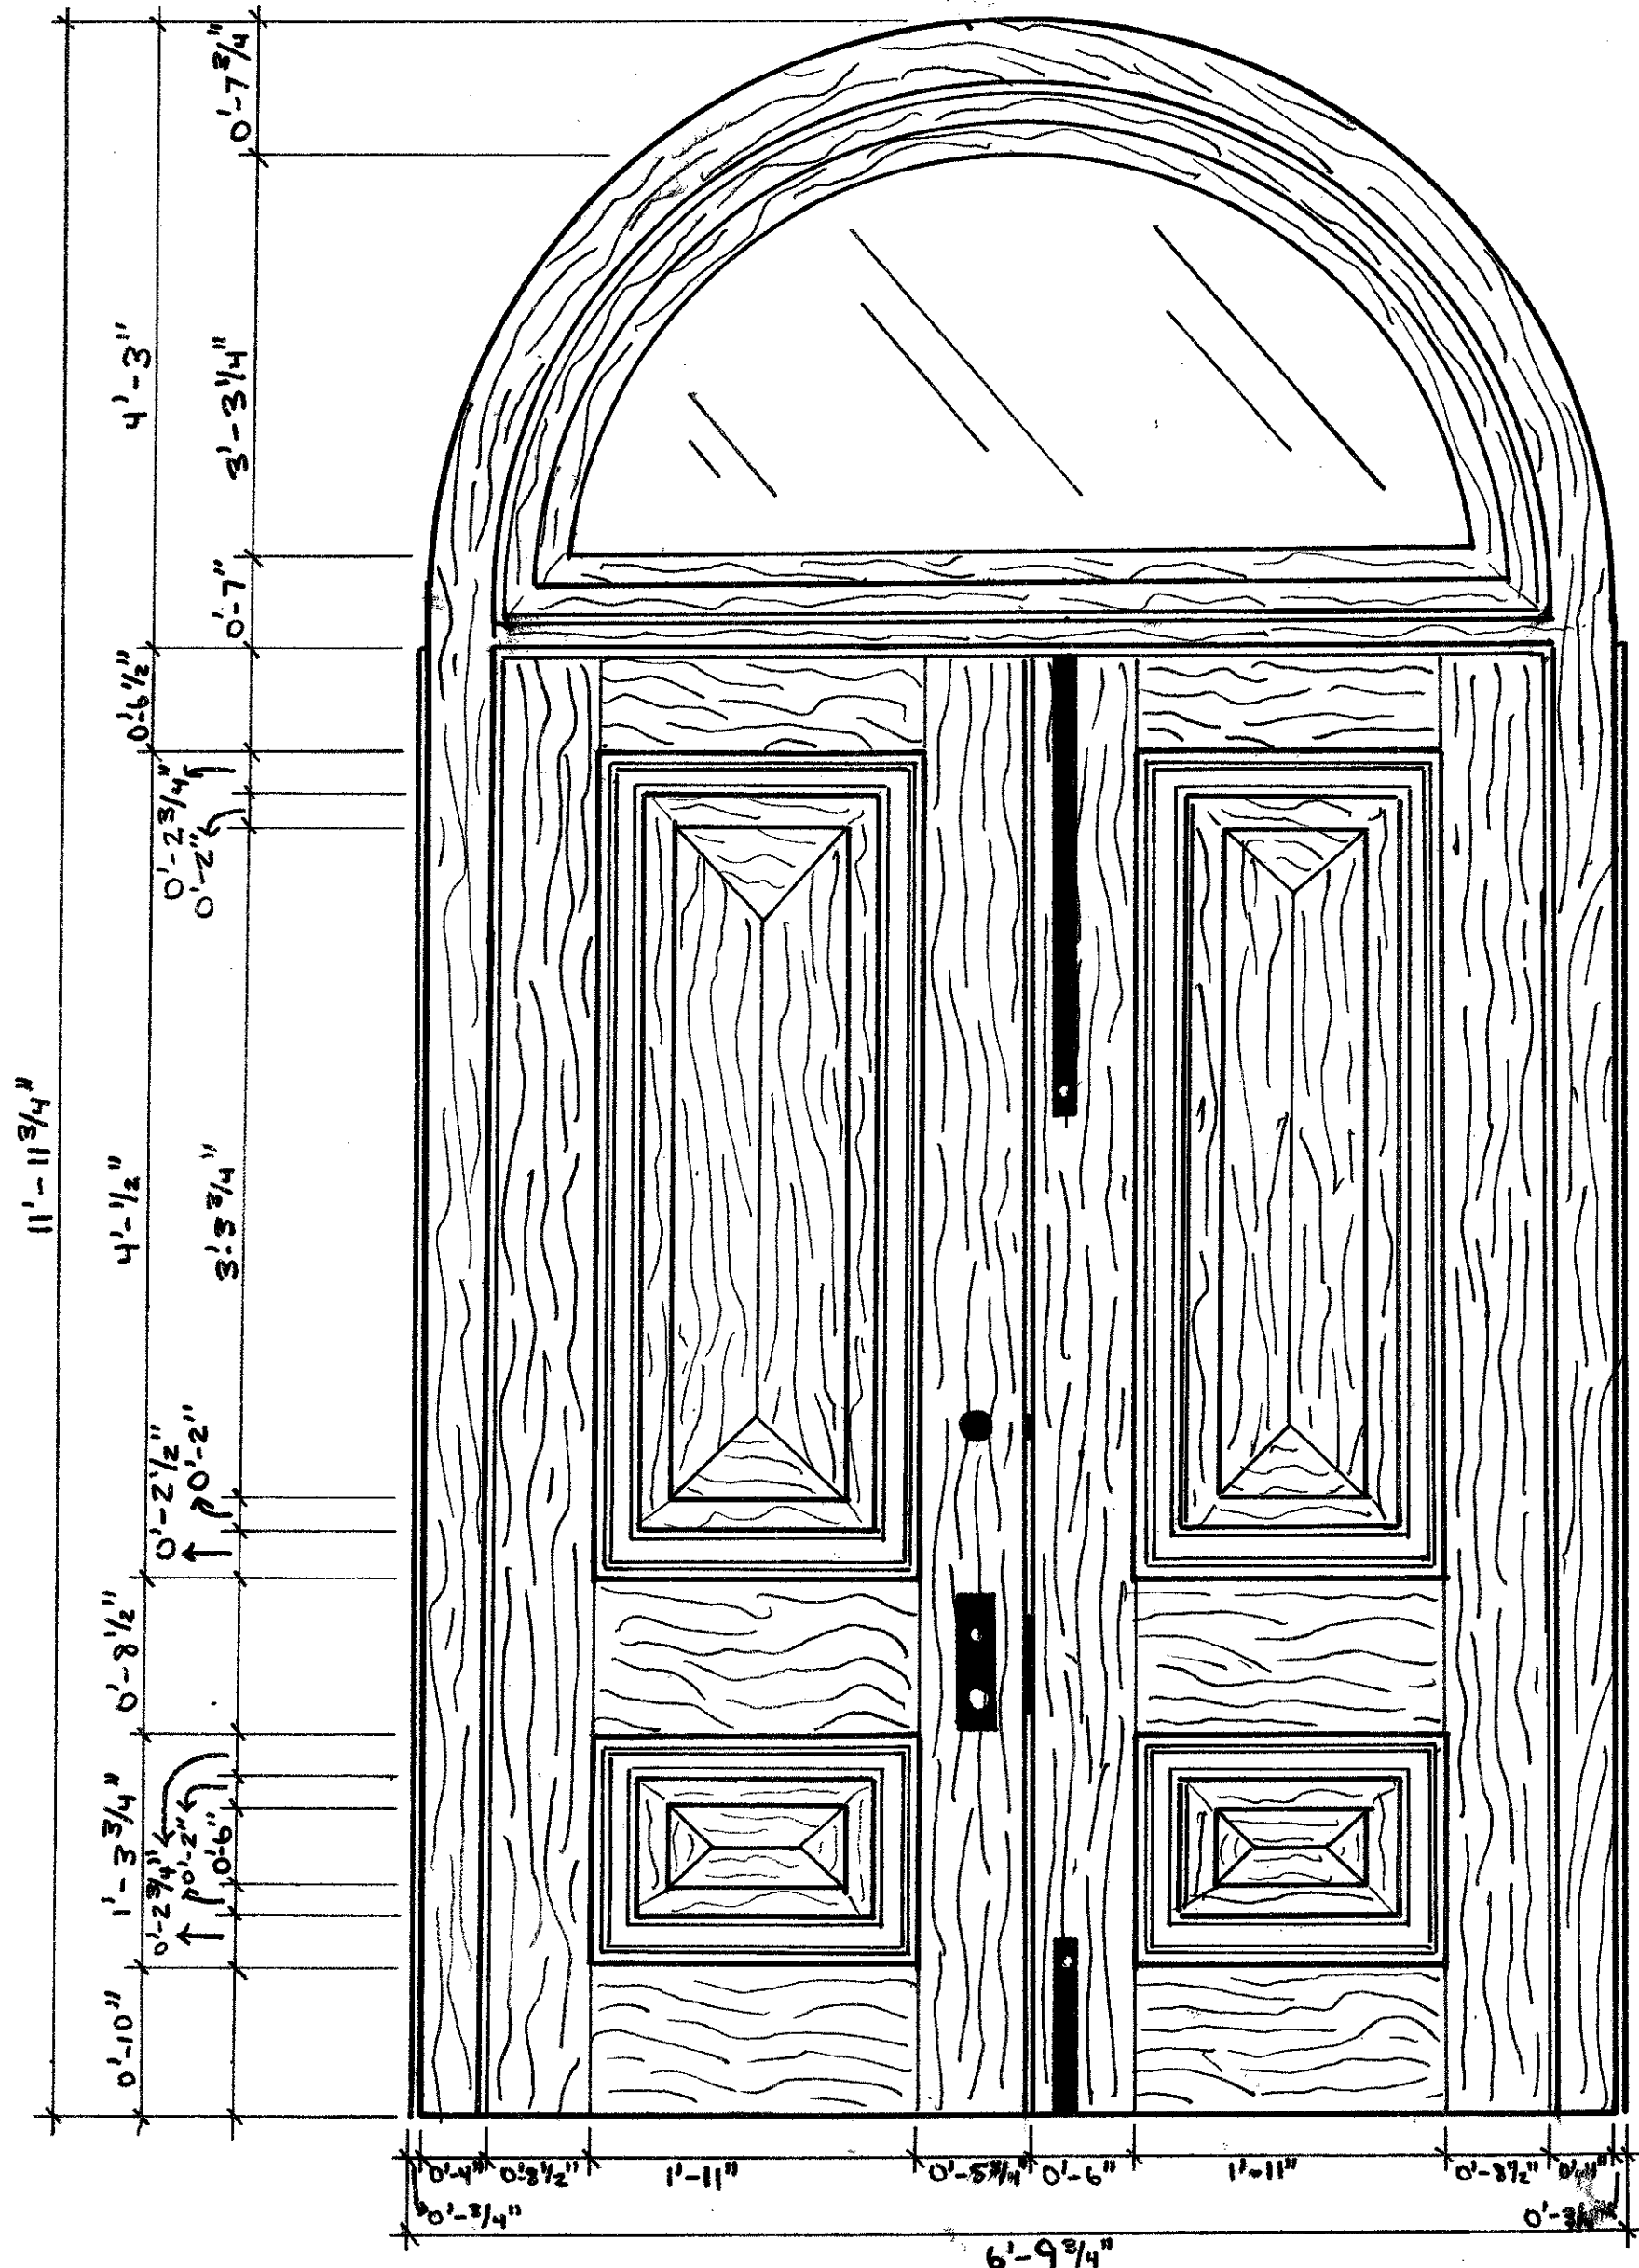
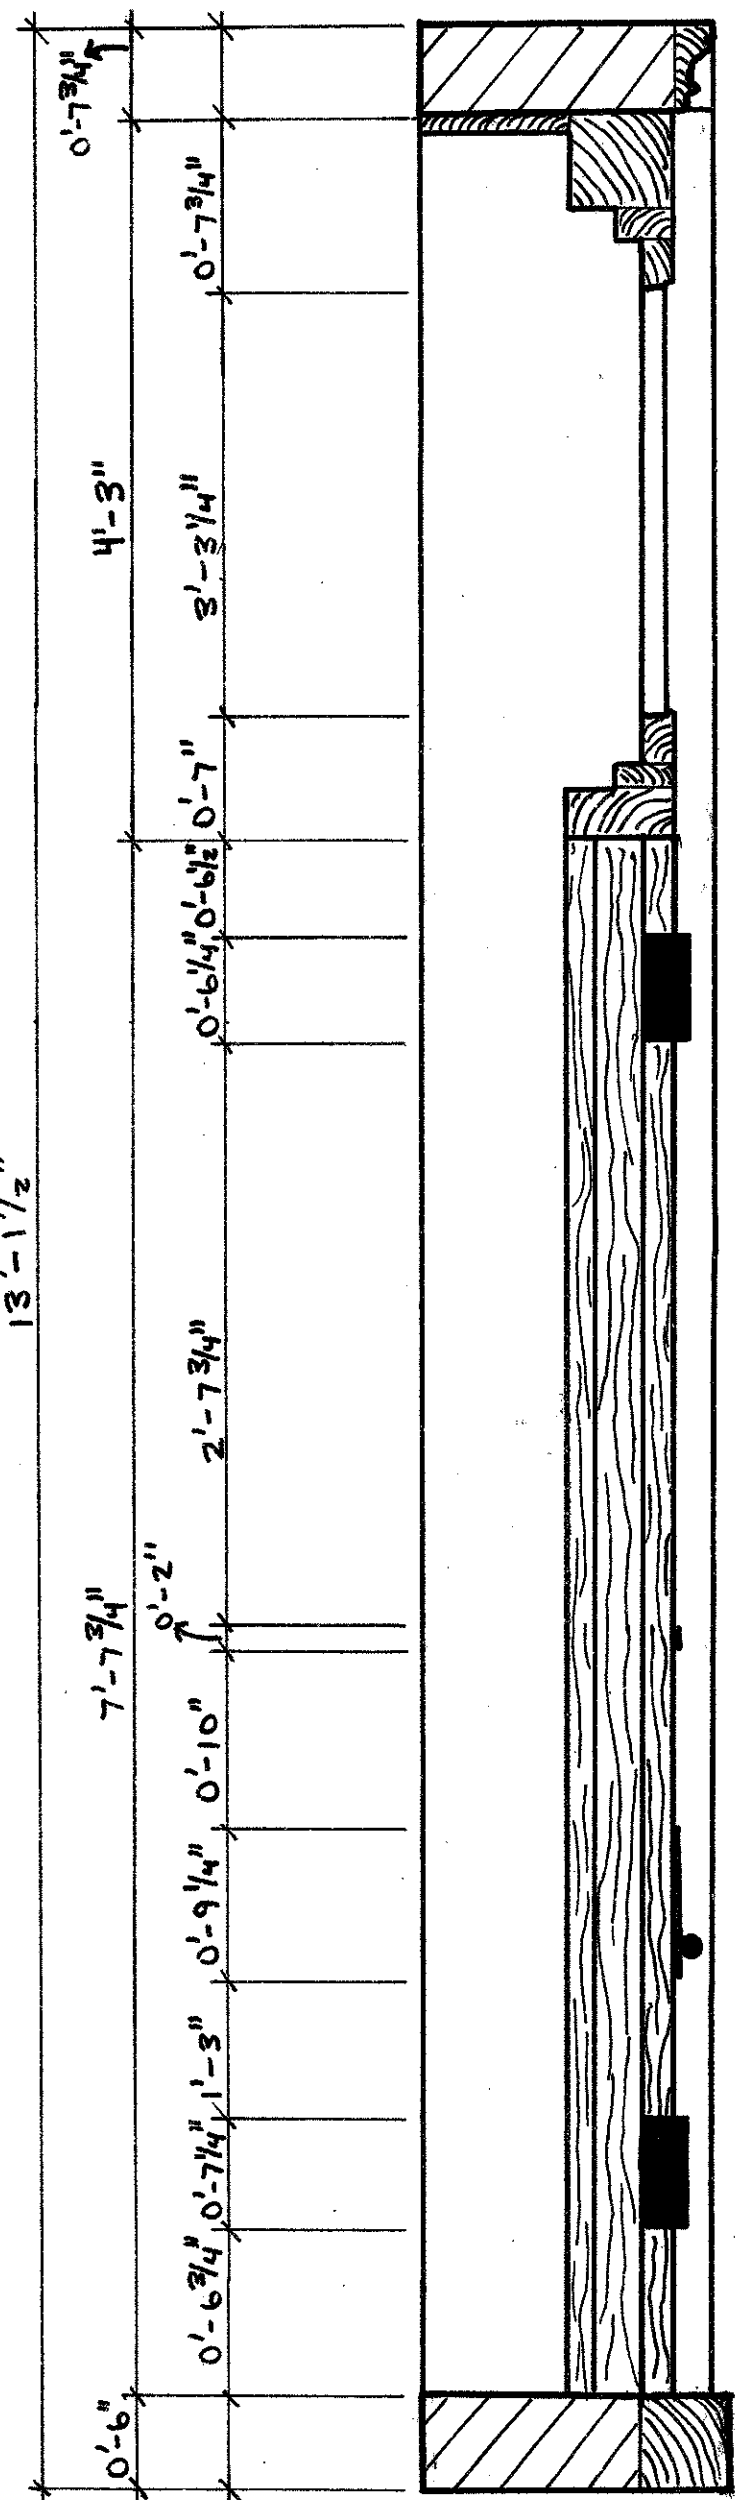
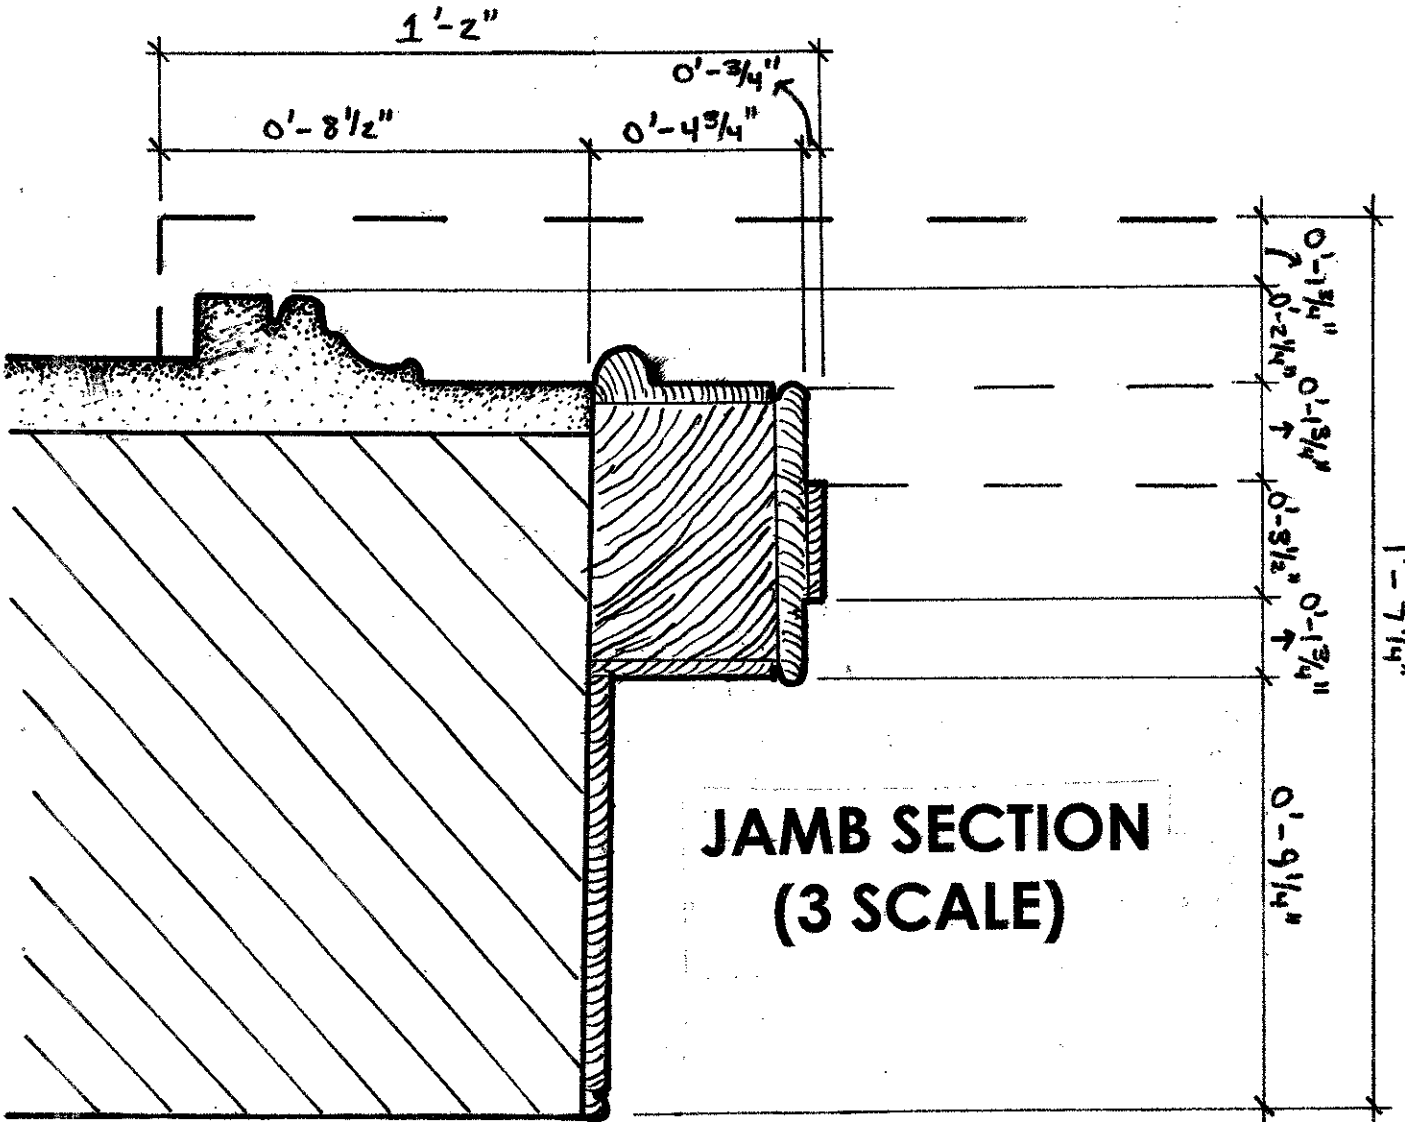
THIS DOOR IS CONSTRUCTED OF ESSENTIALLY TWO FRAME AND PANEL DOORS LAMINATED TOGETHER. THE INTERIOR IS STAINED PINE AND THE EXTERIOR IS A PAINTED HARDWOOD; PROBABLY OAK OR MAHOGANY. THE FRAME OF THE DOOR IS CONSTRUCTED OF VERTICAL STYLES AND HORIZONTAL RAILS THAT ARE JOINED BY MORTISES AND THROUGH TENONS. THE PANELS ARE SANDWICHED BETWEEN THE RAILS AND DECORATED WITH TRIM MOLDING.

THE FINISH ON THE INTERIOR IS LIKELY SOME SORT OF NATURAL PENETRATING OIL, SUCH AS LINSEED OR TUNG. THE EXTERIOR FINISH WAS PROBABLY ORIGINALLY A LEAD BASED PAINT, BUT HAS LIKELY BEEN SEALED BY A MODERN COAT. IT IS UNKNOWN WHETHER THE COLOR IS ORIGINAL WITHOUT A PAINT SAMPLE. ROUTINE MAINTENANCE IS ESSENTIAL IN THE CONSERVATION OF THESE HISTORIC FINISHES.
