| JAMES L. WARD<br>ASSISTANT PROFESSOR<br><br>COLLEGE OF CHARLESTON<br>ARTH 299-001 FALL 2007<br><br>HISTORIC PRESERVATION &<br>COMMUNITY PLANNING | | LANCE HALL & ADDITION<br>MEETING STREET - CHARLESTON, SC | |
| ASSIGNMENT NO: 5 | | DRAWING TITLE:<br><b>FINAL SITE PLAN<br/>LANCE HALL &amp; ADDITION</b> | |
| DATE: 11.09.07 | | DRAWING PREPARED BY (TEAM/INDIVIDUAL):<br>G. BROWN, B. L'HULLIER, A. MILLER, P. REED | |

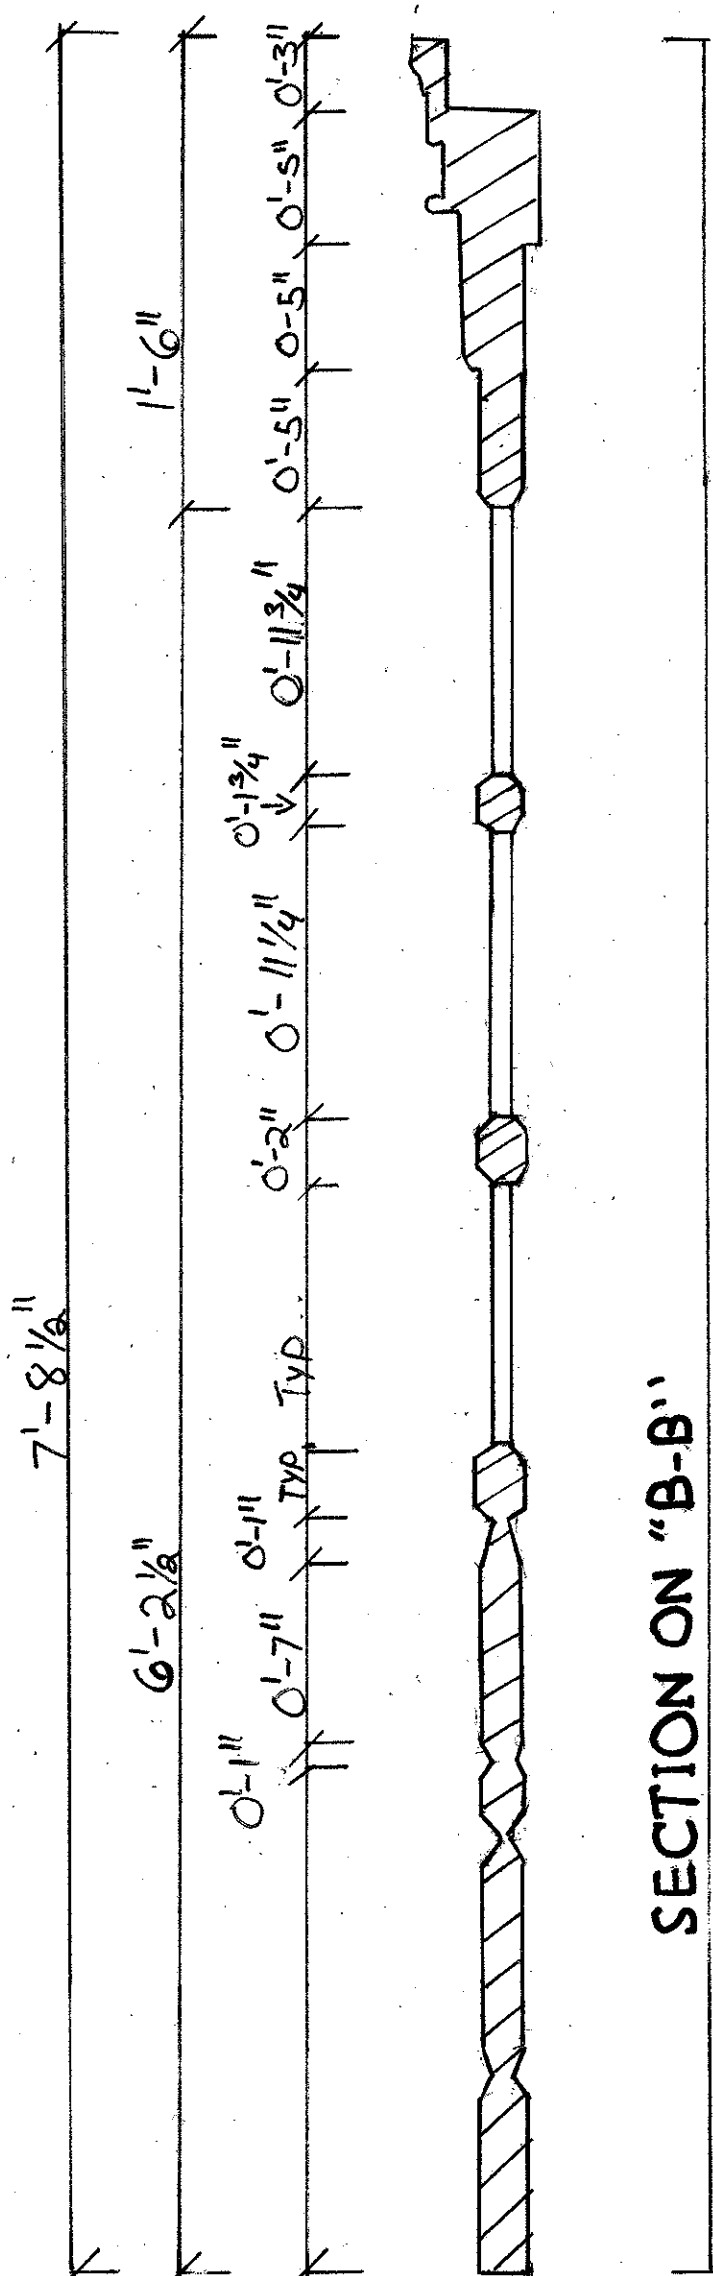
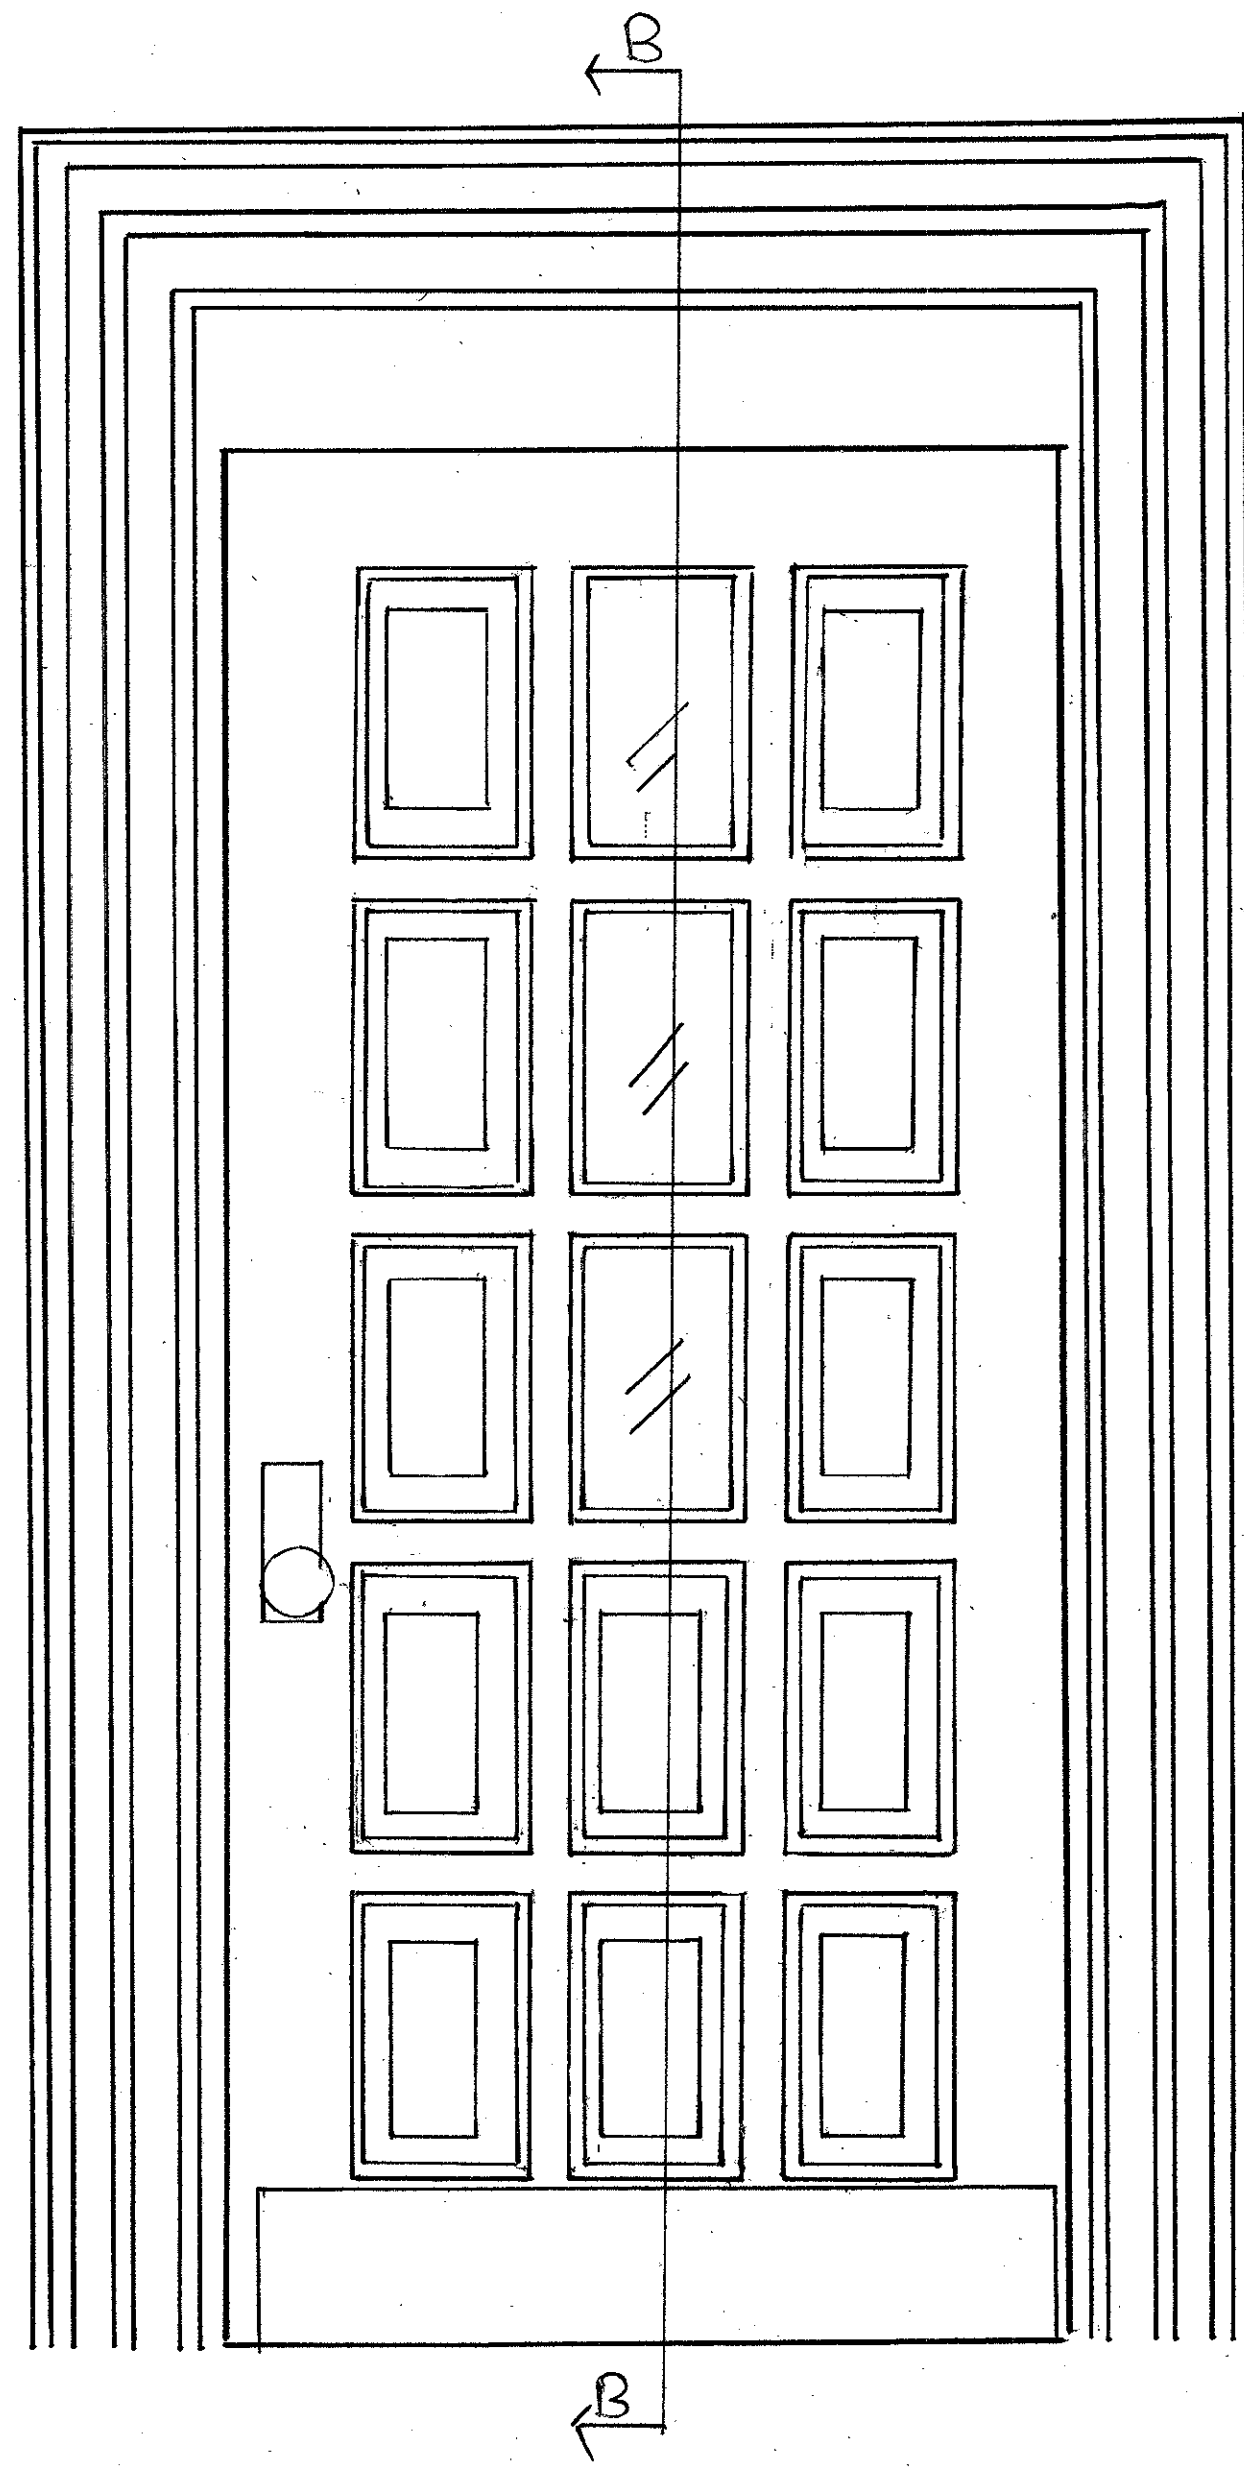
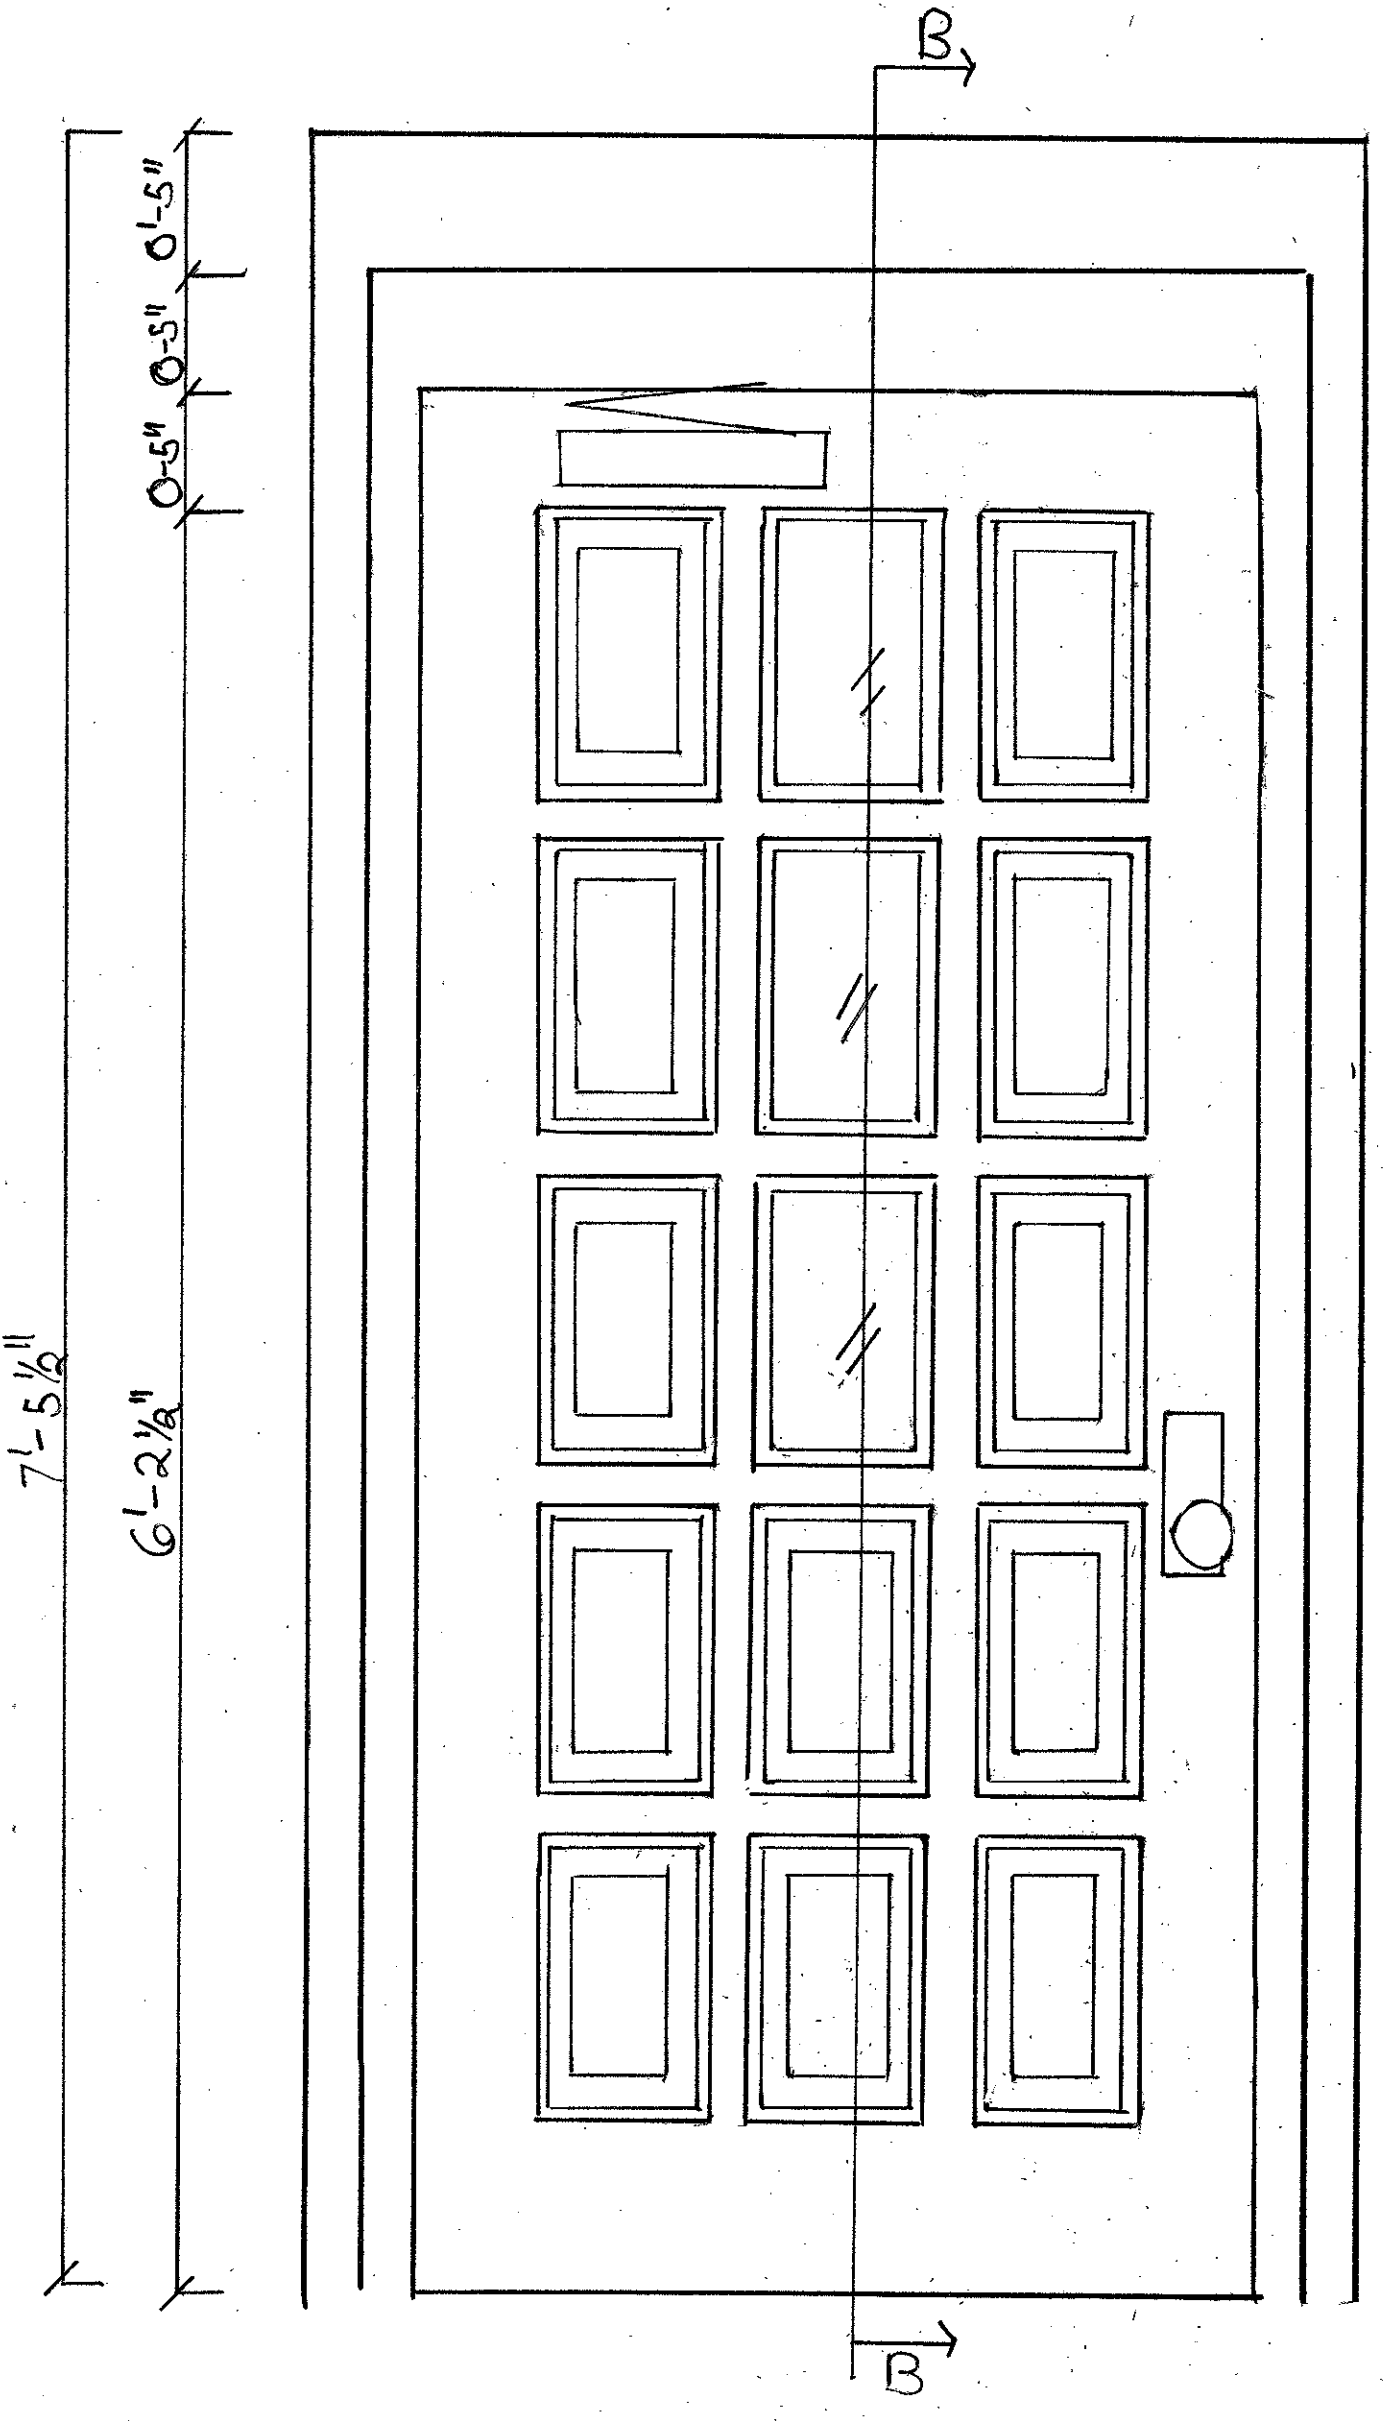
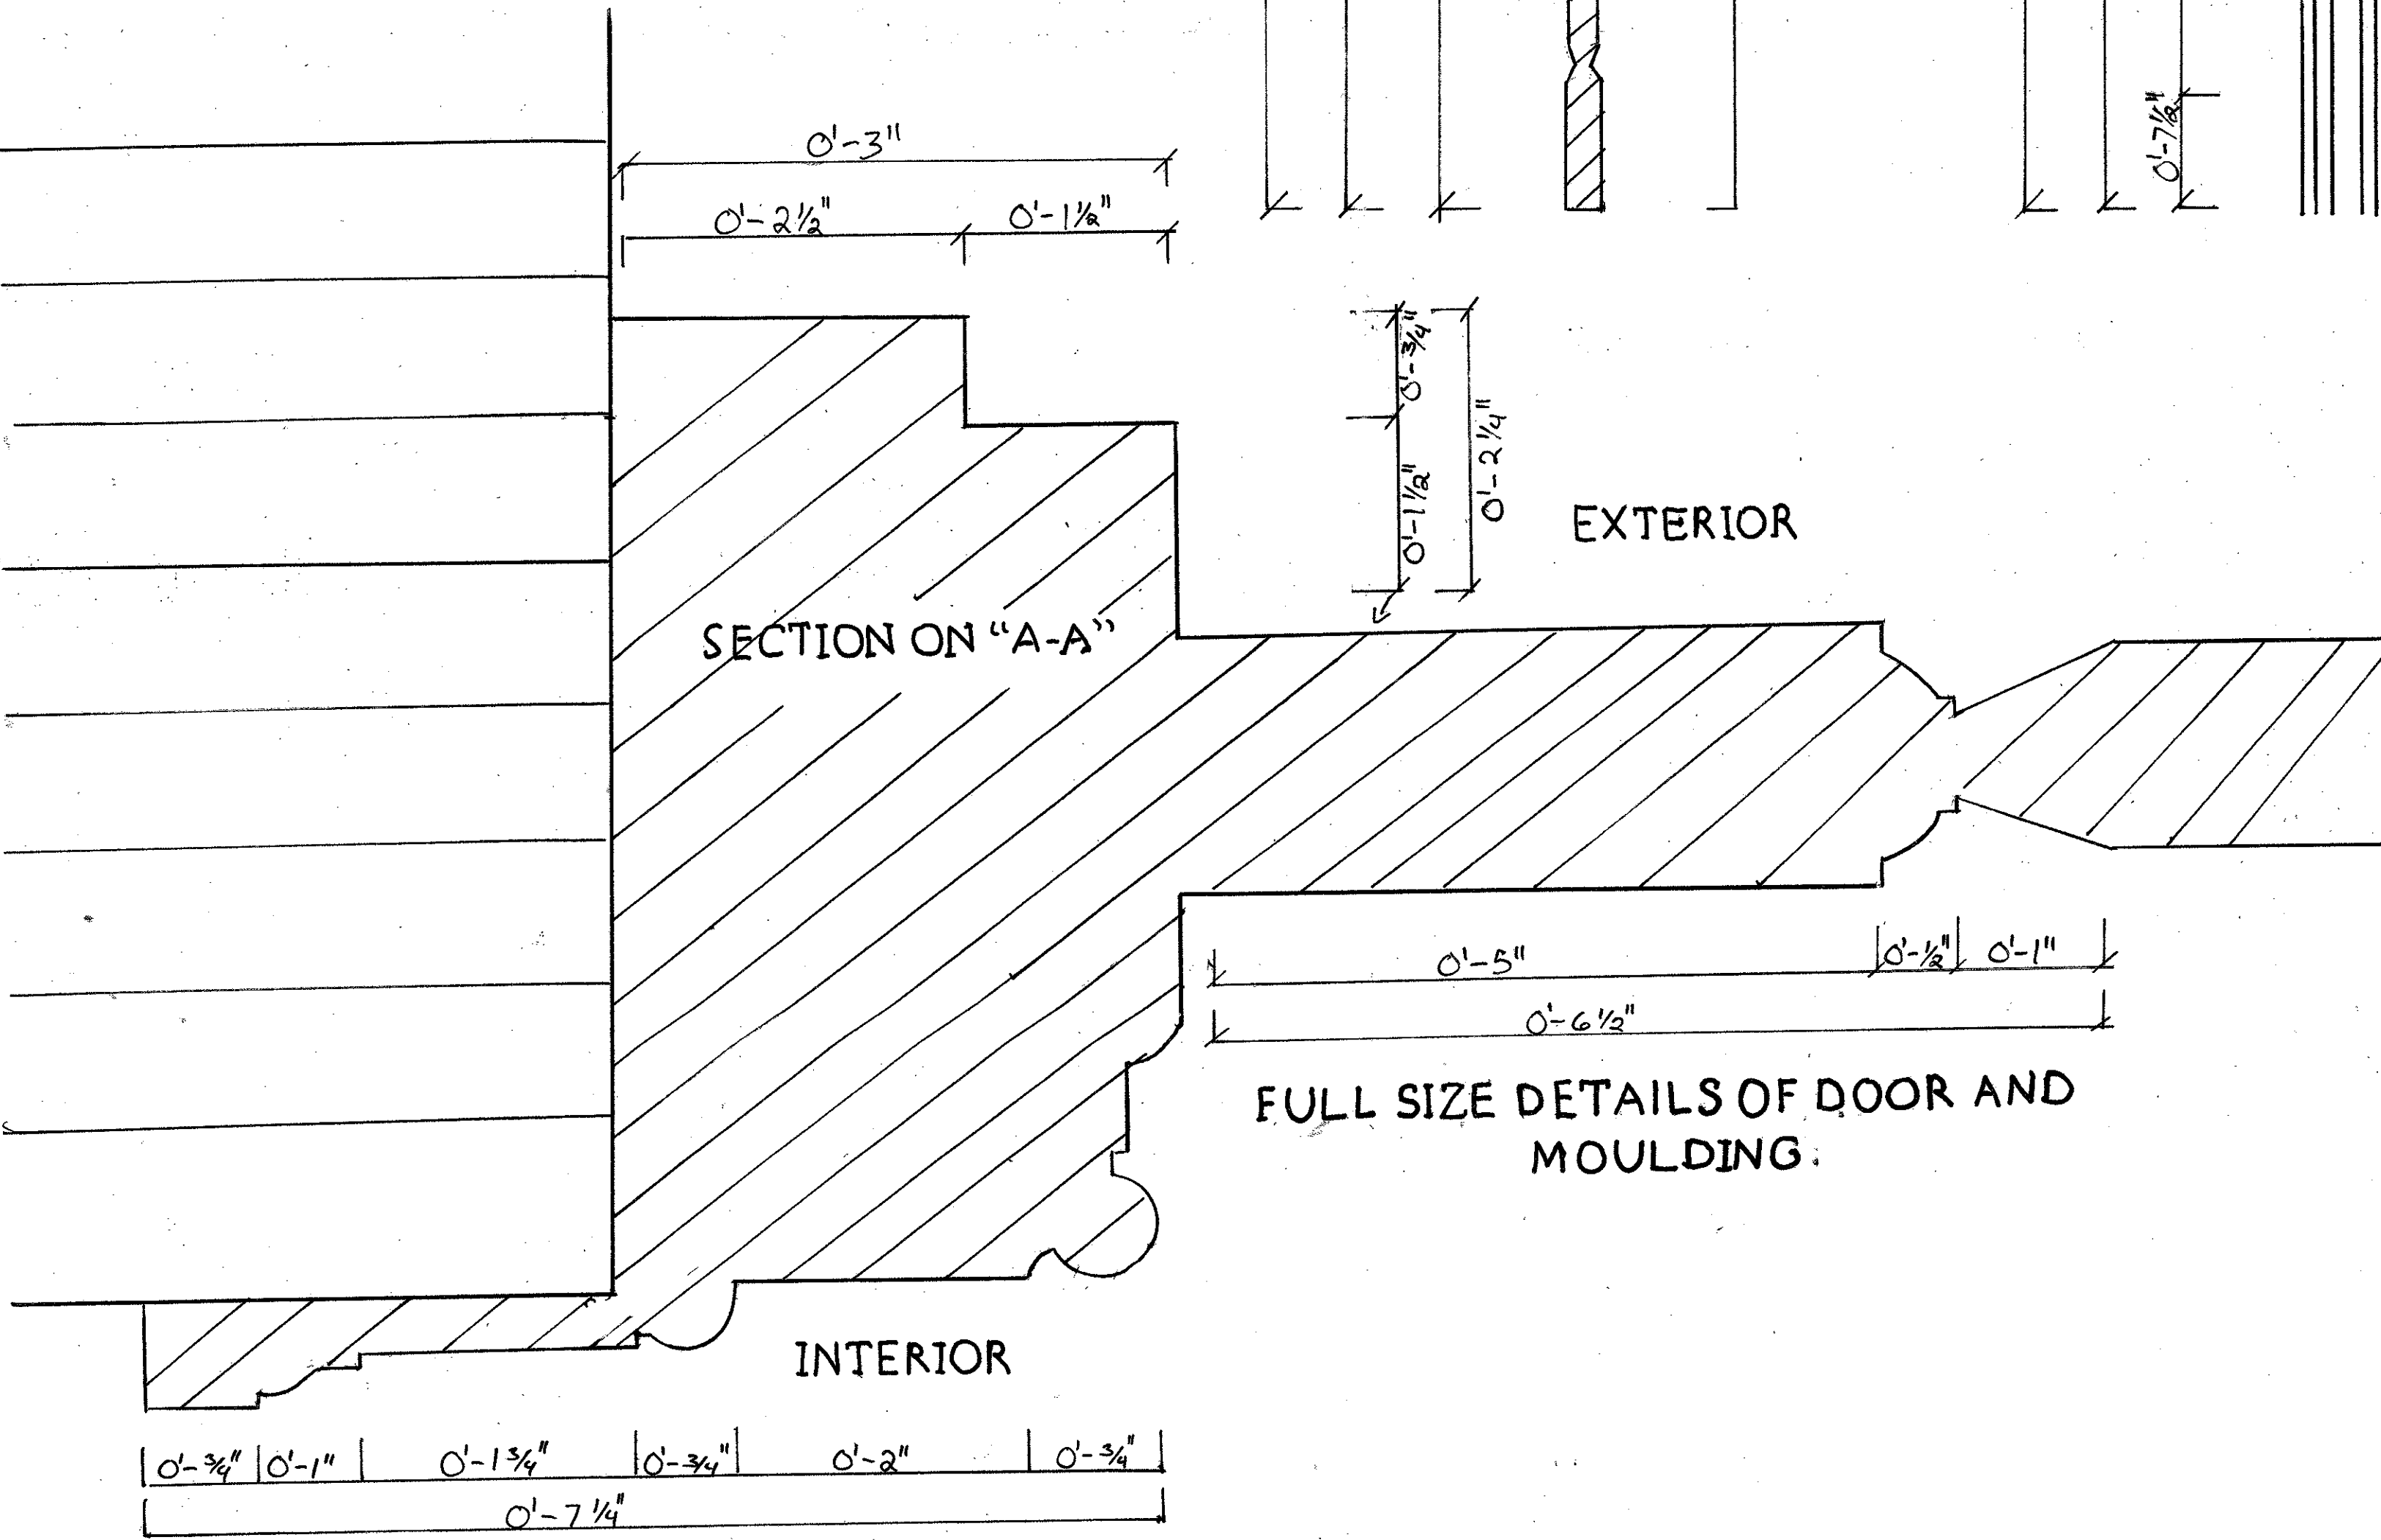
FULL SIZE DETAILS OF DOOR AND  
MOULDING.

- 1.) DOOR CONSTISTS OF 15 PANELS 3 OF WHICH ARE GLASS
- 2.) KICKPLATE ON DOOR MADE OF BRASS
- 3.) HARDWARE ON DOOR OF UNKNOWN COMPOSITION
- 4.) DOOR THICKNESS IS 0 - 1 3/4"

FOR THE PRESERVATION OF ANY DOOR, A CAREFUL EVALUATION MUST BE UNDERTAKEN TO ADDRESS THE CURRENT PHYSICAL CONDITIONS. MOISTURE REMAINS A PRIMARY PROBLEM FOR ANY ARCHITECTURAL WOODEN ITEM AND THE DOOR MUST BE CHECKED FOR ANY SIGNS OF WATER INTRUSION LIKE PAINT FAILURE. TESTING THE WOOD FOR SOUNDNESS USING A SMALL KNIFE IS ANOTHER SIMPLE METHOD TO DETERMINE CONDITION. REMOVAL OF EXCESS PAINT THROUGH THE GENTLEST MEANS POSSIBLE RESTORES THE ORIGINAL DETAILING IN FULL CLARITY. HOWEVER, PAINT OFTEN SERVES AS A PROTECTIVE BARRIER AND SHOULD ONLY BE REMOVED IN CERTAIN CIRCUMSTANCES WHERE THE PAINT IS DAMAGED. THIS REMOVAL REQUIRES HAND SCRAPPING WITH MINIMAL USE OF ABRASIVE TECHNIQUES. A HEAT GUN CAN BE USED TO AID IN THE GENTLE REMOVAL OF DAMAGED PAINT THAT READILY DETACHES FROM THE WOOD. WHEN ROT AND FAILURE OF THE WOOD ITSELF IS PRESENT, STABILIZATION BECOMES A NECESSARY FOCUS. PATCHING, PIECING IN, CONSOLIDATING AND REINFORCING THE WOOD ARE COMMON PRACTICES WHEN DEALING WITH DECAYED WOODEN DOORS. THIS DECAYED WOOD MUST BE WATERPROOFED AND NORMALLY PATCHED WITH AN EPOXY COMPOUND FOLLOWED BY SANDING AND PAINTING TO MAINTAIN A GOOD APPEARANCE. MANY EPOXIES ARE USED TO BUILD UP MISSING SECTIONS OR DECAYED ENDS AND ARE WIDELY AVAILABLE. THESE NEW REPAIRS SHOULD BE PHYSICALLY AND VISUALLY COMPATIBLE TO THE SURROUNDING HISTORIC WOODWORK. IN SPECIAL CASES, WOOD FEATURES MAY BE REPLACED WHEN A PROTOTYPE OF THE ORIGINAL EXISTS WHICH SHOULD ONLY OCCUR WHEN THE FEATURE HAS DETERIORATED BEYOND USE.

THE LANCE HALL DOORS REQUIRE STAGE ONE REPAIRS THAT DEAL WITH SIMPLE MAINTENANCE. TODAY THEY APPEAR TO BE IN EXCELLENT CONDITION AND STILL REMAIN FUNCTIONAL. HOWEVER, AN EFFORT MUST BE MADE TO IMPROVE THEIR ENERGY EFFICIENCY. AIR INFILTRATION CAN CAUSE SUBSTANTIAL HEAT LOSS THROUGH MANY OF THE SPACES SURROUNDING THE DOOR. THE INSTALLATION OF A STORM DOOR CAN HELP BUT SHOULD ONLY BE INSTALLED IN COLDER CLIMATES. WEATHER-STRIPPING ALONG THE EDGES IS A SIMPLE WAY TO REDUCE AIR INFILTRATION AND MANY PRODUCTS SUCH AS FELT AND VINYL STRIPS ARE READILY AVAILABLE. THIS HAS PROVEN TO BE A EFFECTIVE IMPROVEMENT THAT OVERALL ENHANCES THE HEALTH OF THE BUILDING.

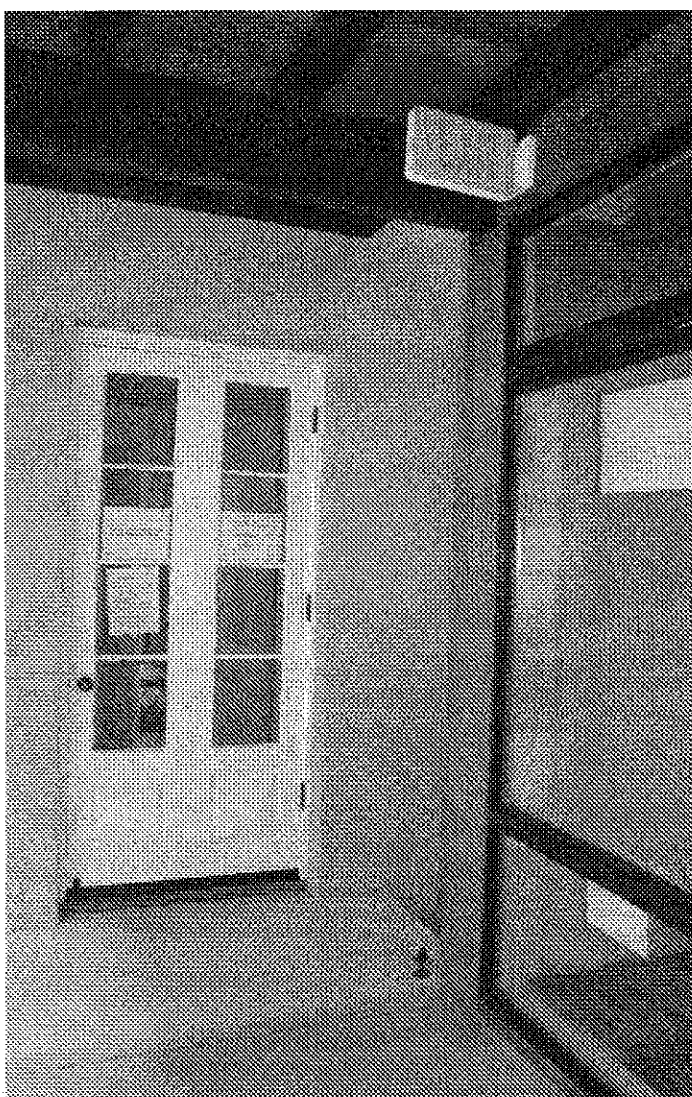
LANCE HALL'S NEW SIDE DOOR

**SIGNIFICANCE**  
ALTHOUGH THE SIDE DOOR OF LANCE HALL IS NOT HISTORIC, ITS PLACEMENT IS VERY SIGNIFICANT. IT ALLOWS EASY ACCESS TO THE NEW GREEN ADDITION. THIS RELATIVELY NEW DOOR REPLACES ONE OF THE WINDOWS. THIS IS EVIDENT DUE TO A SHUTTERDOG THAT REMAINS, ALONG WITH MANY NOTICEABLE MARKS ON THE MASONRY. THE TRUE SUCCESS OF THIS DOOR IS ARGUABLE. SOME FACTORS INCLUDE THE SIZE, LOCATION, STYLE AND WHETHER OR NOT THE DOOR HARMONIZES WITH THE OTHER HISTORIC FEATURES OF LANCE HALL. DOES THIS DOOR TRULY CREATE A SMOOTH TRANSITION FROM LANCE HALL TO ITS NEW ADDITION?

**ABOVE:**  
THIS PHOTOGRAPH ILLUSTRATES THE RELATION BETWEEN THE DOOR AND THE VERY NEAR NEW GREEN ADDITION. THERE IS ALSO A SMALL ALLEY-LIKE PASSAGEWAY BETWEEN THESE TWO BUILDINGS.

**RECOMMENDATIONS**  
ALTHOUGH THIS DOOR ACCOMODATES THE MODERN LOOK OF THE NEW GREEN ADDITION, THE DOOR LACKS TRUE HARMONY WITH THE HISTORIC LANCE HALL. THE DOOR HAS A SLIGHT HISTORIC LOOK: THERE IS AN INDENTION DOWN THE CENTER TO SIMULATE TWO PANELS, SIMILAR TO THE HISTORIC DOORS AROUND DOWNTOWN CHARLESTON. A REPLACEMENT DOOR TO COORDINATE WITH THE DARK DOORS UNDER THE PORTICO OF LANCE HALL WOULD ACHIEVE HARMONY ON THE CHURCH SITE.

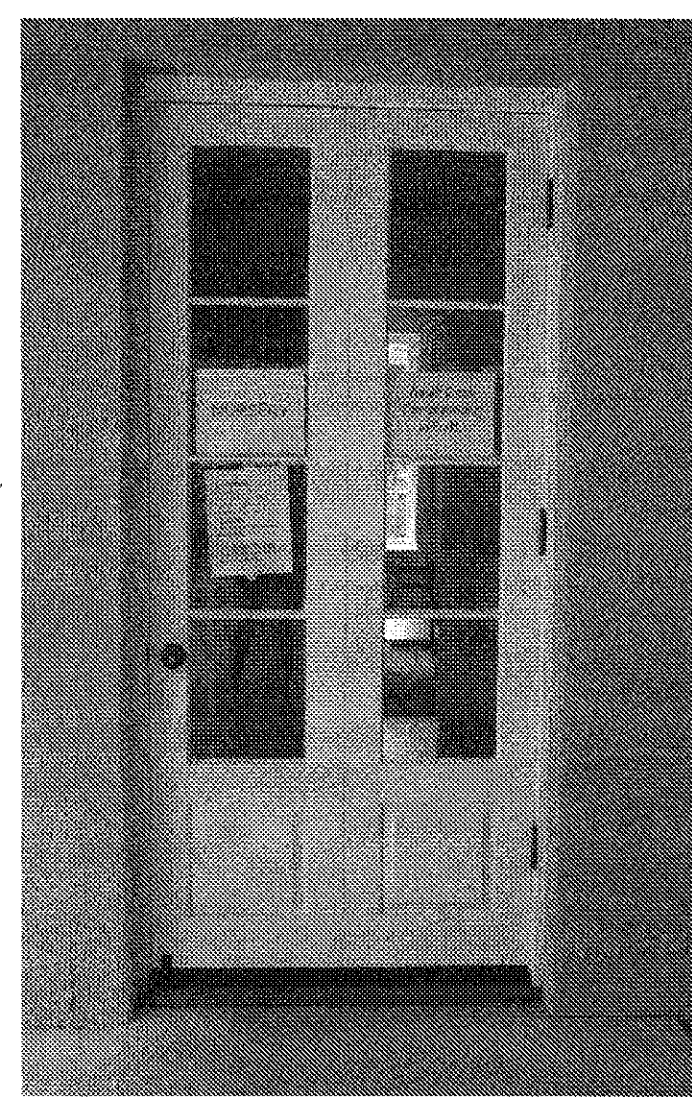
**CATEGORIZATION OF DOOR**  
THIS DOOR IS NOT CONSIDERED A TYPICAL EXTERIOR DOOR. IT HAS A VERTICAL RIBBON OF FOUR WINDOWS, GIVING IT A PRAIRIE, OR EVEN MODERNISTIC FEEL. IT HAS NO DECORATIVE CROWN ON THE EXTERIOR, BUT INSTEAD HAS A VERY SIMPLE CASEMENT. IT MOSTLY CONSISTS OF THIS GLAZING, BUT ALSO HAS TWO SQUARE PANELS AT THE BOTTOM. THE INTERIOR OF THE DOOR HAS SOME CROWN MOLDING SURROUNDING THE DOOR, ACHIEVING A MORE CLASSICAL FEELING ON THE INSIDE. THE ARCHITRAVE TRIM IS DRAWN TO SCALE AT THE FAR LEFT. THIS ADDS SOME WARMTH AND CHARACTER TO THE INTERIOR, YET THE SIMPLICITY OF THE DOOR AND ITS SURROUNDS ON THE EXTERIOR CORRELATE WITH THE MODERN NEW GREEN ADDITION THAT IS NEAR. THE CONTRASTS BETWEEN THE INTERIOR AND EXTERIOR OF THE DOOR ARE FAIRLY MINIMAL, YET ARE FOR GOOD REASON, AND ACHIEVE SOMEWHAT OF A CORRELATION WITH THE NEW GREEN ADDITION.

**ABOVE:**  
PHOTOGRAPH OF EXTERIOR ELEVATION OF DOOR. NOTICE SCORE LINES OF MASONRY AND SIMPLICITY OF THE DOOR SURROUND AND CASEMENT. THE WINDOWS CURRENTLY CONTAIN SIGNAGE FOR THE PURPOSES OF THE NURSERY WHICH THE DOOR LEADS TO.

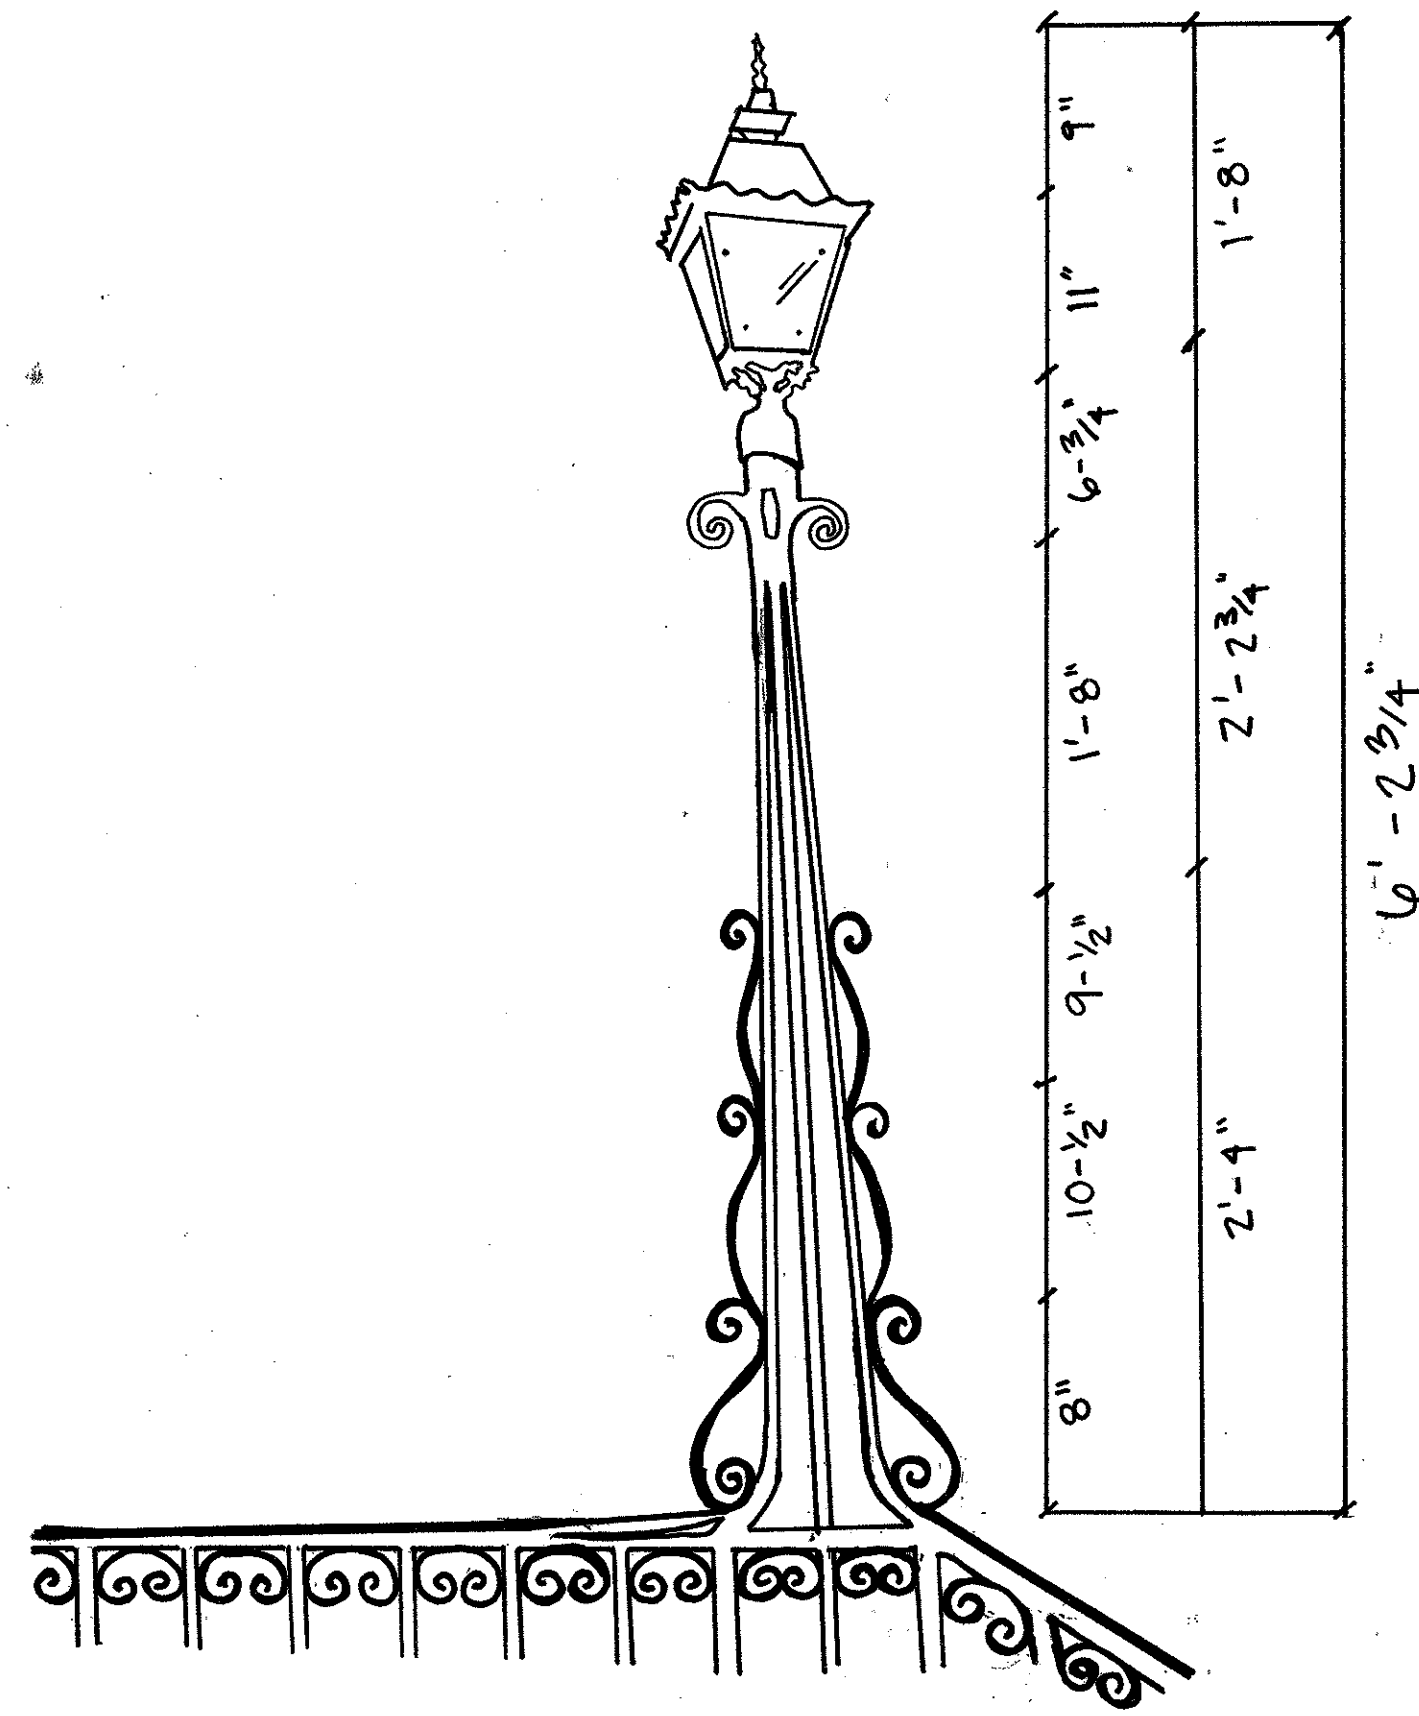
SOUTH LAMP-LANCE HALL  
NOT TO SCALE

THE CURRENT EXTERIOR LIGHTING OF LANCE HALL NEEDS TO BE UPDATED. THE LAMPS ON THE EXTERIOR NEED TO BE REPLACED WITH ONES THAT REFLECT THE GREEK REVIVAL STYLE OF THE BUILDING. THE CURRENT LIGHTING HAS MORE OF A VICTORIAN FLAIR WITH SCALLOPED EDGES AROUND THE LAMP FIXTURE. THE CURRENT FIXTURE IS POST MOUNTED ON WROUGHT IRON. THESE POSTS ARE ON THE NORTH AND SOUTH SIDES OF THE PORTICO OF LANCE HALL AT THE CIRCULAR CONGREGATIONAL CHURCH. PROPOSED ARE SEVERAL OPTIONS FOR NEW EXTERIOR LIGHTING FOR THIS HISTORIC STRUCTURE. PROBLEMS WITH THE EXISTING LIGHTING INCLUDE THE MISSING HURRICANE GLOBE OVER THE NORTH SIDE BULB. THE STRUCTURE IS INEFFICIENT IN TERMS OF GREEN STRUCTURE LIGHTING, AND THE FIXTURE NEEDS REPLACING. THE CURRENT LAMP SYSTEM IS SET UP FOR GAS OR ELECTRIC. ALTHOUGH ELECTRIC IS CURRENTLY USED AND THE GAS LINE HAS BEEN DISCONNECTED ON THE SIDE OF LANCE HALL ACCORDING TO SITE RESEARCH.

1. REPLACE THE LAMP WITH A FIXTURE FROM A GREEN BUILDING COOPERATIVE MEMBER (CHARLESTON GAS LIGHT COMPANY NOW OFFERS ELECTRICAL AND GAS LIGHTING AND IS A GREEN BUILDING SUPPORTER).
2. REPLACEMENT LAMP SHOULD BE MADE OF A RUST RESISTANT MATERIAL SUCH AS PAINTED COPPER, SO THAT THE LAMP DOES NOT NEED REPLACEMENT FOR YEARS TO COME.
3. SOLAR LIGHTING IS AN OPTION IF THE SOLAR PANEL CAN BE CONCEALED IN AN INCONSPICUOUS AREA.
4. LOW VOLTAGE LIGHTING WOULD LOWER ENERGY COST, BUT THE CONVERSION MECHANISM FROM A REGULAR OUTLET TO A 12V. OUTLET CAN BE EXPENSIVE.
5. TAKE NECESSARY GREEN MEASURES INSIDE LANCE HALL TO CONSERVE ENERGY AND USE LESS LIGHTING.

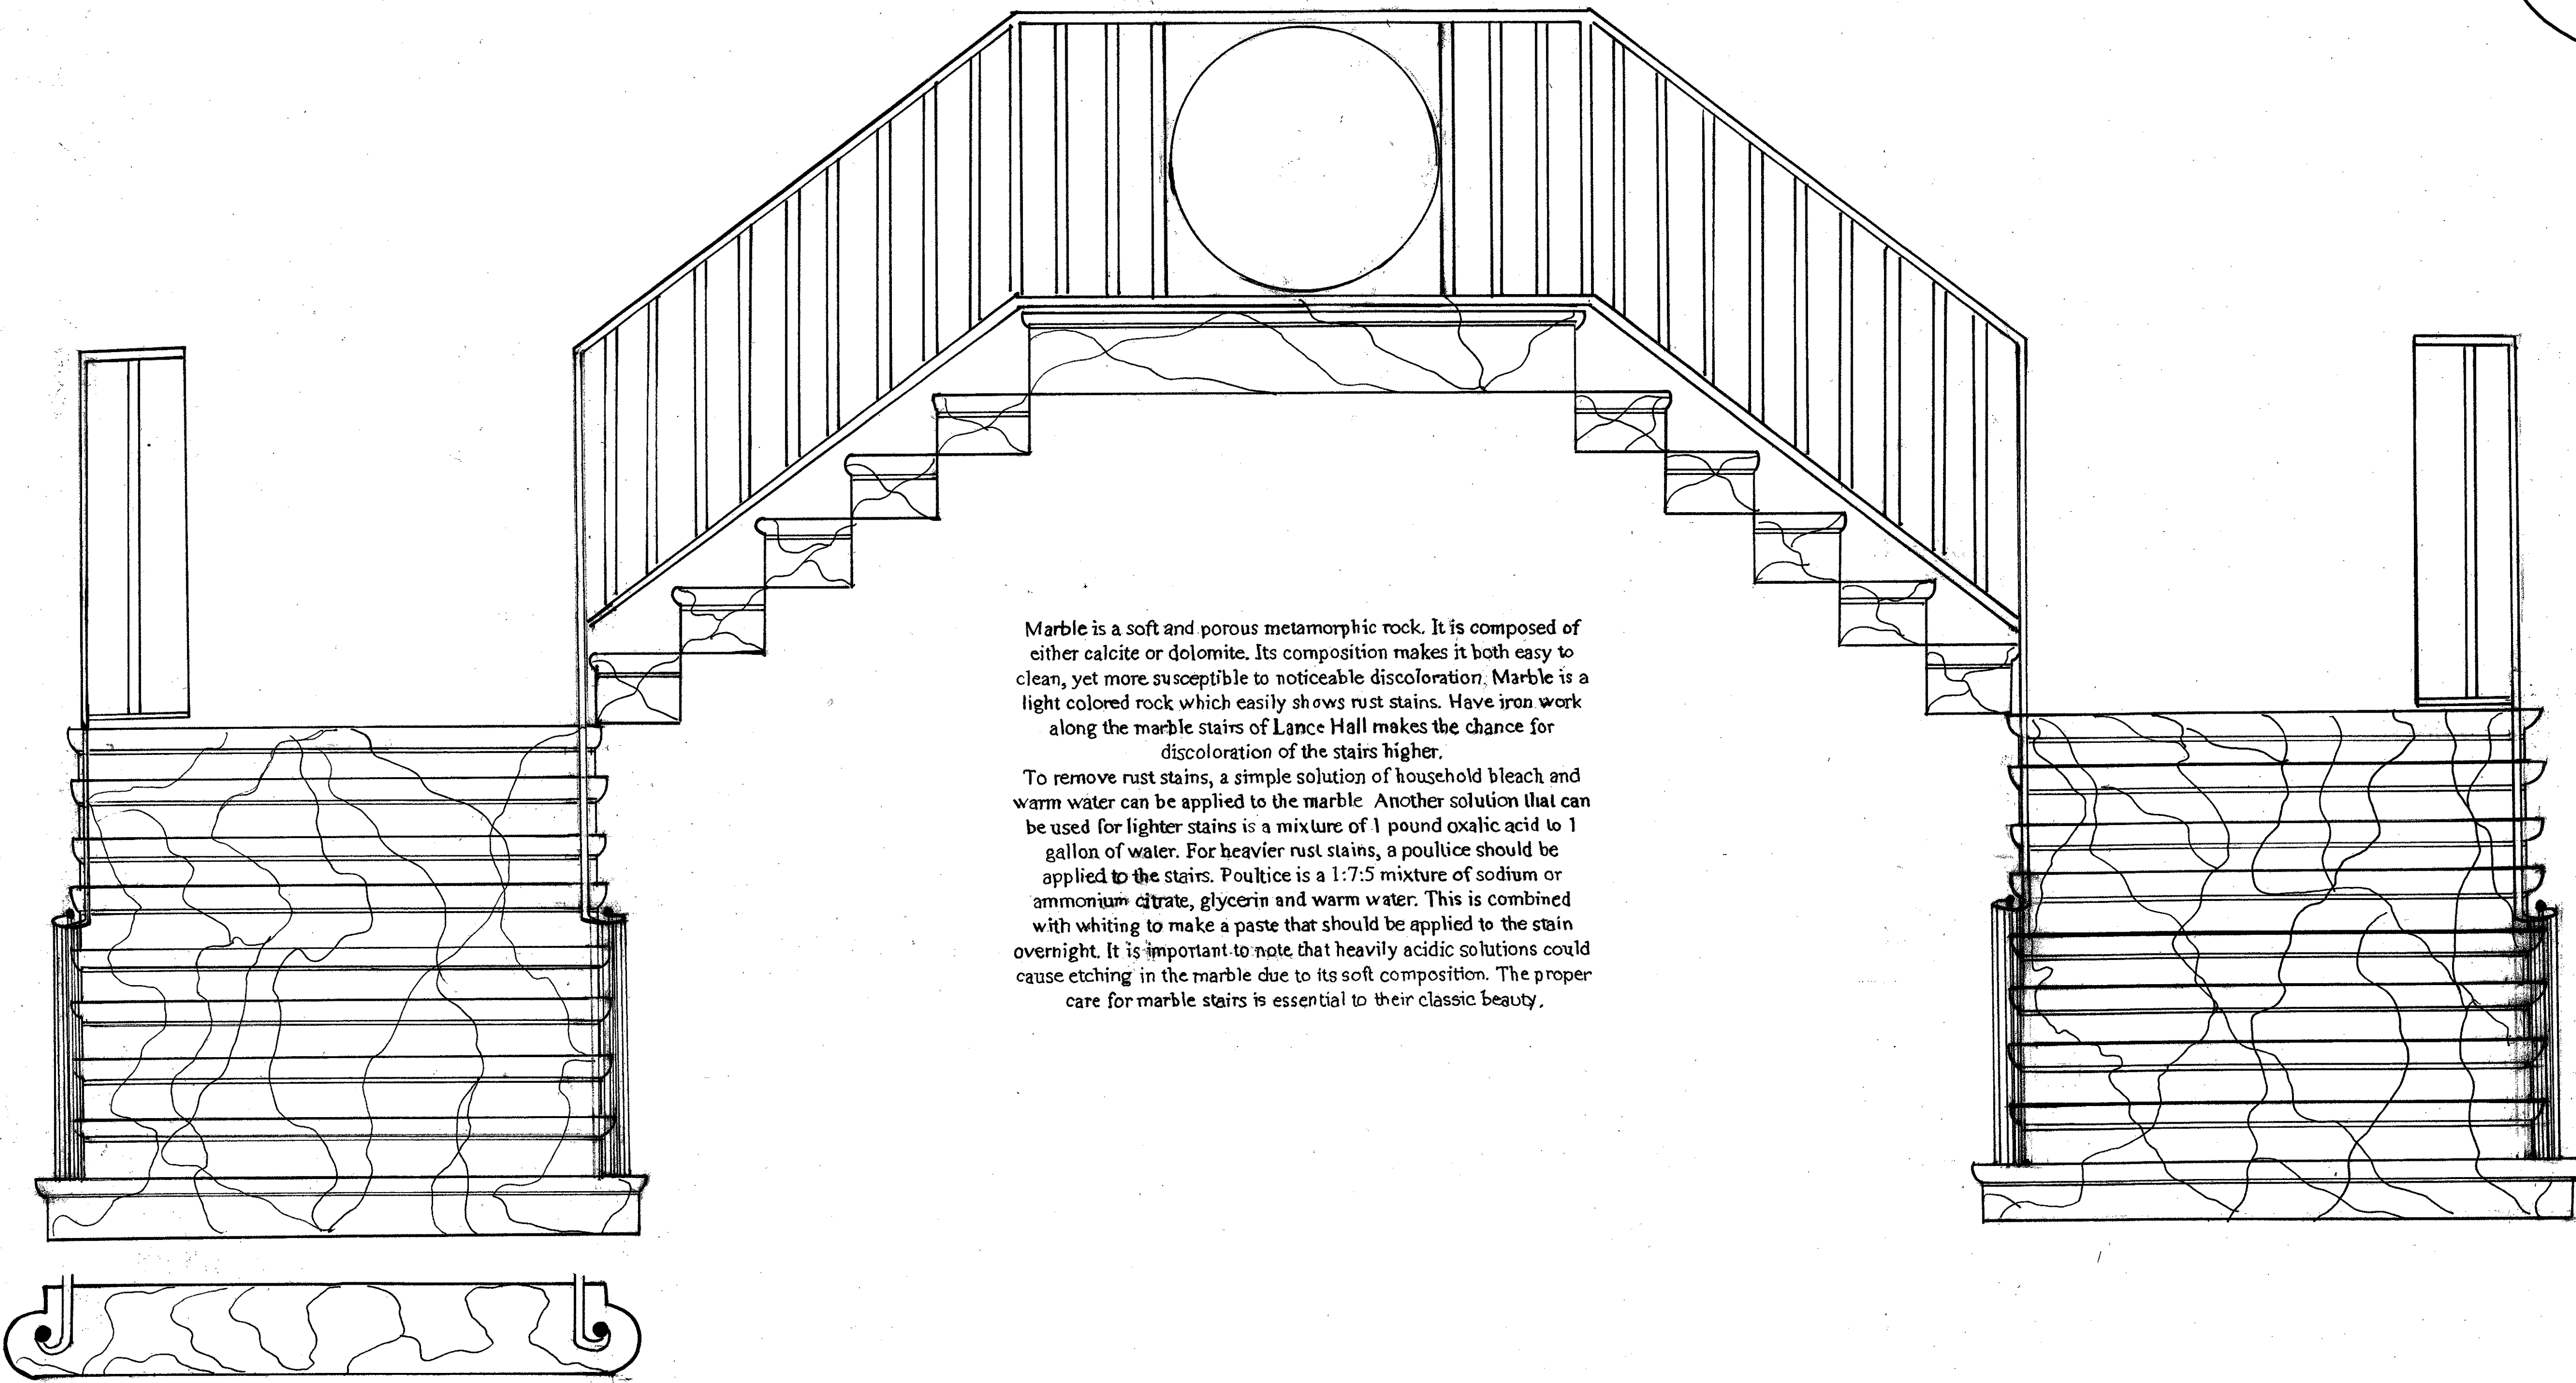
# LANCE HALL

Marble is a soft and porous metamorphic rock. It is composed of either calcite or dolomite. Its composition makes it both easy to clean, yet more susceptible to noticeable discoloration. Marble is a light colored rock which easily shows rust stains. Have iron work along the marble stairs of Lance Hall makes the chance for discoloration of the stairs higher.

To remove rust stains, a simple solution of household bleach and warm water can be applied to the marble. Another solution that can be used for lighter stains is a mixture of 1 pound oxalic acid to 1 gallon of water. For heavier rust stains, a poultice should be applied to the stairs. Poultice is a 1:7:5 mixture of sodium or ammonium citrate, glycerin and warm water. This is combined with whiting to make a paste that should be applied to the stain overnight. It is important to note that heavily acidic solutions could cause etching in the marble due to its soft composition. The proper care for marble stairs is essential to their classic beauty.
