| JAMES L. WARD<br>ASSISTANT PROFESSOR<br><br>COLLEGE OF CHARLESTON<br>ARTH 299-001 FALL 2007<br><br>HISTORIC PRESERVATION &<br>COMMUNITY PLANNING | | LANCE HALL & ADDITION<br>MEETING STREET - CHARLESTON, SC | |
| ASSIGNMENT NO: 5 | | DRAWING TITLE:<br><b>FINAL SITE PLAN<br/>LANCE HALL &amp; ADDITION</b> | |
| DATE: 11.09.07 | | DRAWING PREPARED BY (TEAM/INDIVIDUAL):<br>G. BROWN, B. L'HULLIER, A. MILLER, P. REED | |

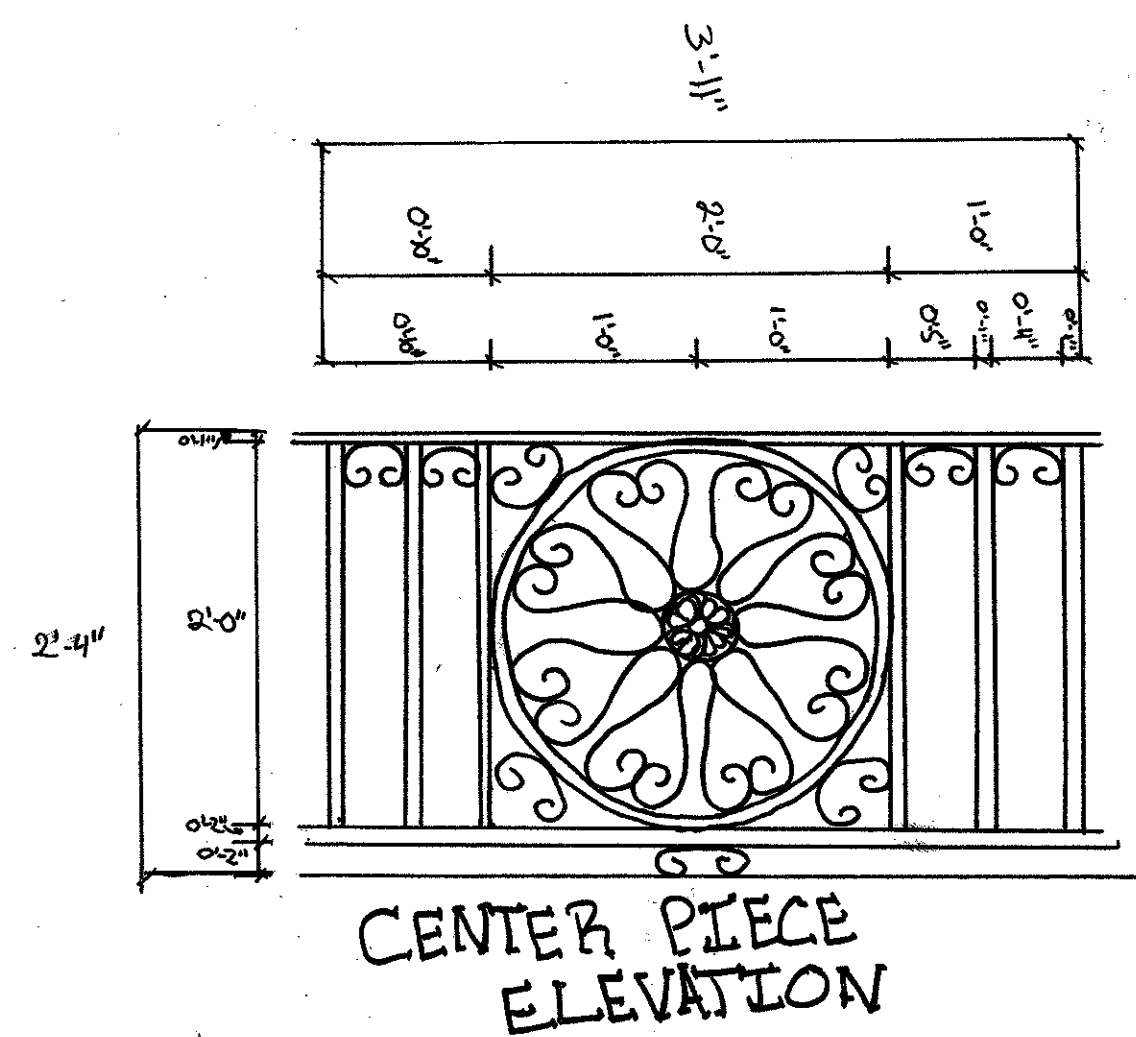
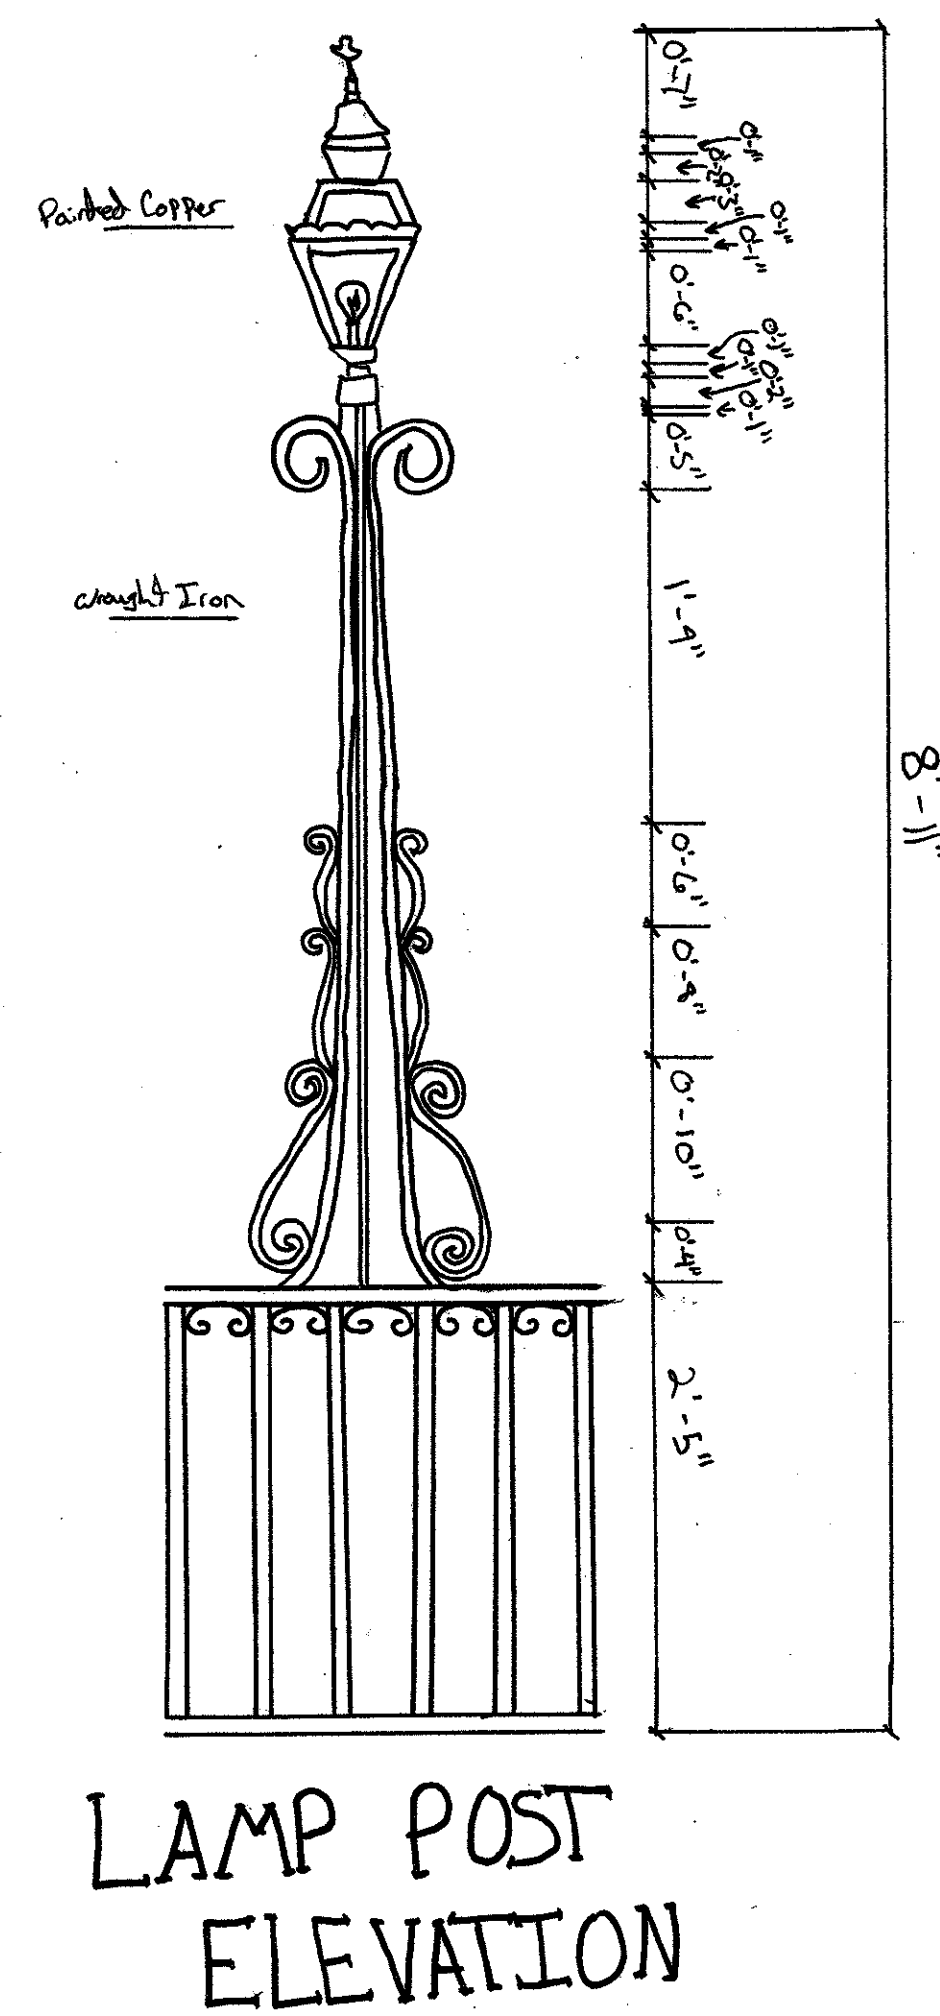
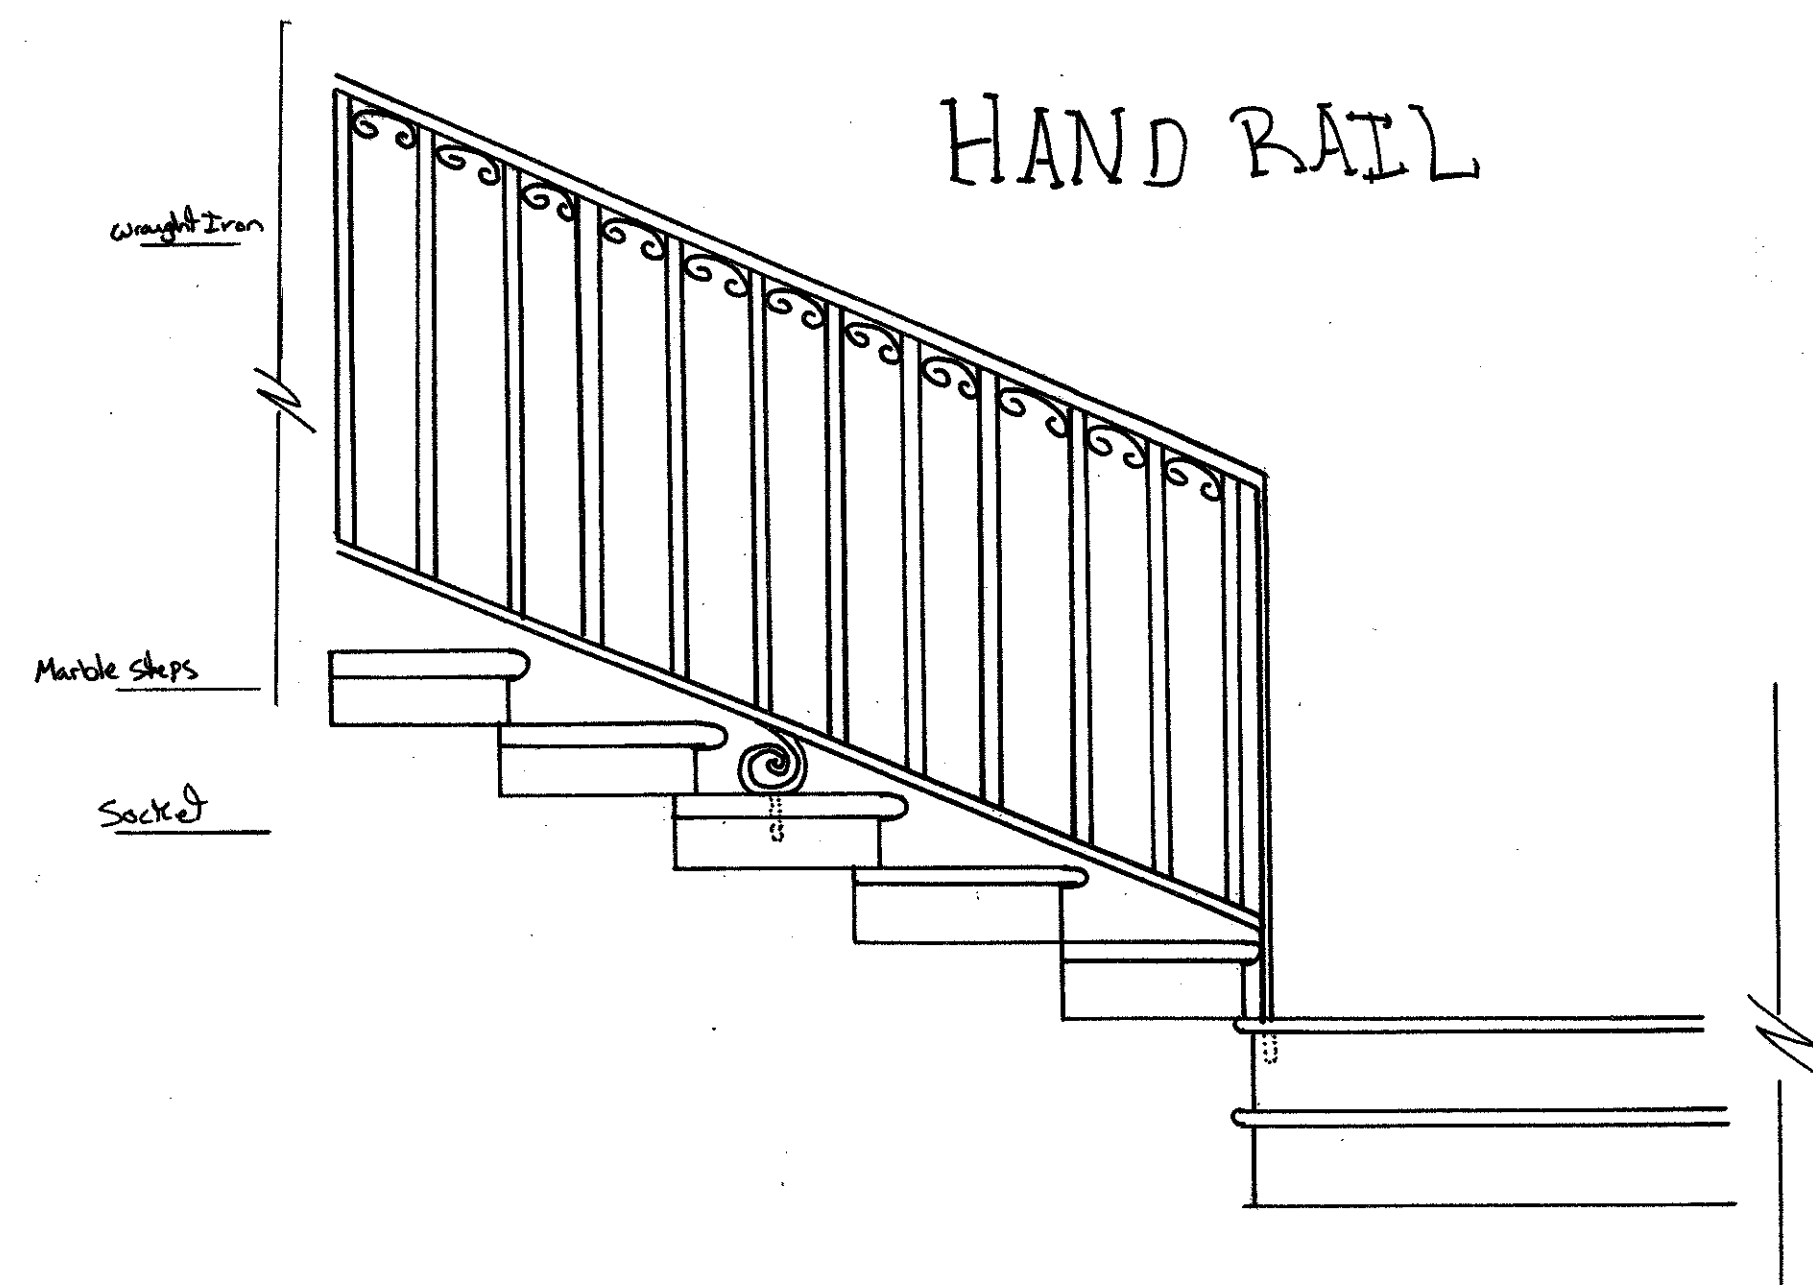
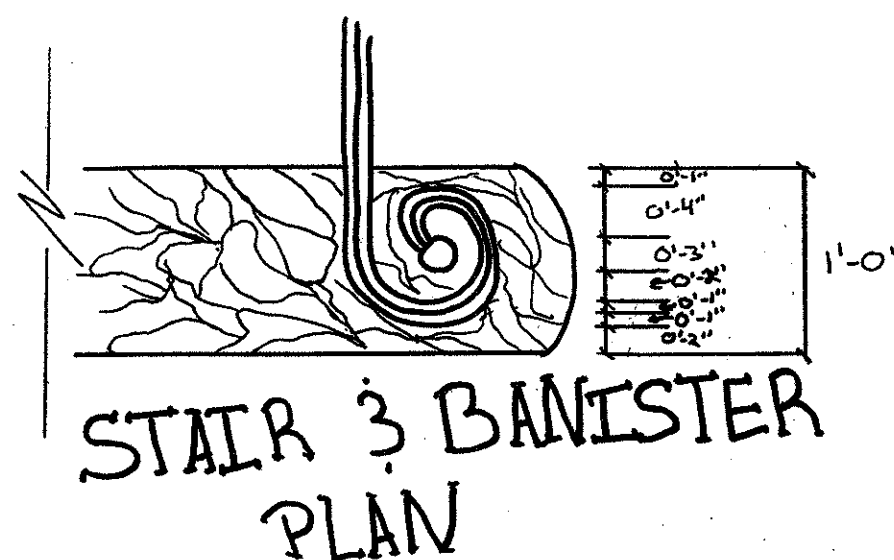
# Lance Hall Wrought Iron Details

Much of the wrought iron work on Lance Hall and the surrounding property is in great need of maintenance and repair due to its age and little attention given to it. On the building, the railings have been painted over; most likely as quick solutions to repairing rust spots and other issues. The metal will last longer and look better without any paint on the surface because the paint builds in small spots muting the important details.

The safest way to remove the paint is to use chemical agents and steam cleaning. This will restore it to the metal's original appearance. To repair the rust spots it is necessary to physically remove the iron detail from its location and reheat the metal. When the metal heats it will expand but the rust will not causing it to loosen from the metal allowing it to be brushed off. This will not alter the structural qualities of the metal or the appearance other than improving it. The most important thing to take note of when cleaning iron is the high lead content, proper care must be taken to not inhale or ingest dust or vapors when working with the metal.

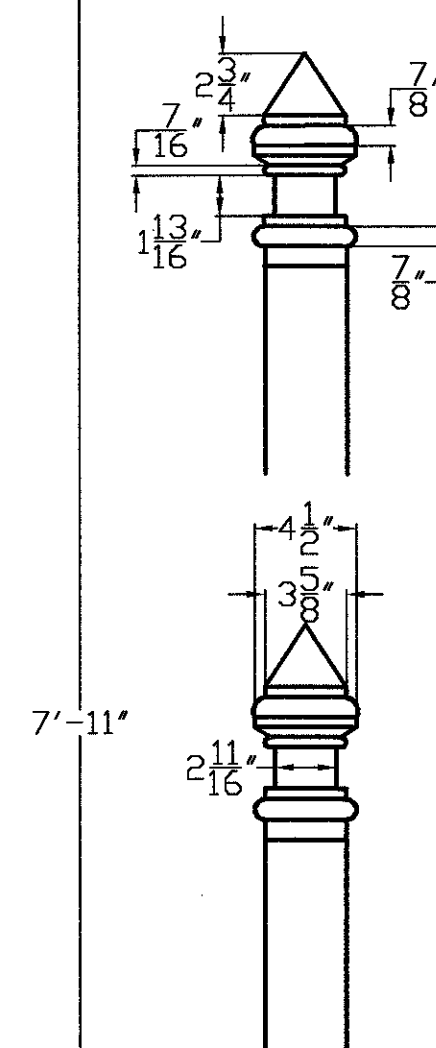
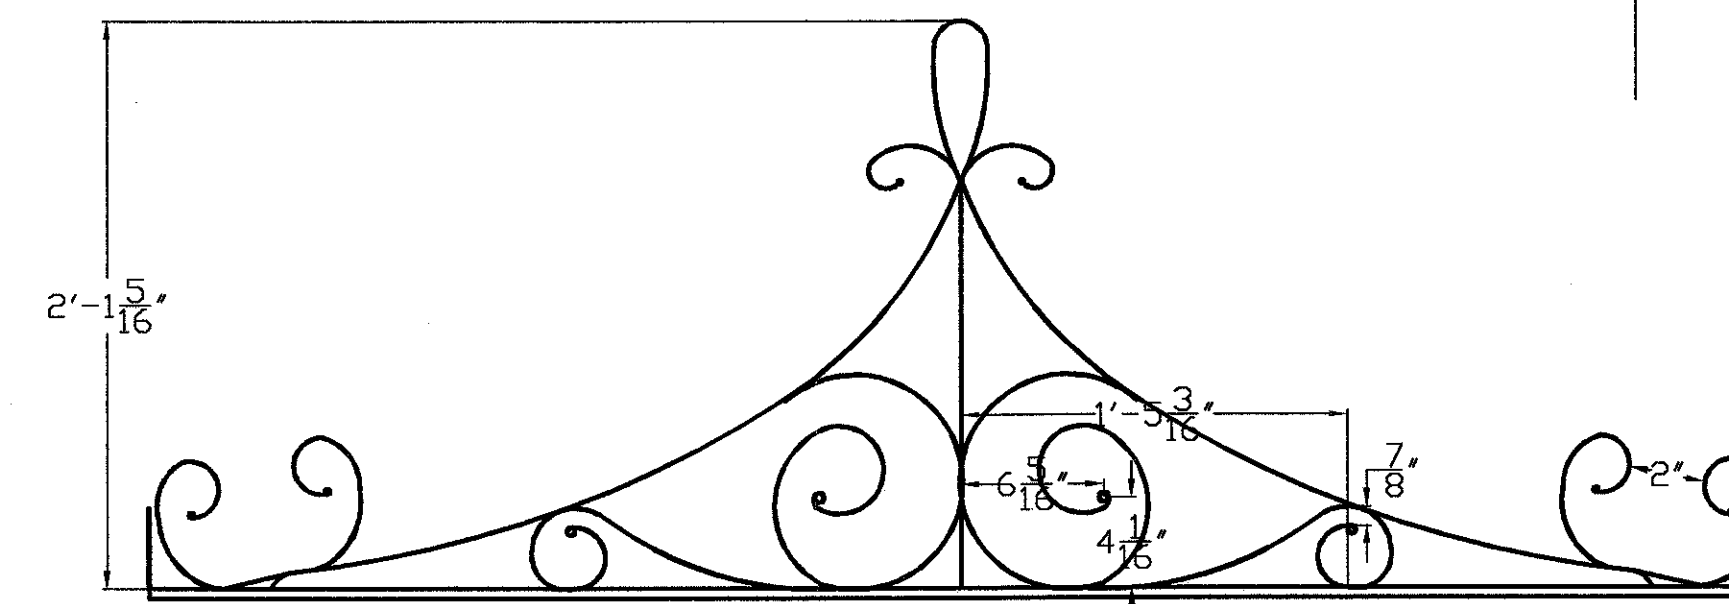
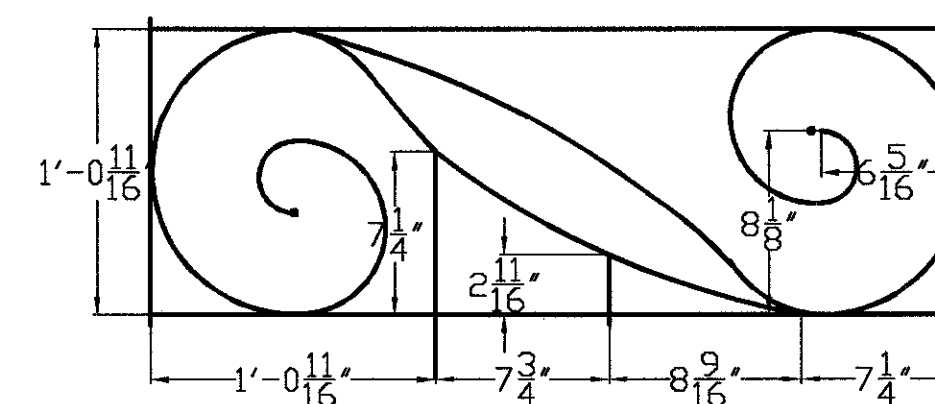
This gate is not original to the site however it is a good exapmle of early cast ironwork. Part of a much larger perimeter fence that aligns along Meeting St. the fence also contians another larger gate. The fence and gate are painted black and the fence is situated upon a brick base covered with cast iron this cast iron and brick base has fallen into disrepair and has broken or fallen off. The significance of this gate is the fact that it aligns to the center of Lance Hall and there used to be a pathway linking the street to the building. This gate is raised off the sidewalk by 8 inches with a slab of granite. Other than the Base of the fence it is in good condition. Proper matienence will ensure that this important gate will stand the test of time.
