| JAMES LIPHUS WARD<br>SC RLA | | <b>GLEBE STREET RESIDENCES</b> | |
| COLLEGE OF CHARLESTON<br>HPCP 299-SPRING 2010<br>HISTORIC PRESERVATION &<br>COMMUNITY PLANNING | | DRAWING TITLE:<br><b>14 GLEBE STREET</b><br><b>Floor Plan</b><br>DRAWING PREPARED BY (TEAM/INDIVIDUAL):<br><b>TEAM: Galtor Frick Voneshatz</b> | |

| JAMES LIPPHUS WARD<br>SC RLA | | GLEBE STREET RESIDENCES | |
| COLLEGE OF CHARLESTON<br>HPCP 209-SPRING 2010 | | DRAWING TITLE:<br>14 GLEBE ST<br>ELEVATIONS | |

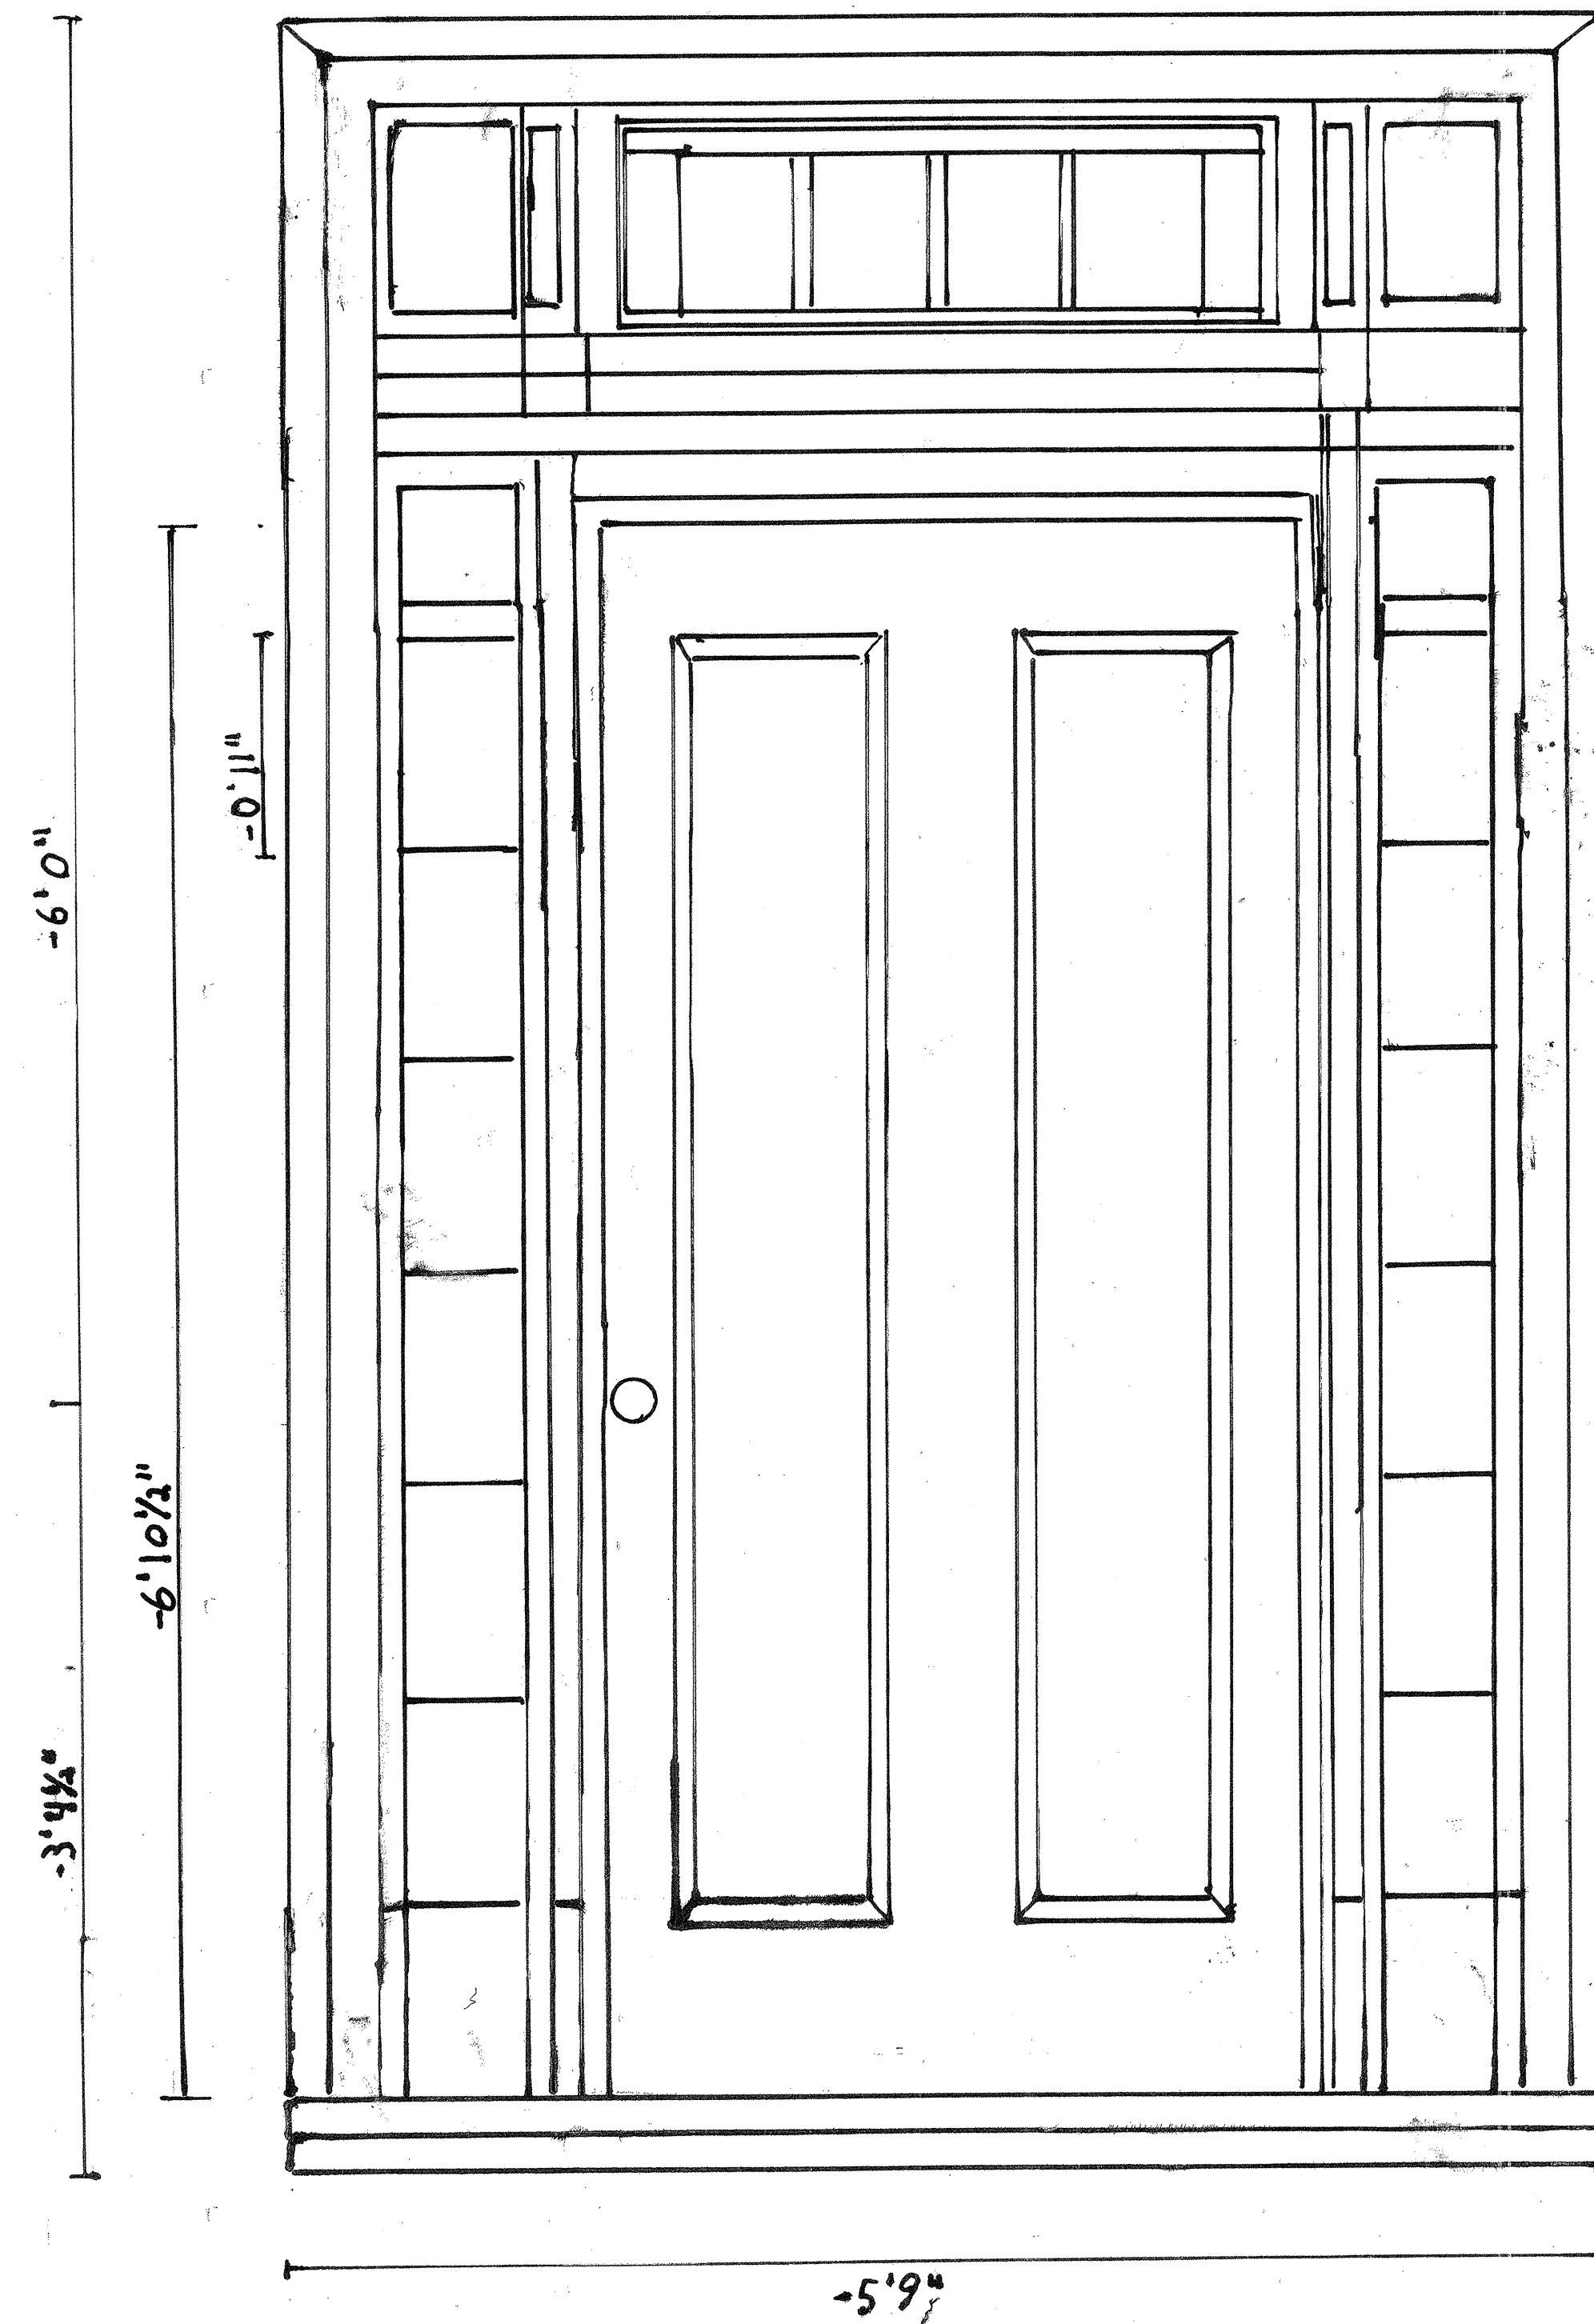
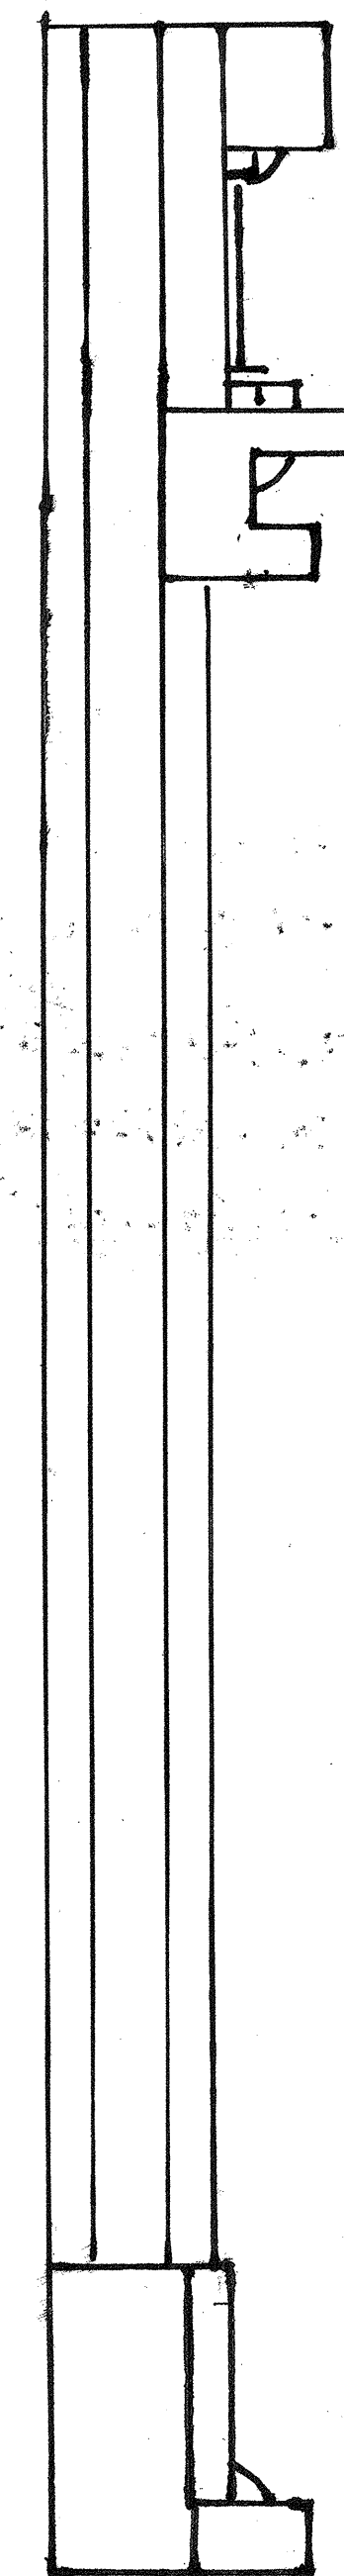
## Door Detail

1. DOOR Foundation made of cement.
2. Door and Header made of wood and glass.
3. Signs of former screen door.
4. Door and frame are original.
5. Section is not to scale.

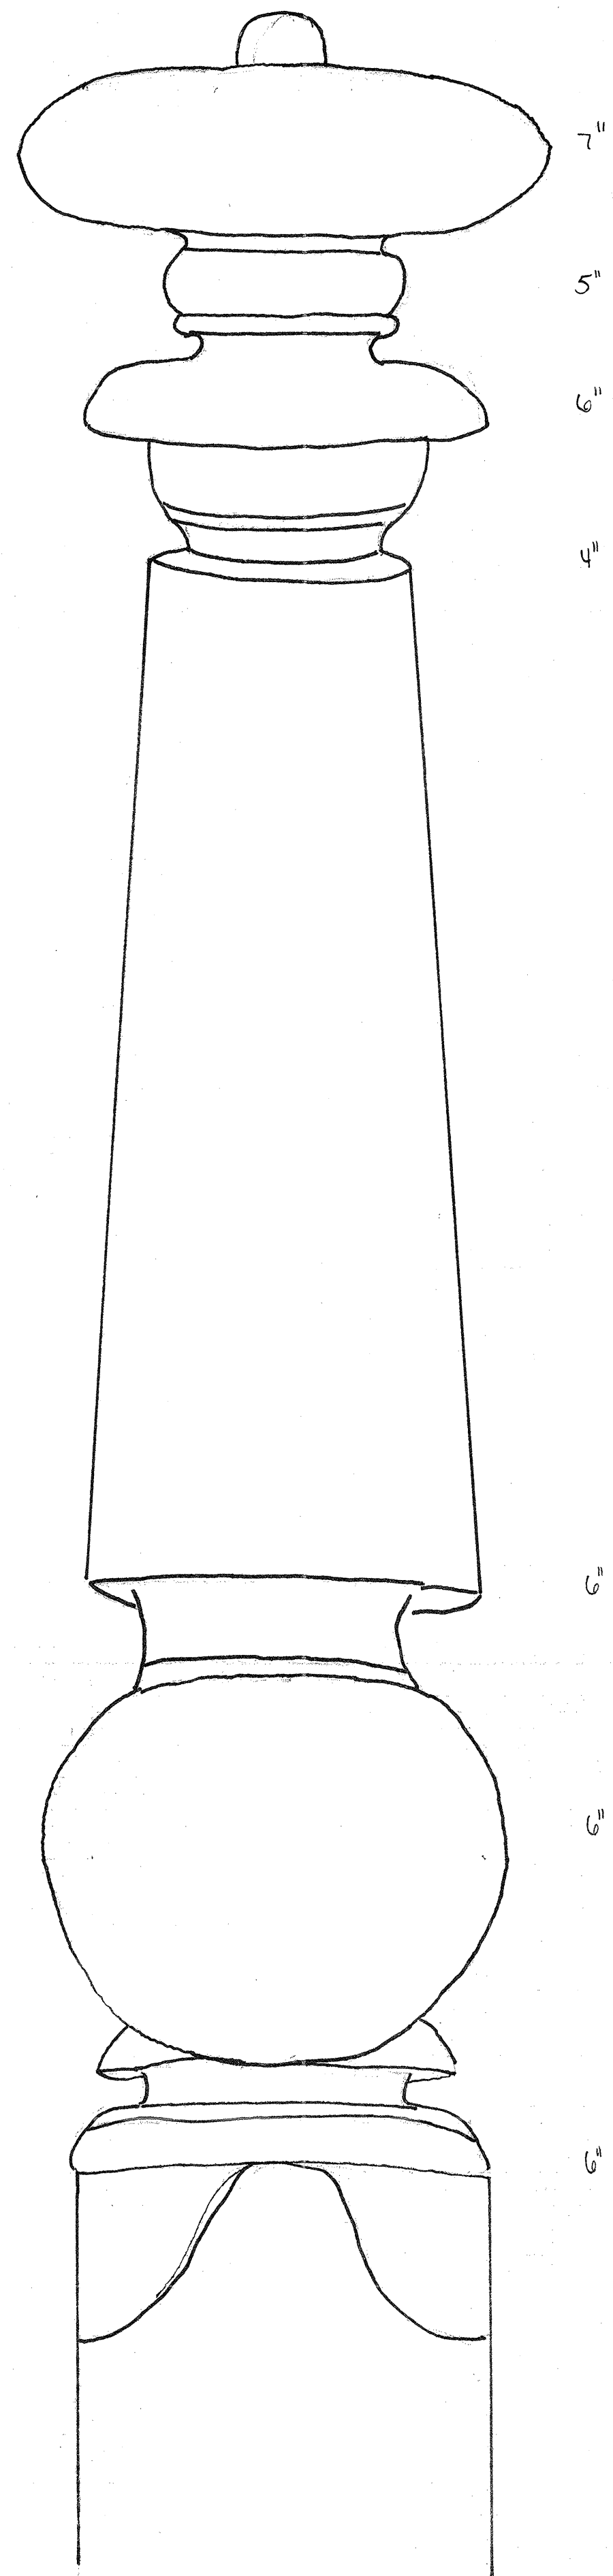
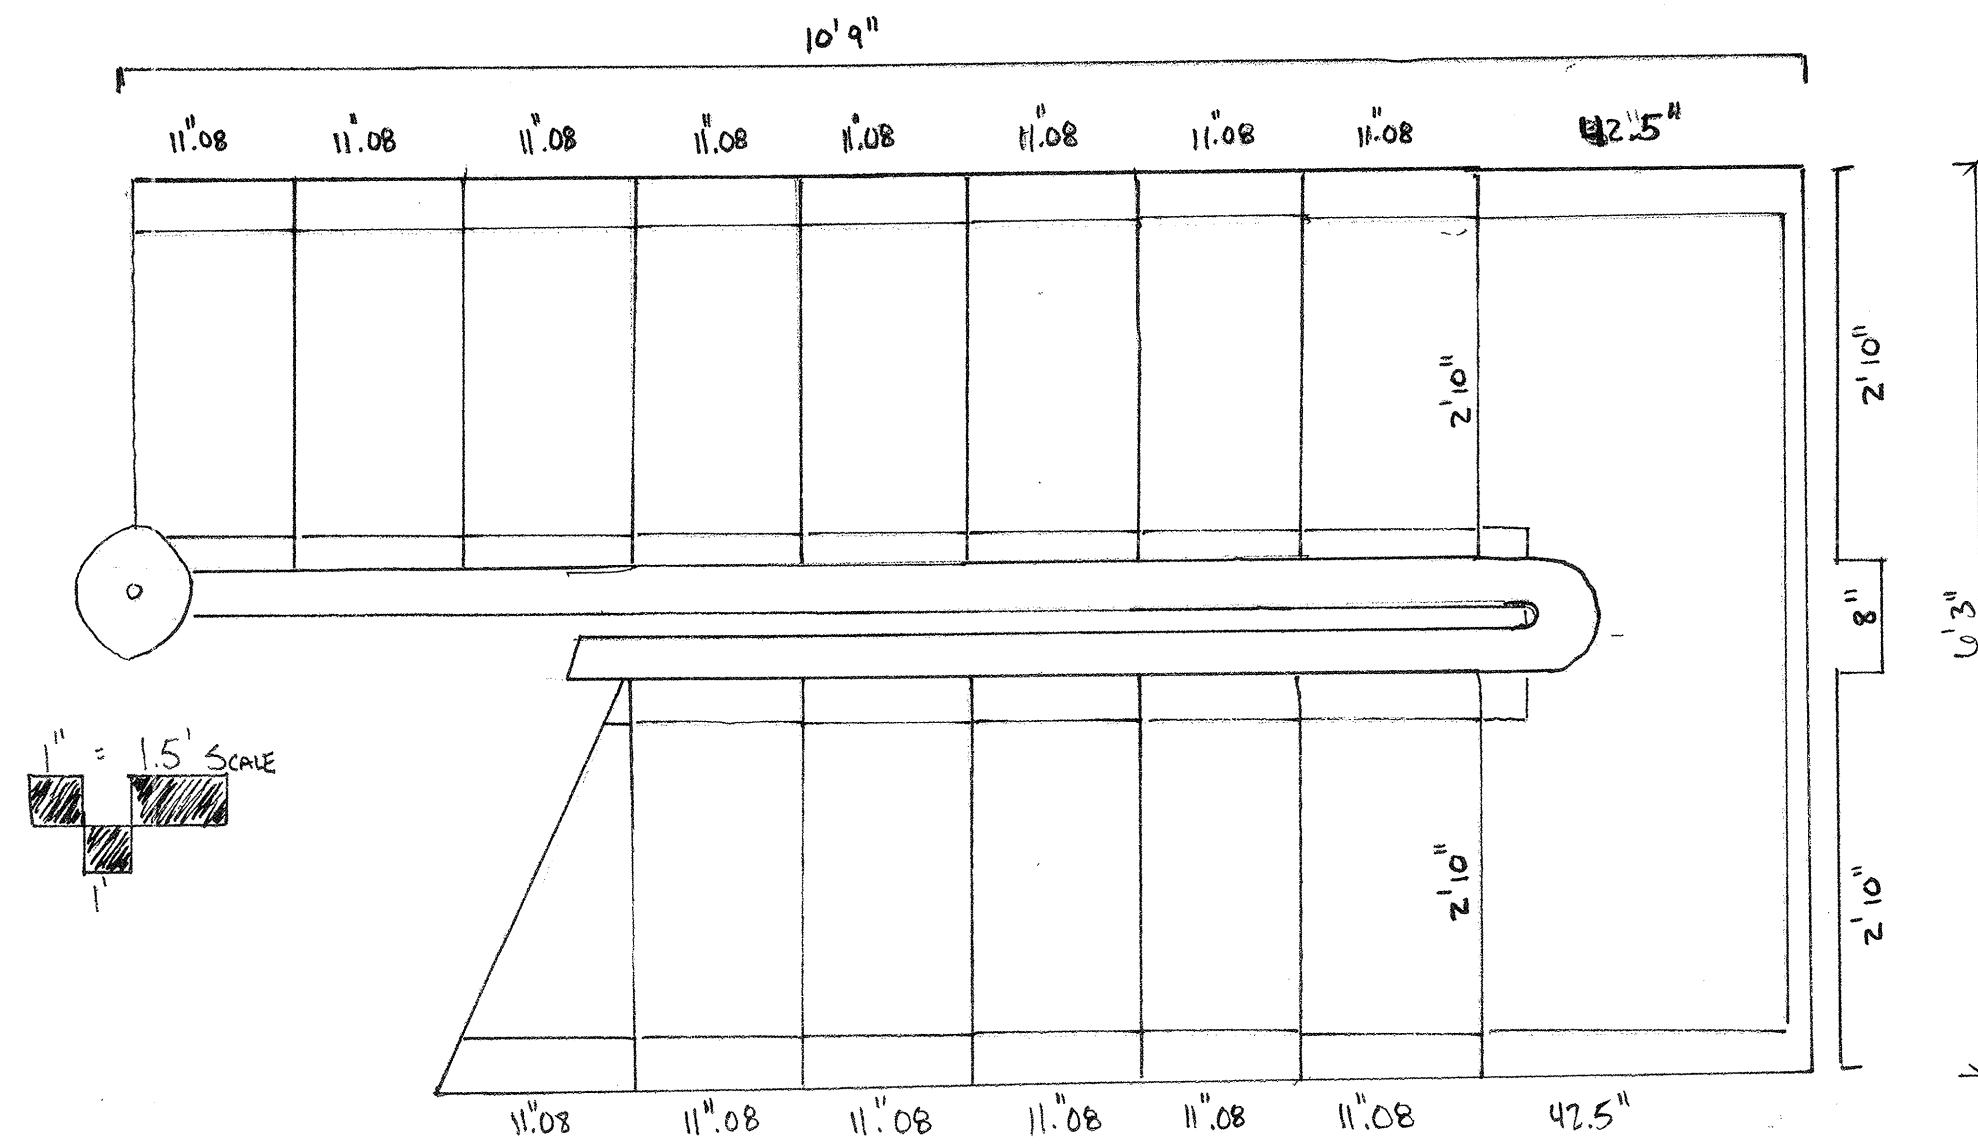
RAILING SUPPORTS ARE  
ENTIRELY DIFFERENT SIZES

ORIGINAL HARDWOOD IS  
COVERED WITH CARPET

NEWEL MAYBE ORIGINAL

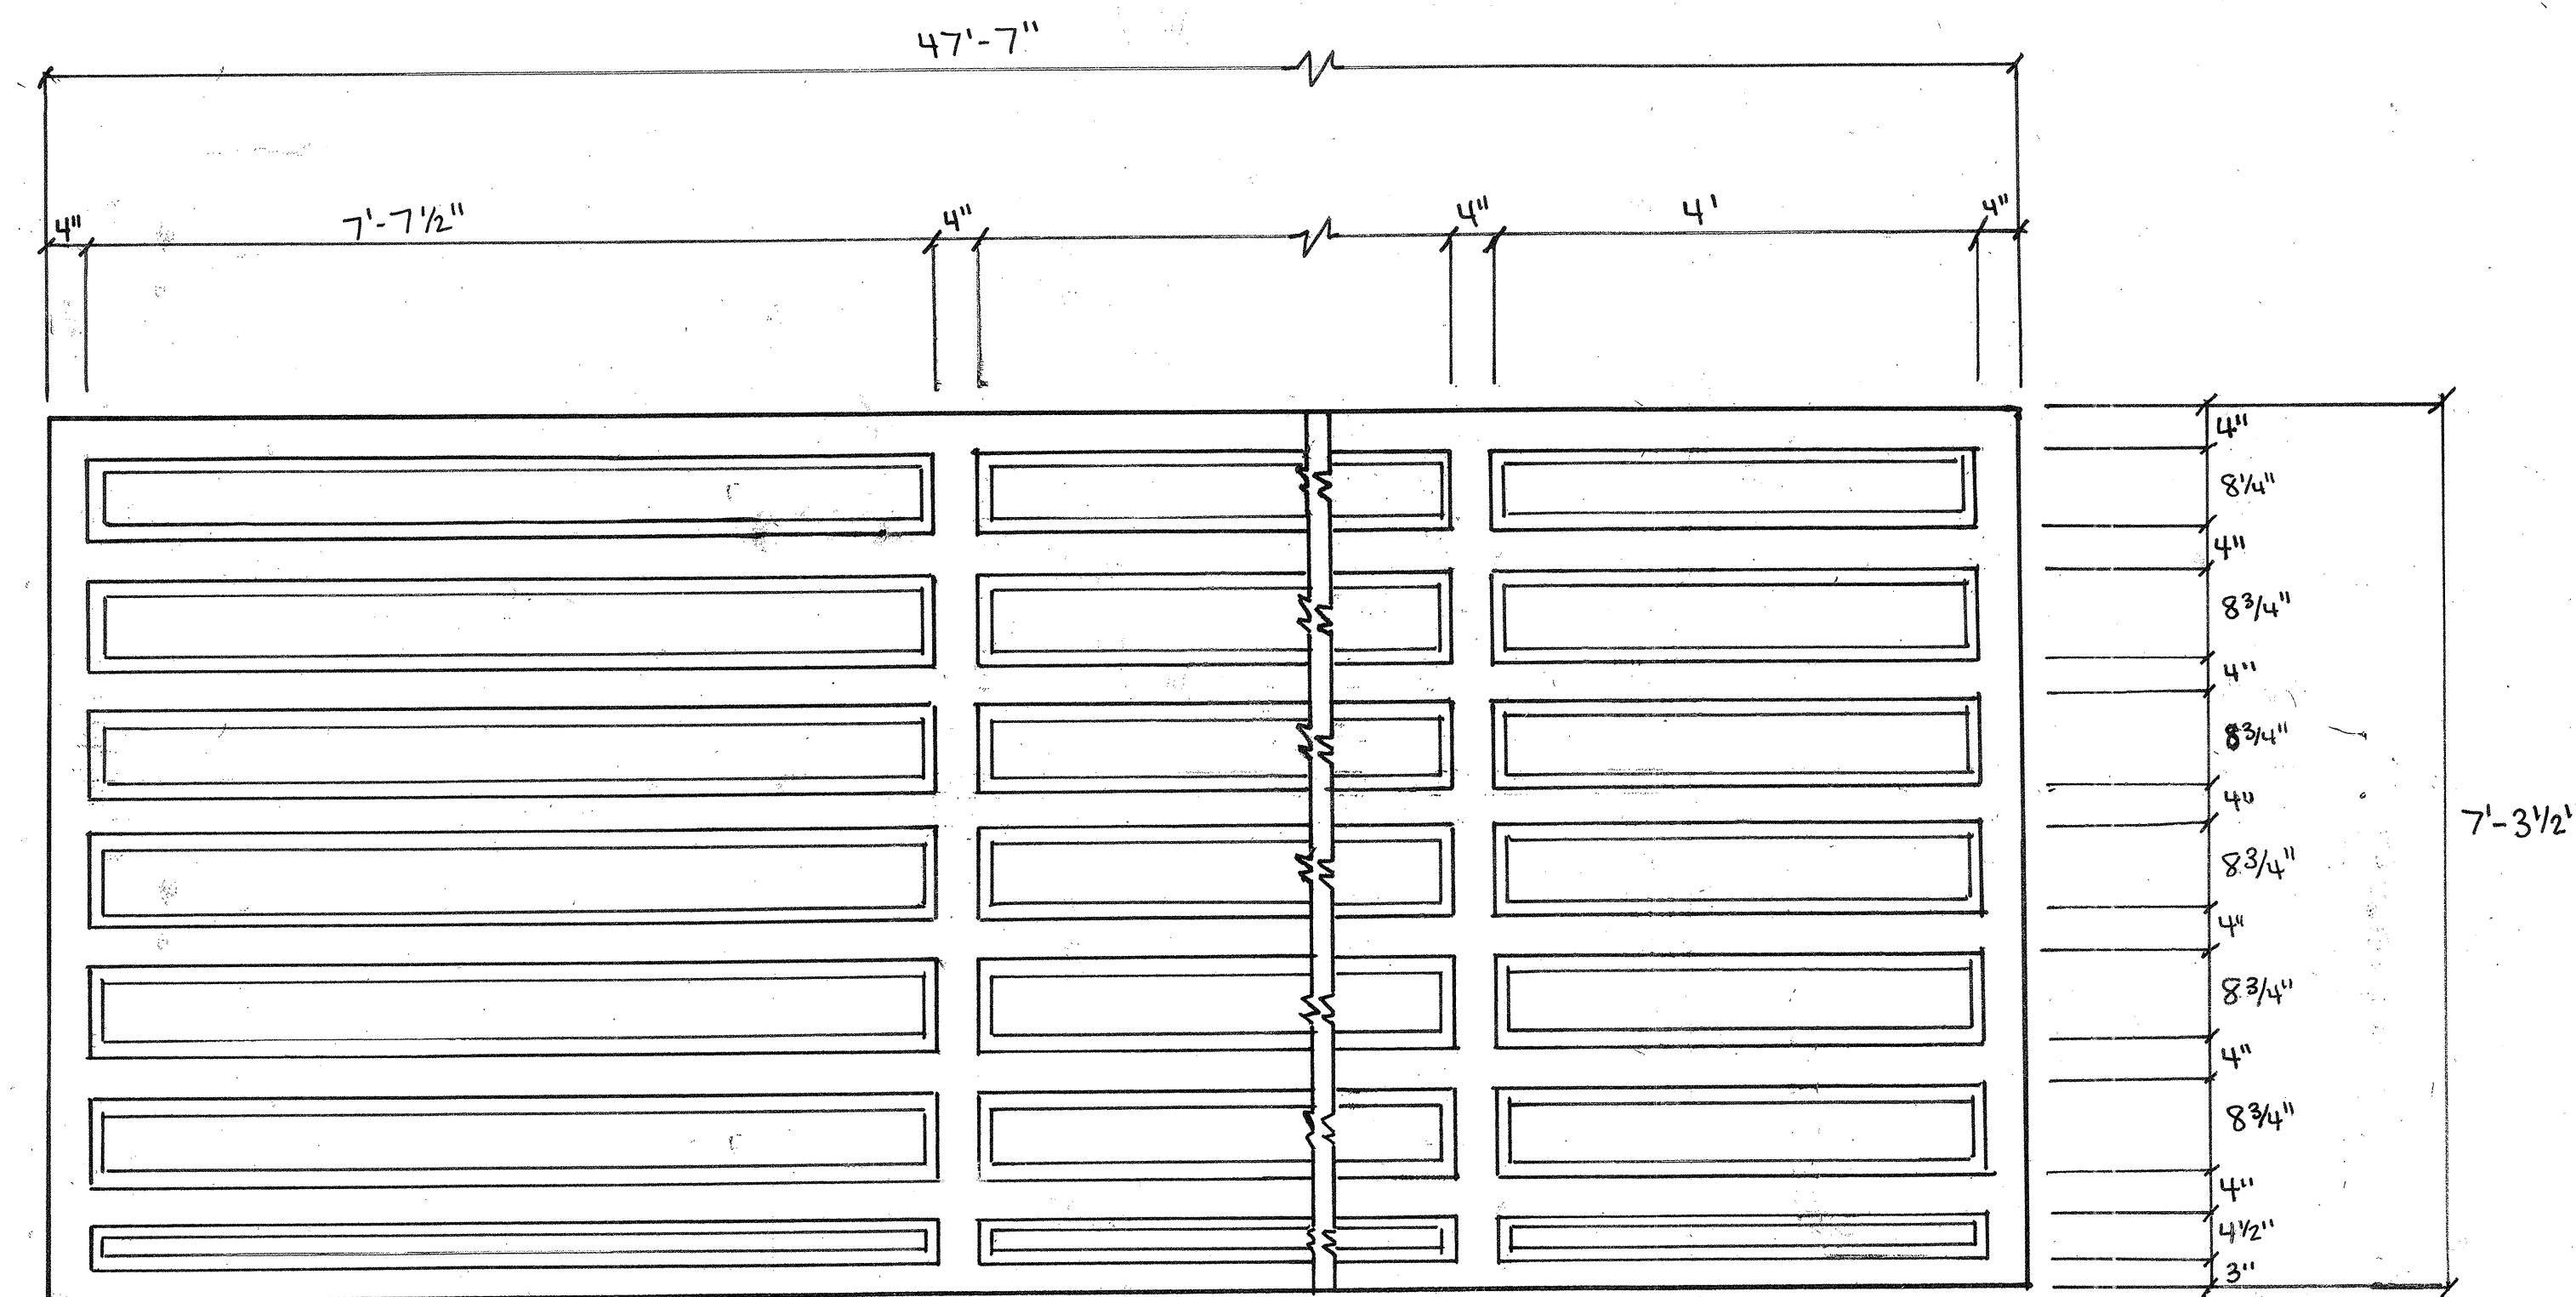
PORCH CEILING REFLECTION

- THERE ARE 6 ROWS OF INDENTATIONS AND ALL ARE 7'-7 1/2" IN LENGTH EXCEPT THE LAST, WHICH IS 4' IN LENGTH
- DESIGN OF CEILING MAY BE INTENDED TO REFLECT THE 2 LONG PANELS ON THE DOORS AND MAY BE THE ORIGINAL STYLE BASED ON THE APPEARANCE OF THE SAME DESIGN ON OTHER PROMINENT HOUSES IN THE AREA
- THE PORCH LANTERN MAY ALSO BEEN MODELED AFTER THE ORIGINAL CEILING AND DOOR STYLE BASED ON THE FACT THAT THE PANEES OF GLASS ARE LONG AND RECTANGULAR
- THE LANTERN ON THE RIGHT IS MORE ACCURATE FOR THE ASSUMED STYLE OF THE HOUSE AND WOULD MOST LIKELY BE WALL MOUNTED
- THE CEILING SHOULD BE PROTECTED FROM MOLD AS BEST AS POSSIBLE AND TOO MANY COATS OF PAINT SHOULD BE AVOIDED BECAUSE COFFERING WILL BE LESS PROMINENT

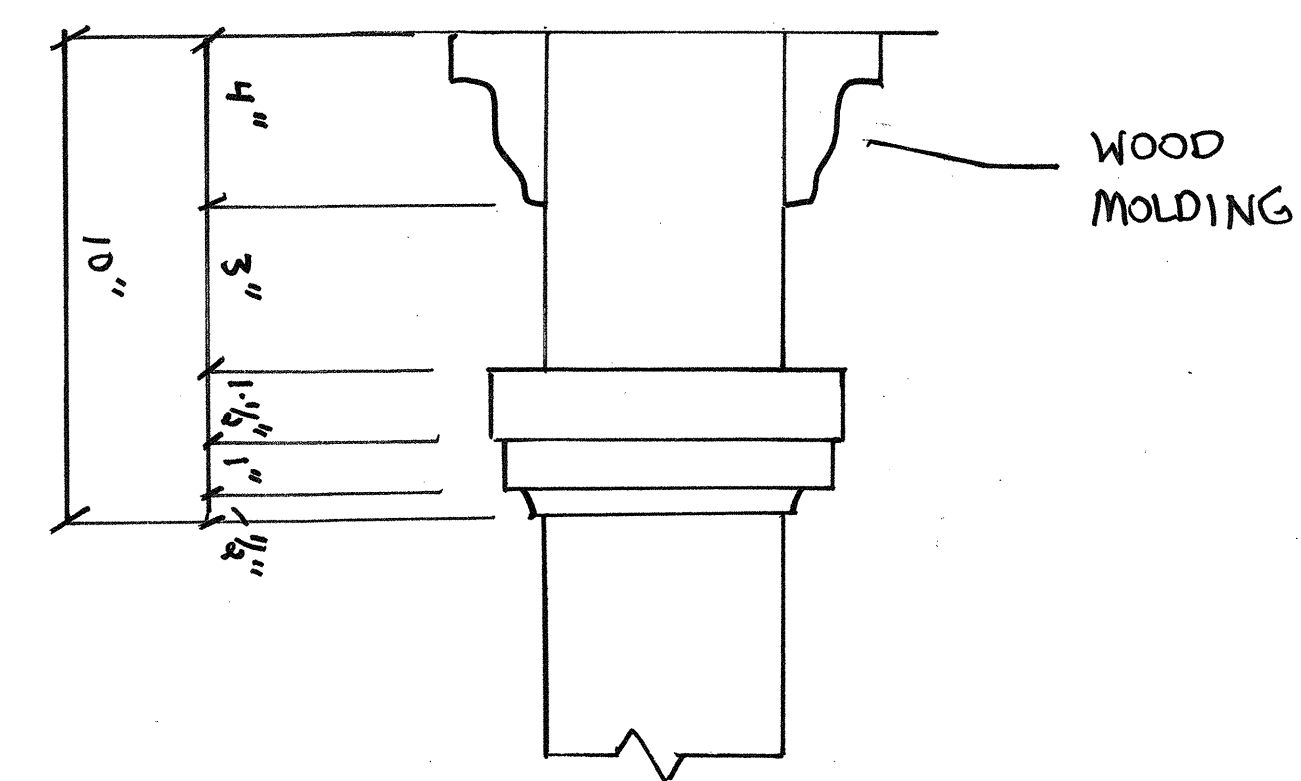
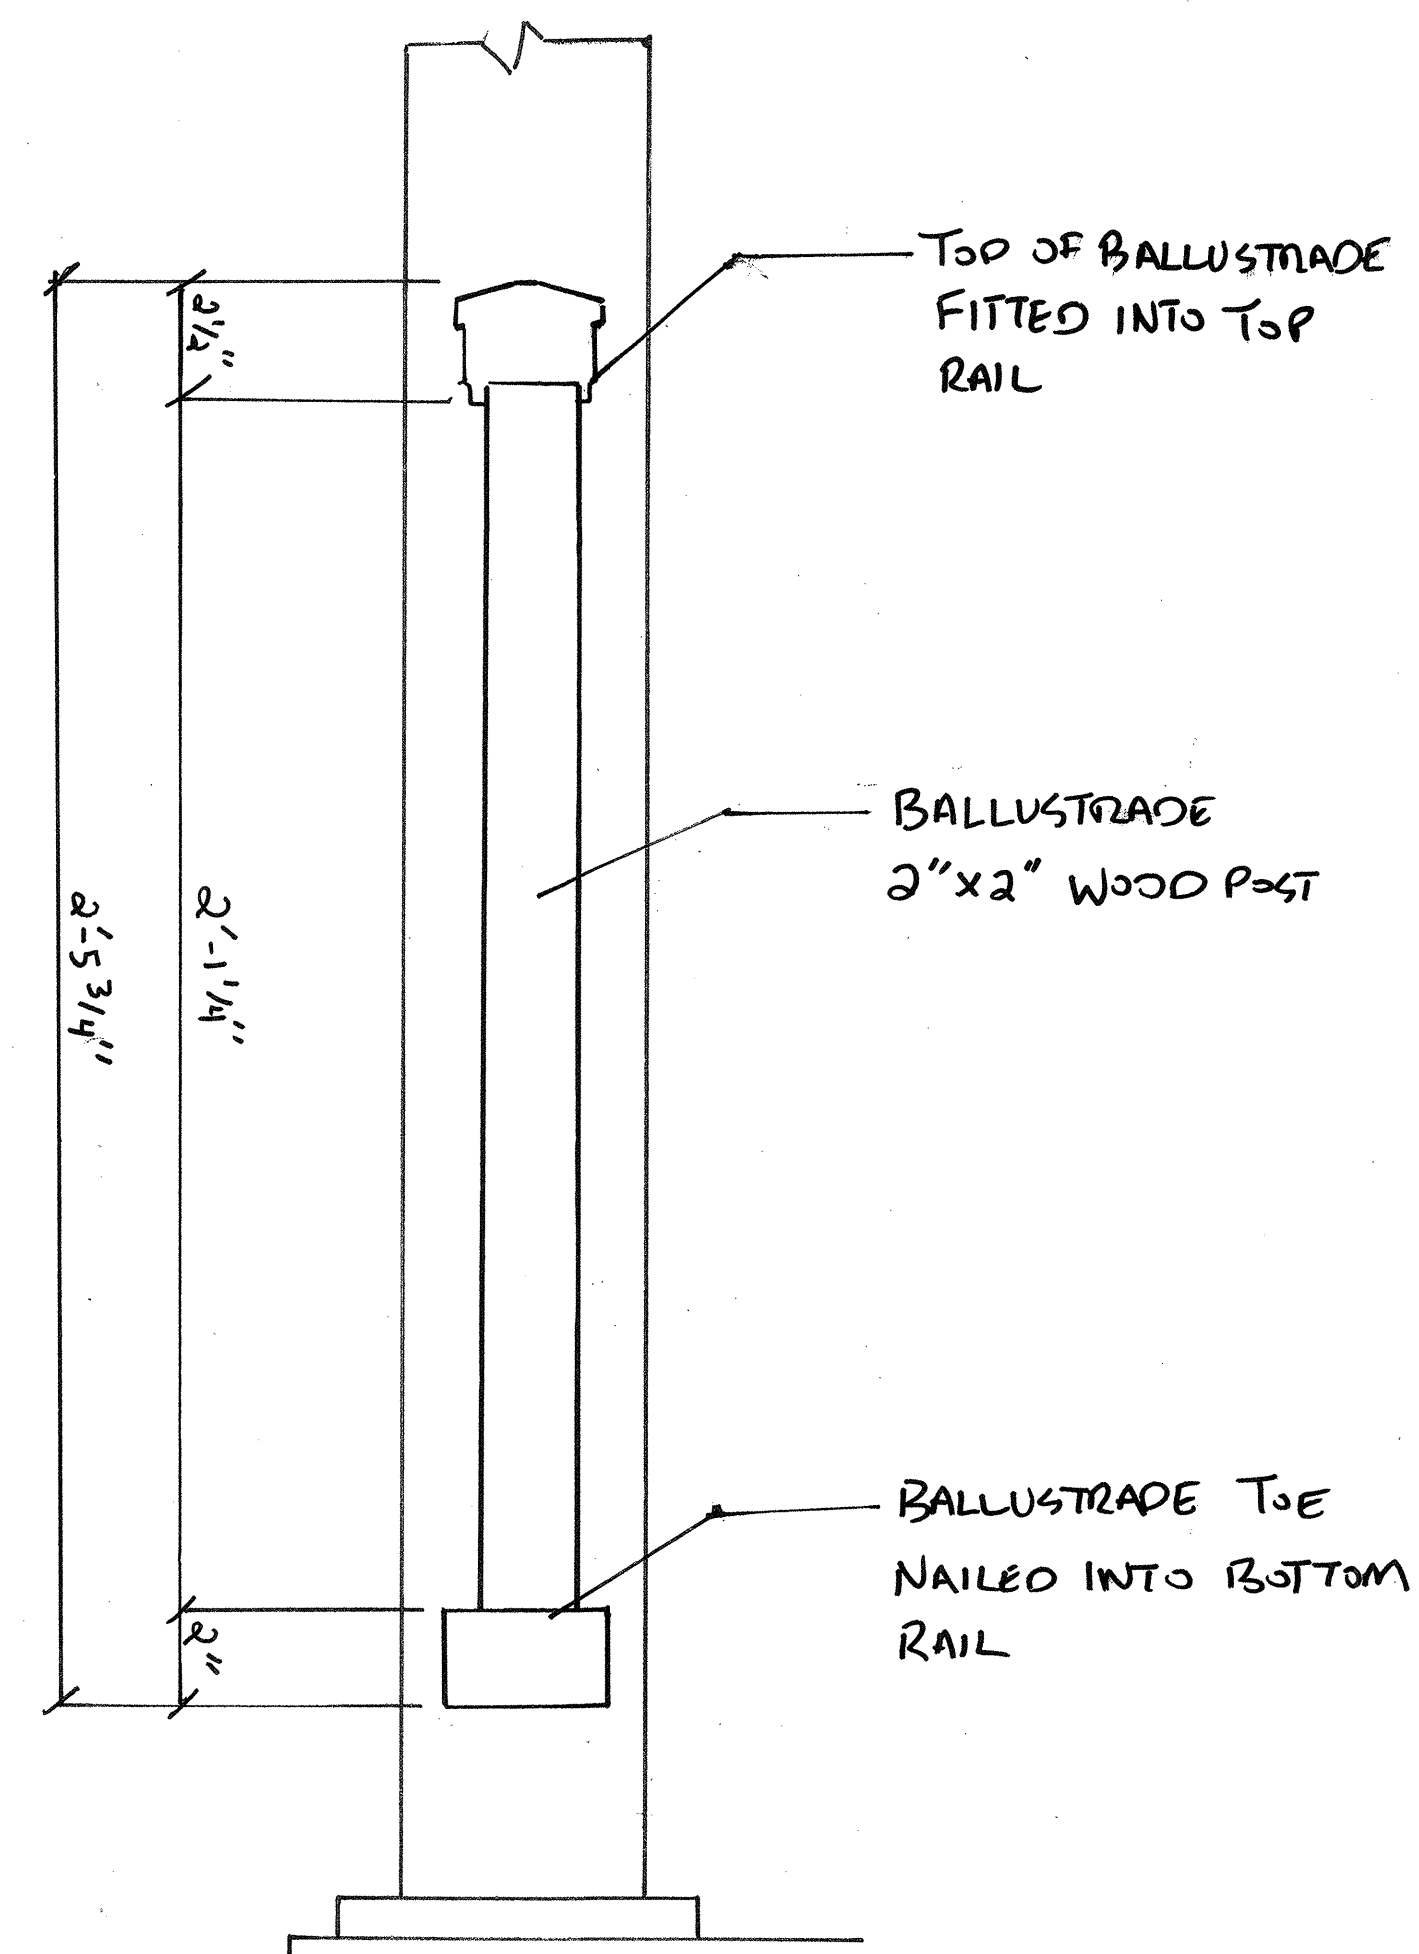
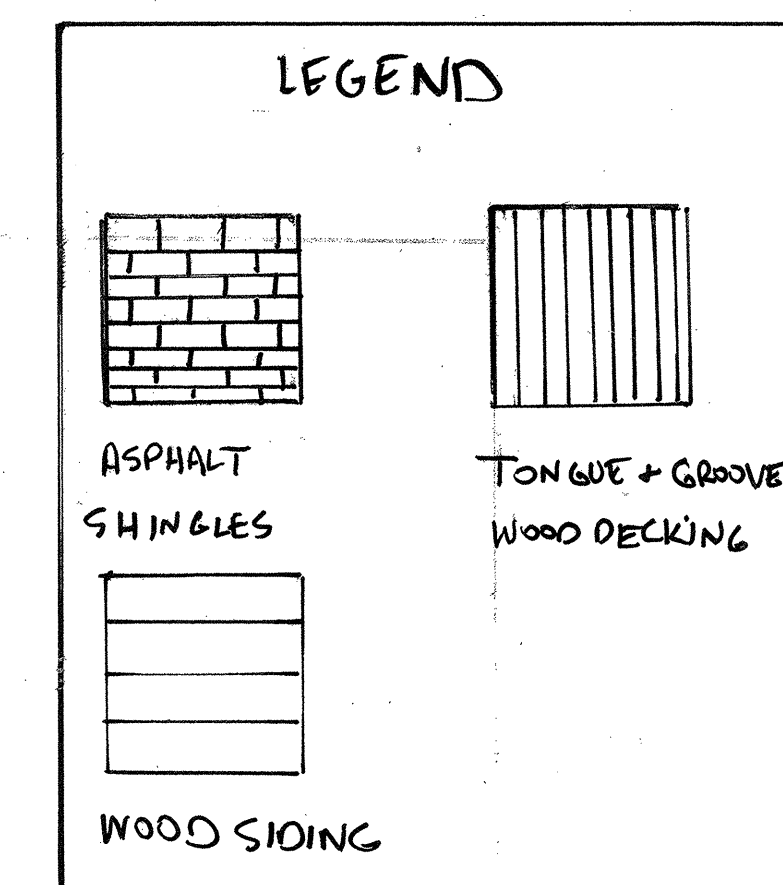
SIDE PORCH DETAIL 2ND FLOOR  
SCALE 3/4" = 1'

PORCH FLOOR IS AT AN ANGLE TO ALLOW FOR WATER RUNOFF

PORCH CEILING HAS WOOD BAT FROM WATER LEAK
