| JAMES LIPHUS WARD<br>SC RLA | | <b>GLEBE STREET RESIDENCES</b> | |
| COLLEGE OF CHARLESTON<br>HPCP 299-SPRING 2010<br>HISTORIC PRESERVATION &<br>COMMUNITY PLANNING | | DRAWING TITLE:<br><b>14 GLEBE STREET</b><br><b>Floor Plan</b><br>DRAWING PREPARED BY (TEAM/INDIVIDUAL):<br><b>TEAM: Galtor Frick Voneshatz</b> | |

| JAMES LIPPHUS WARD<br>SC RLA | | GLEBE STREET RESIDENCES | |
| COLLEGE OF CHARLESTON<br>HPCP 209-SPRING 2010 | | DRAWING TITLE:<br>14 GLEBE ST<br>ELEVATIONS | |

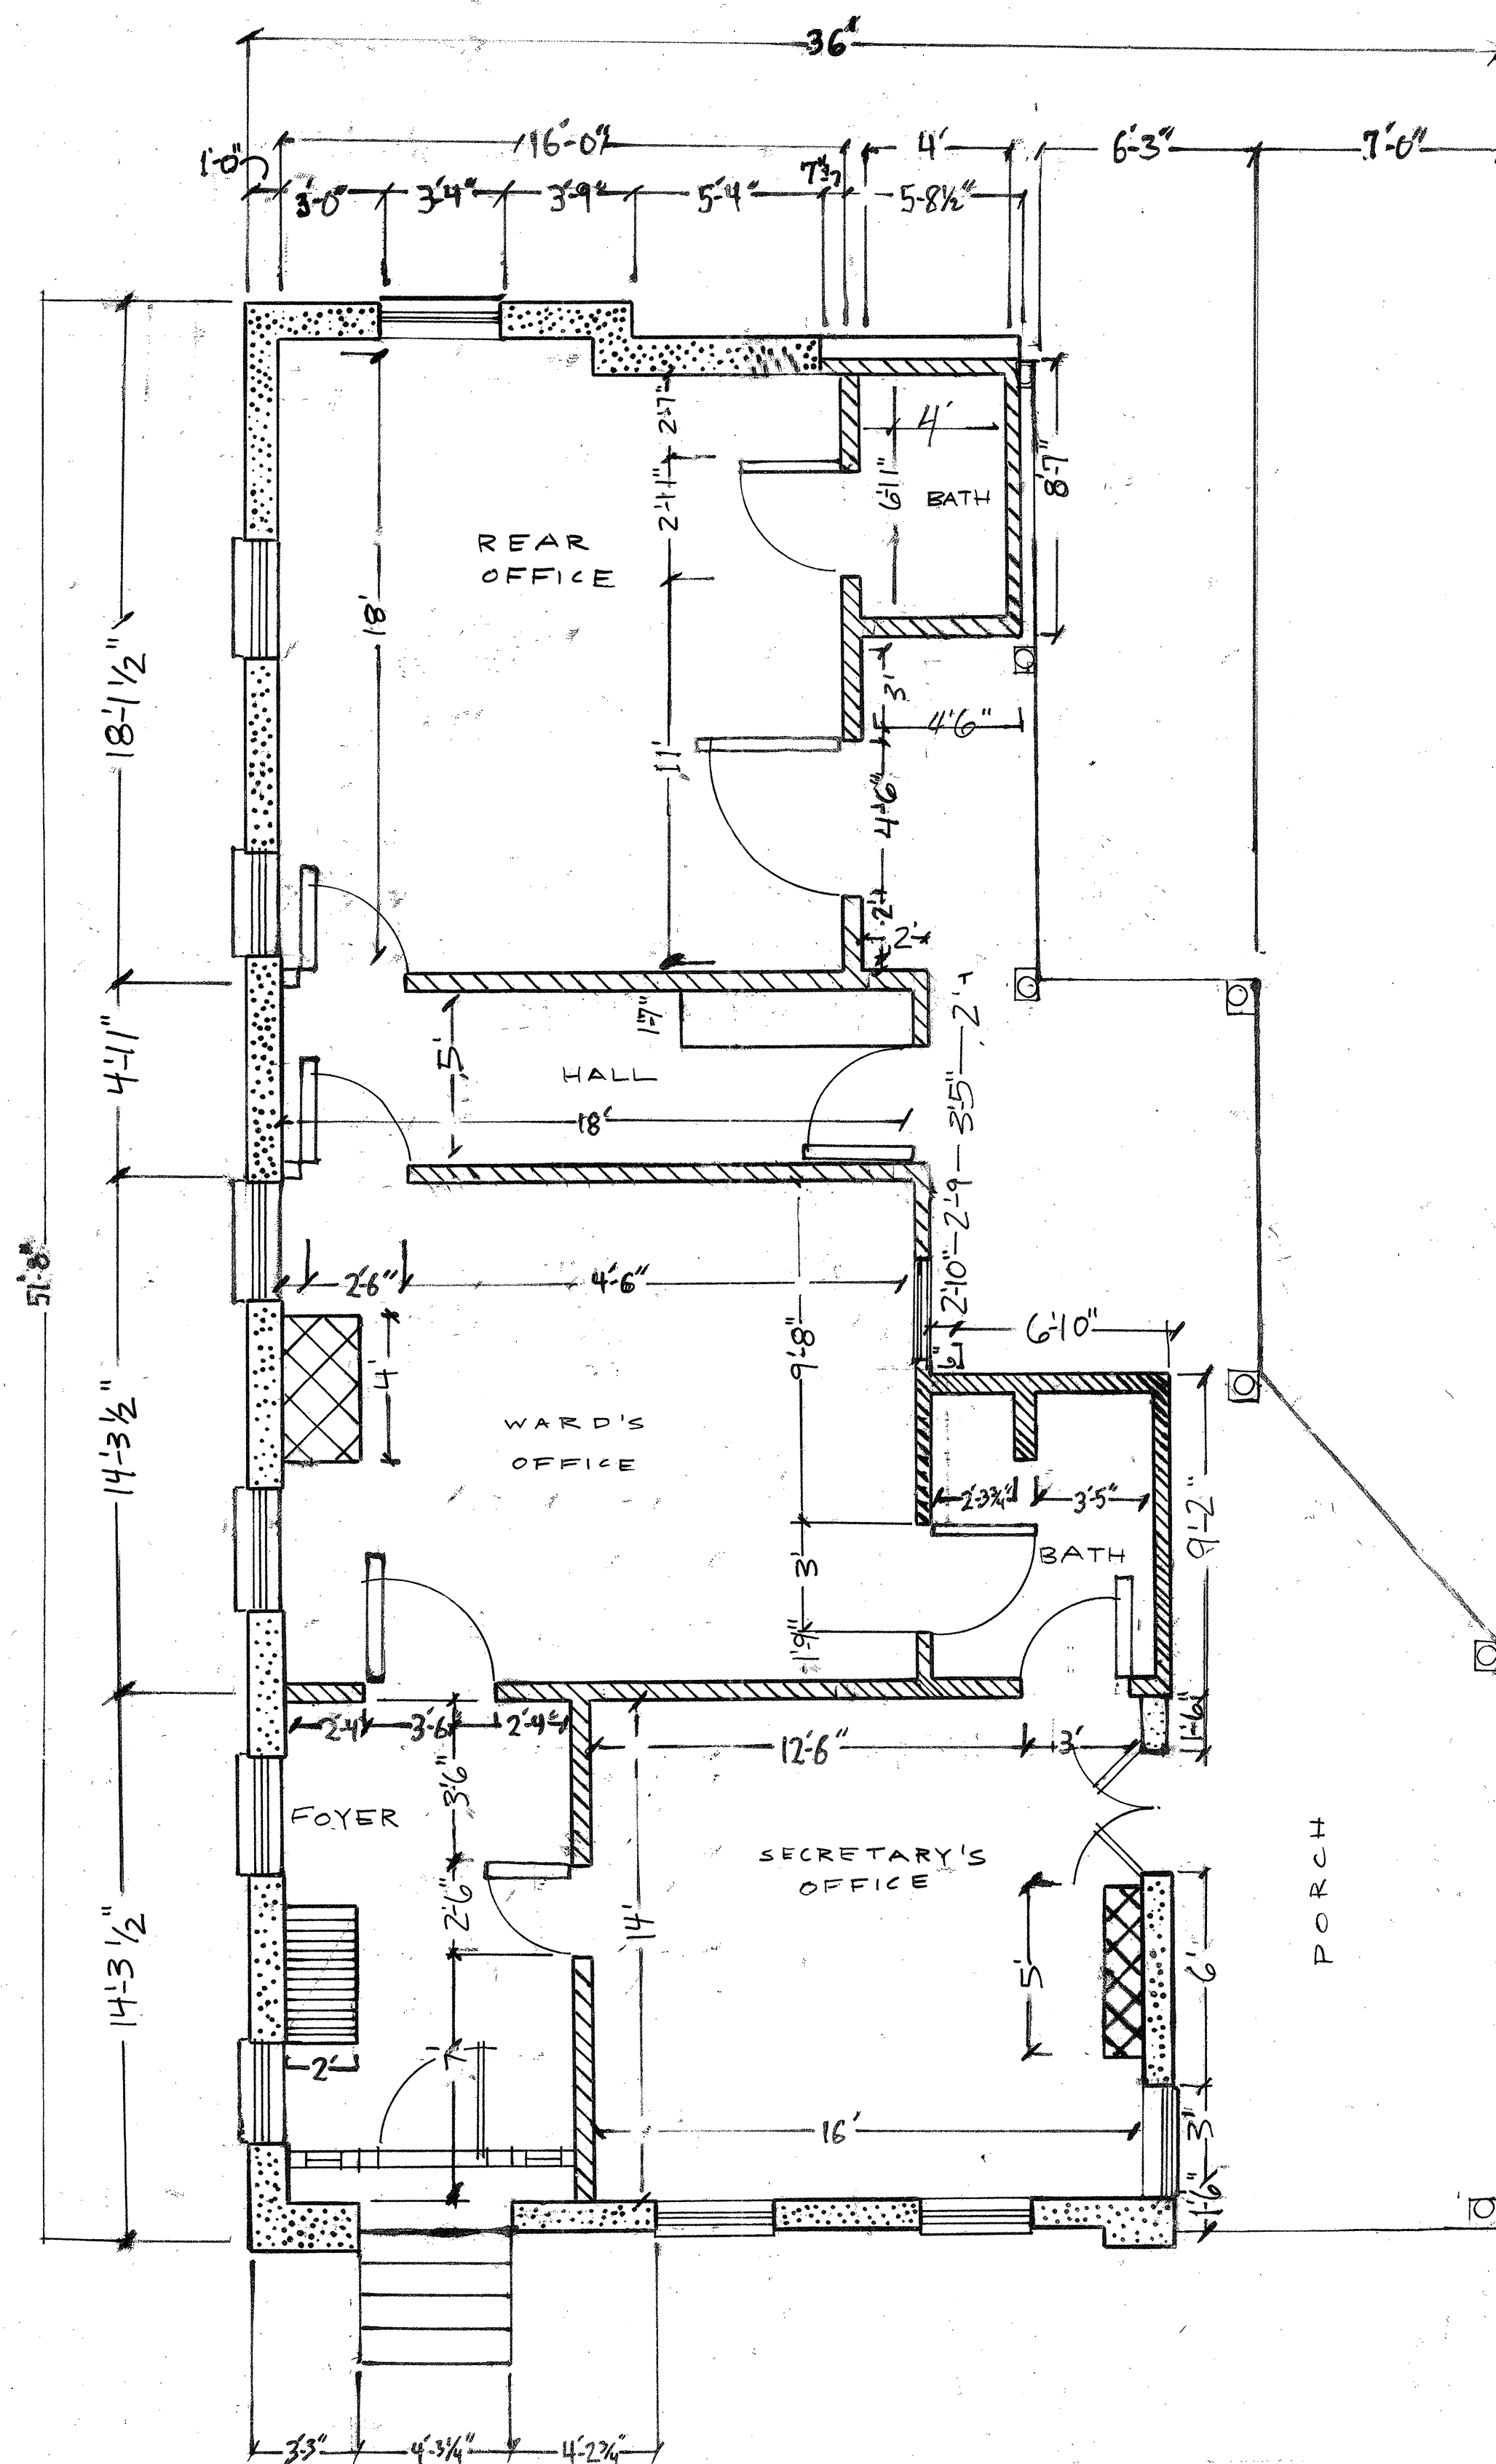
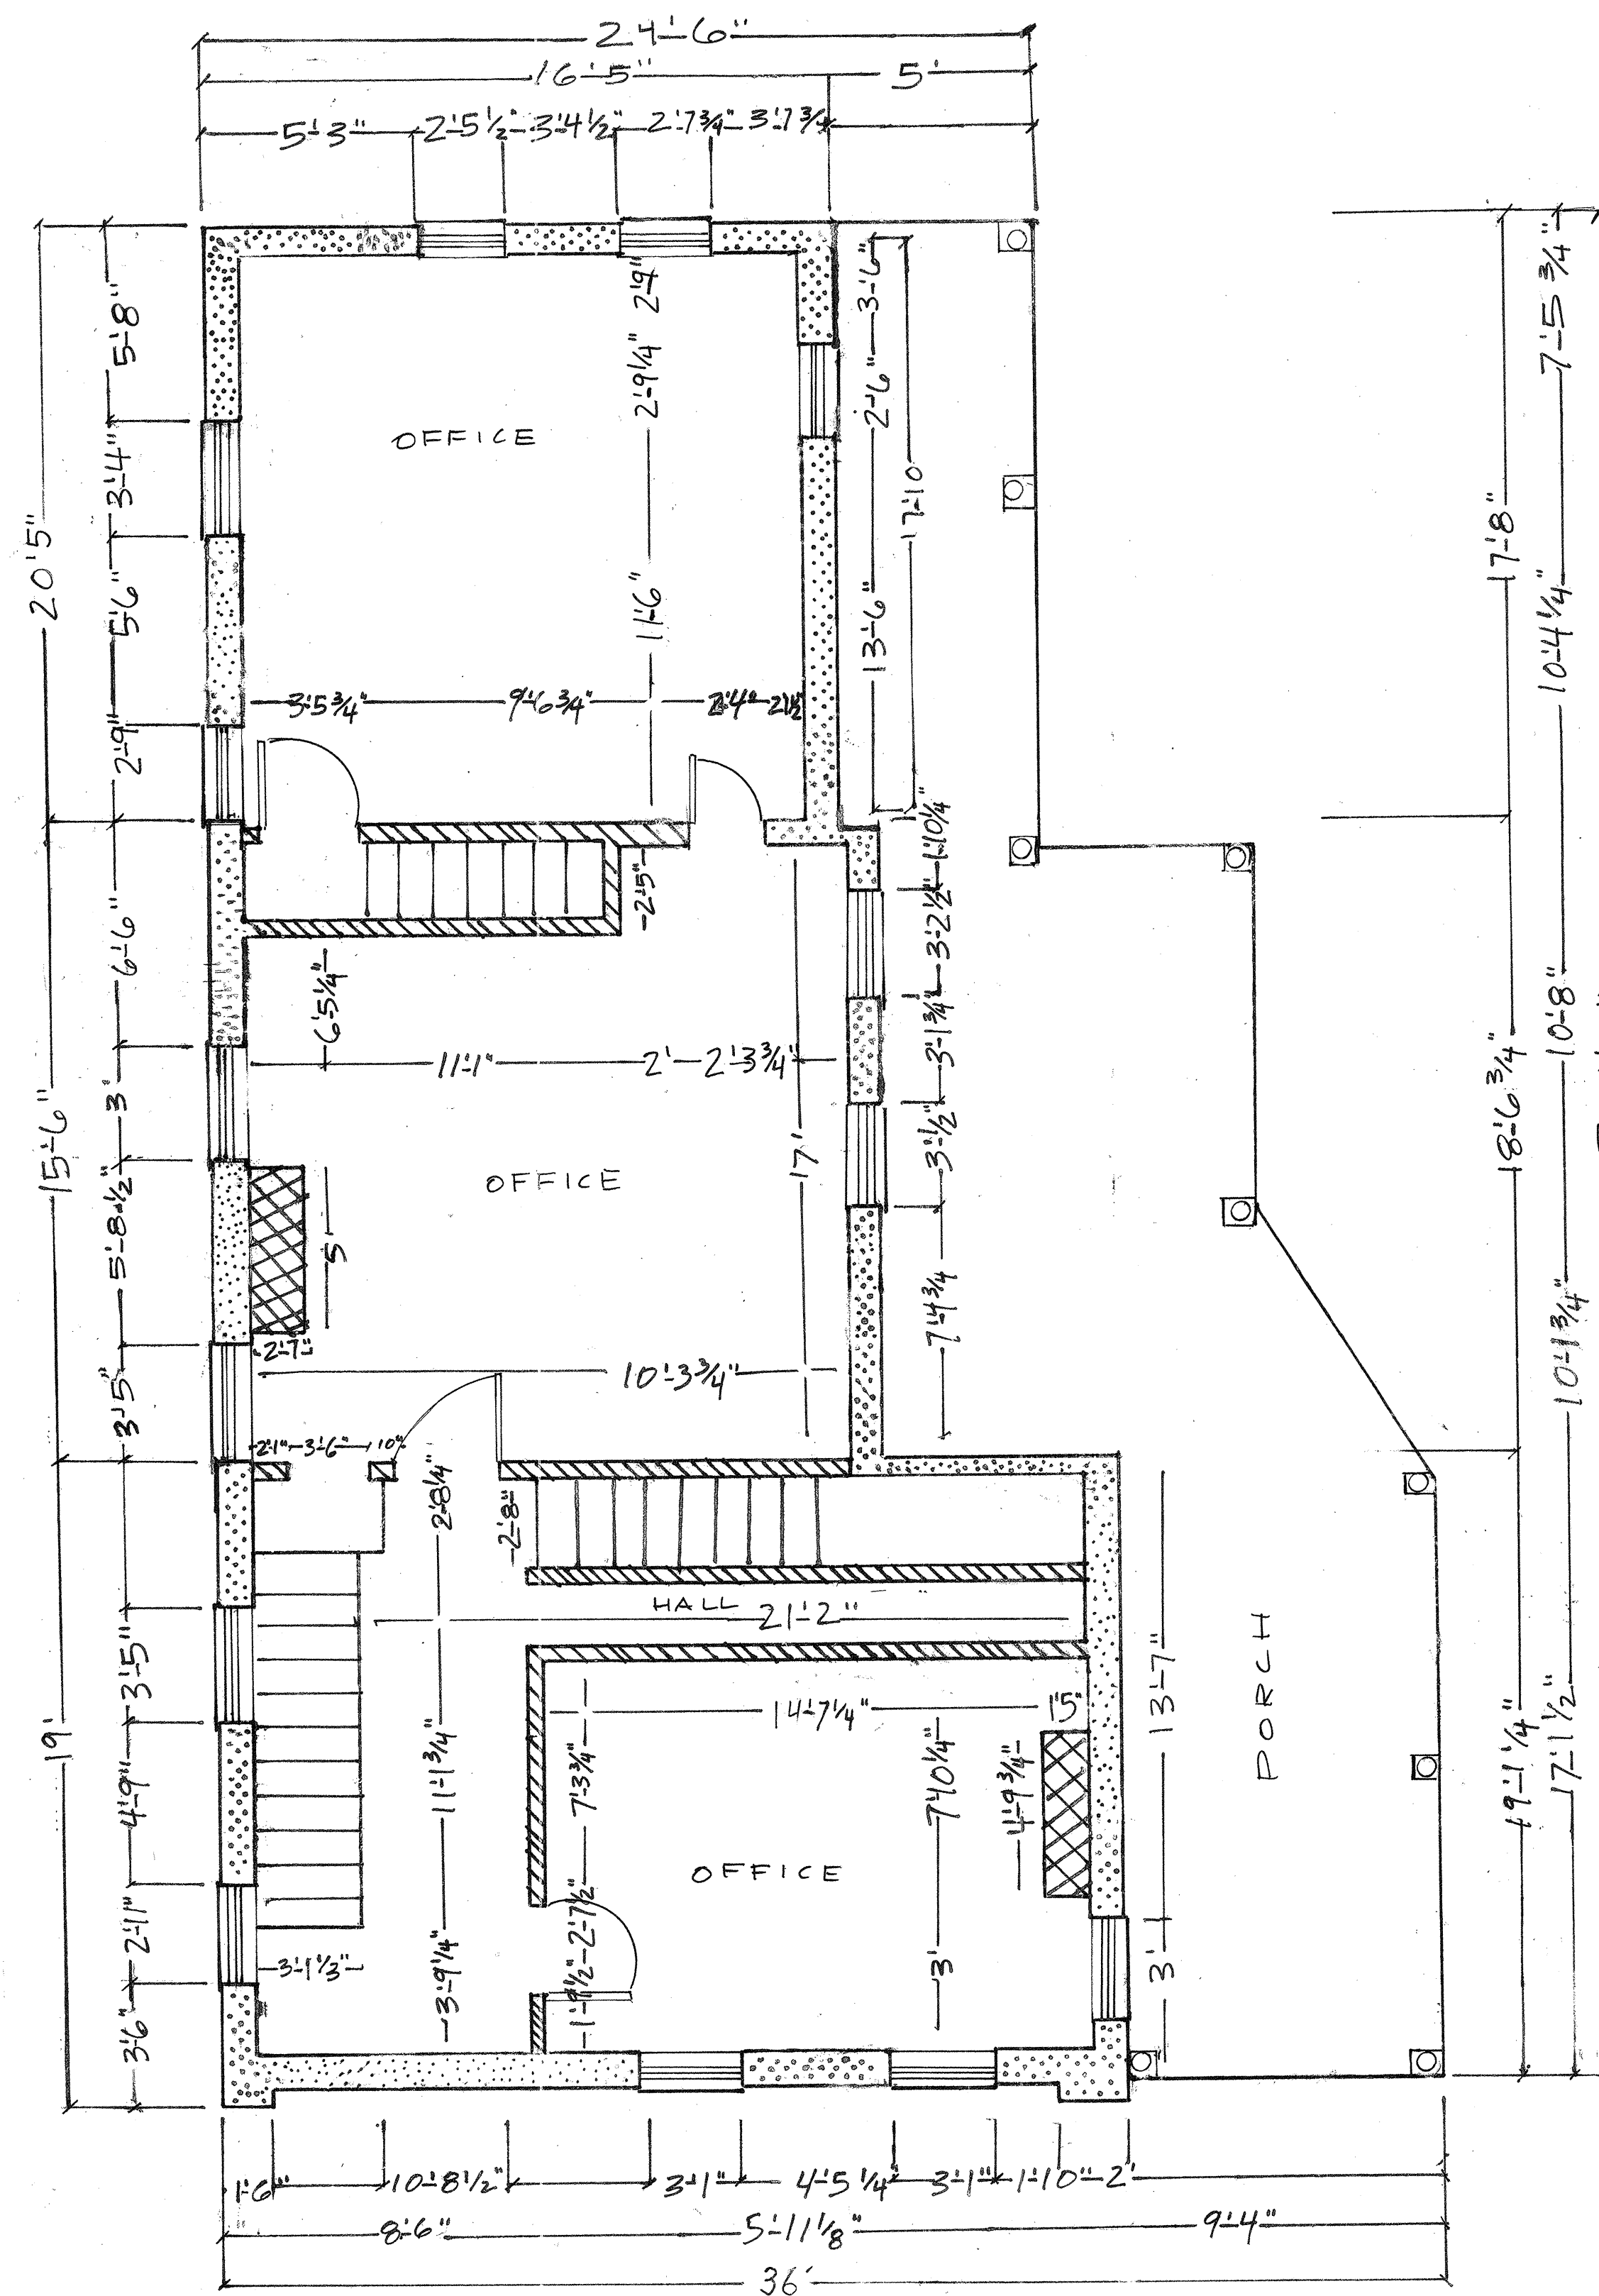
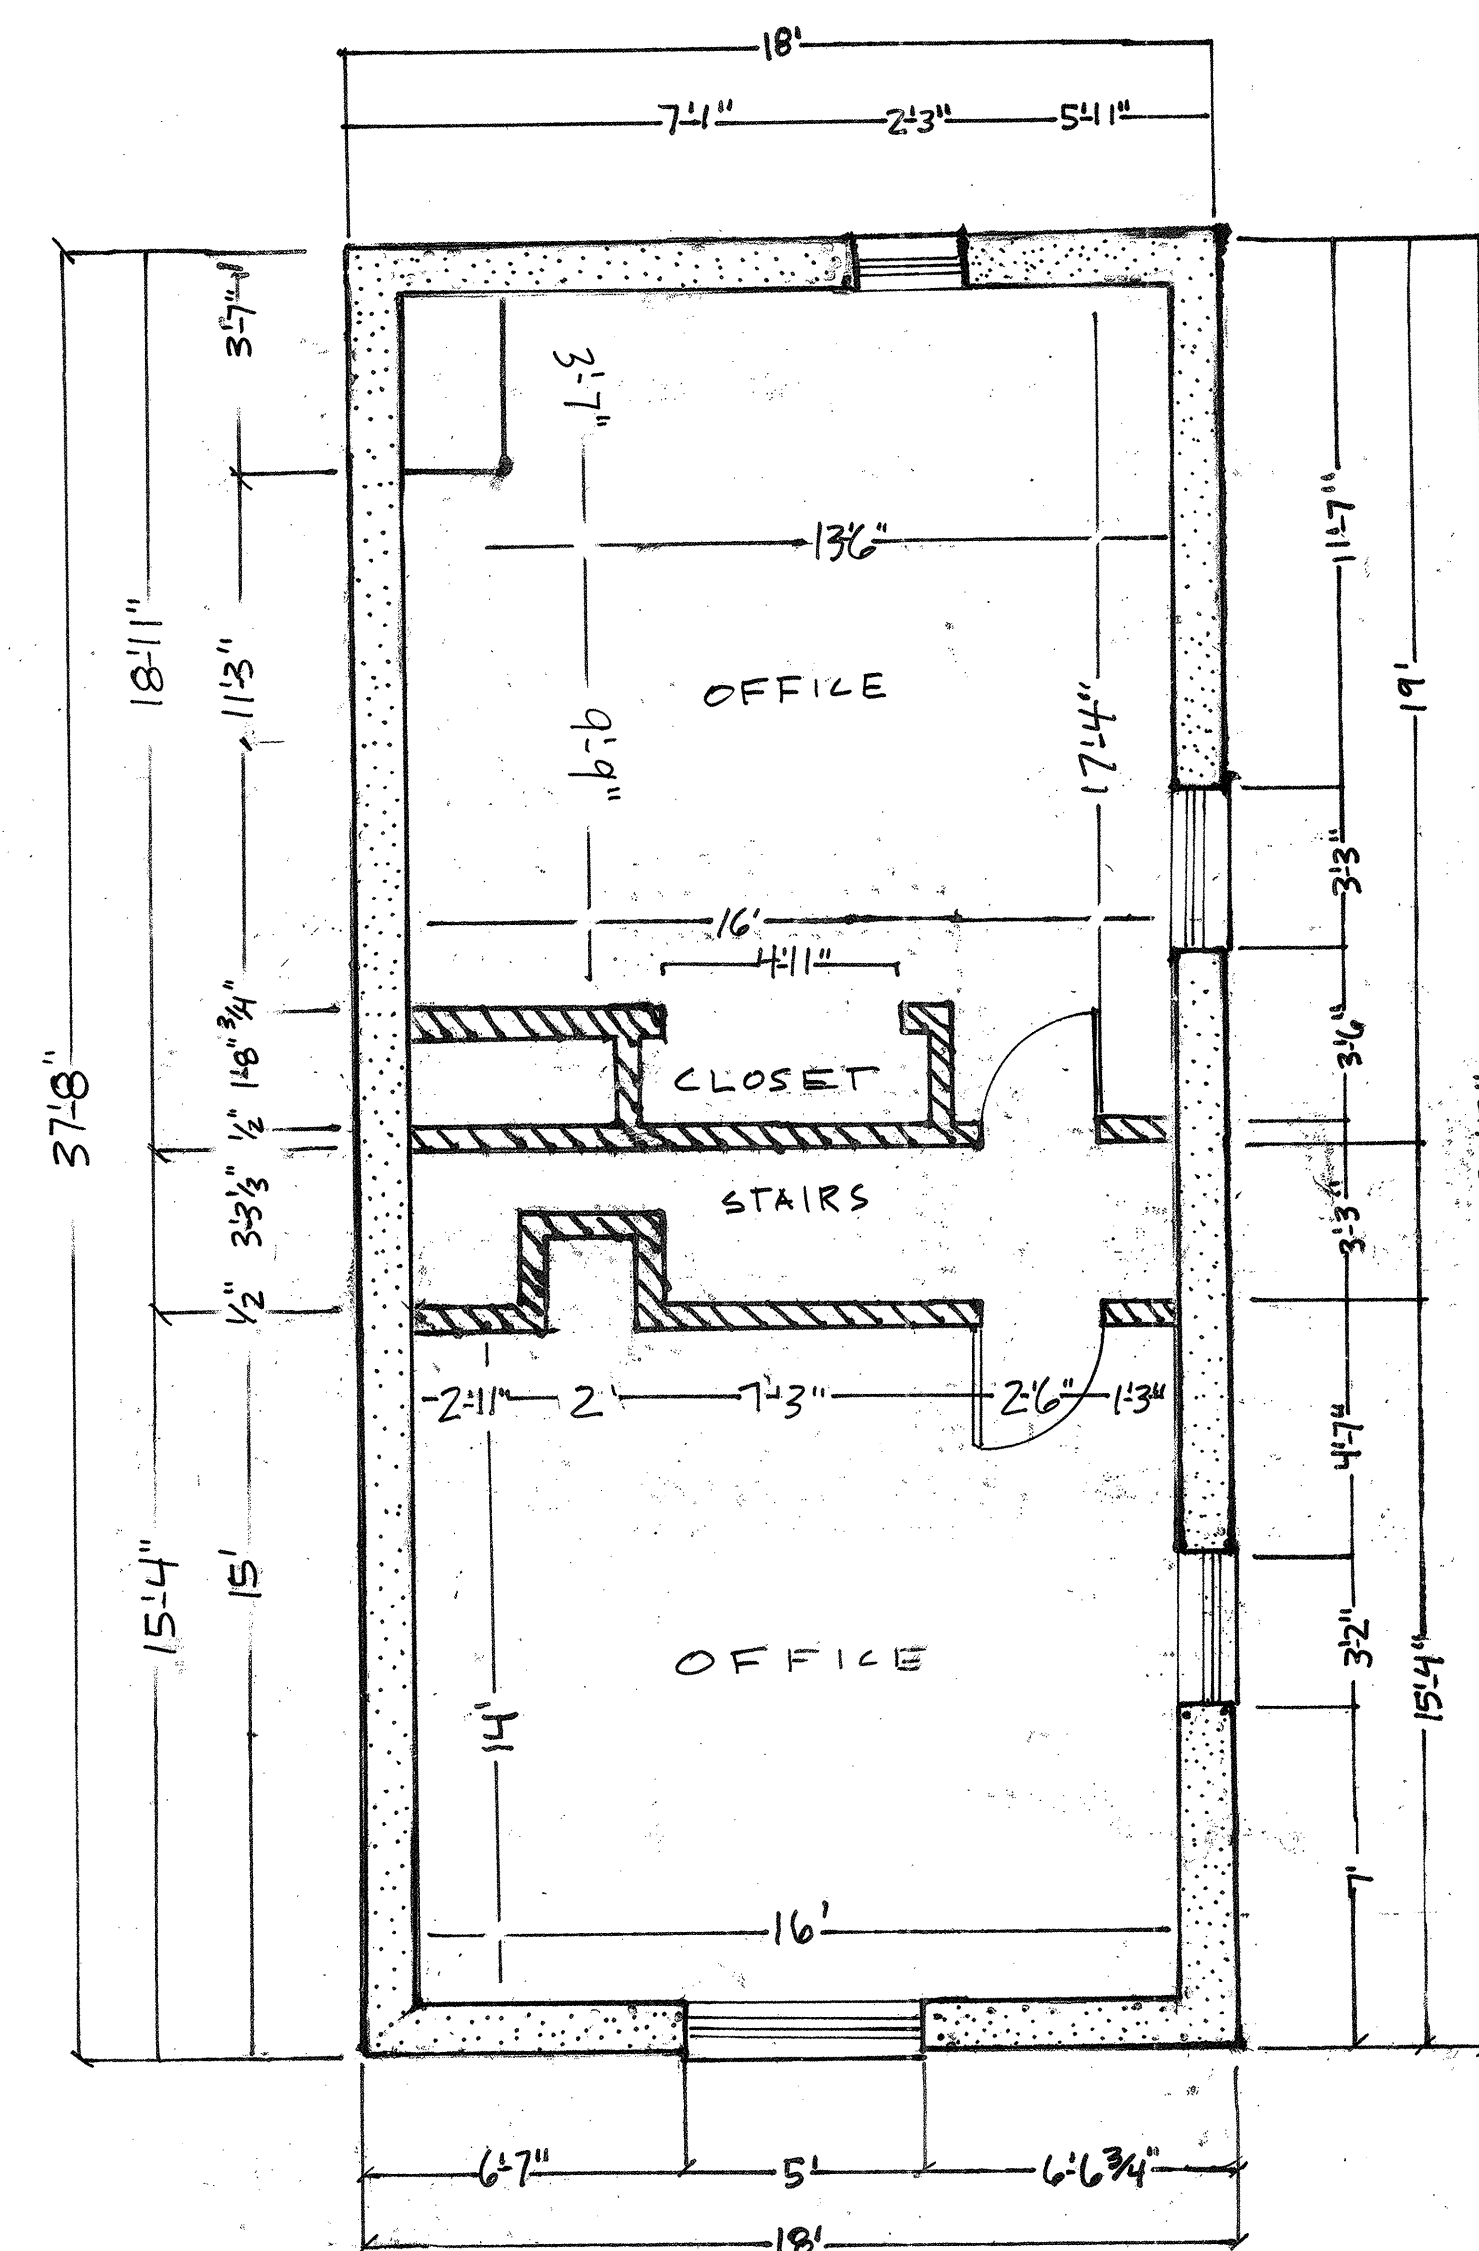
NOTES:  
 ① PORCH FLOORING AND COL-UMNS ARE PINEWOOD  
 ② MEASURED VERTICAL LINES WITH TRANSIT AND BY COUNTING STUCCO LINES  
 ③ FIREPLACES HAVE BEEN CLOSED OFF  
 ④ MASONRY WITH A NATURAL CEMENT STUCCO  
 ⑤ DOOR JAMBS EXPOSE SEVERAL LAYERS OF PAINT  
 ⑥ MOST FLOORING OF INTERIOR FLOORING IS COVERED WITH INDUSTRIAL CARPET

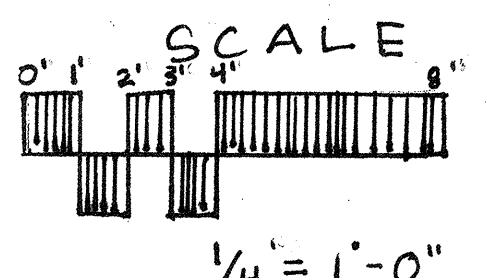
# WEST ELEVATION

NOTES:  
 ① STRUCTURE IS MASONRY COVERED IN STUCCO (POSSIBLY NATURAL CEMENT)  
 ② BUILT ON BRICK PIER FOUNDATION  
 ③ HVAC ARE LOCATED IN CRAWL SPACE  
 ④ ALL MEASUREMENTS FOR WINDOWS AND DOORS ARE FRAME TO FRAME  
 ⑤ ROOF CONSTRUCTION IS SLATE  
 ⑥ TOP OF ROOF IS LINED WITH TERRACOTTA  
 ⑦ SLATE SHINGLES ARE 9" TALL  
 ⑧ ROOF MEASURED BY SHINGLE COUNT  
 ⑨ ROOF HAS ISSUES WITH FLASHING AND IMPROPER INSTALLATION OF MATERIALS

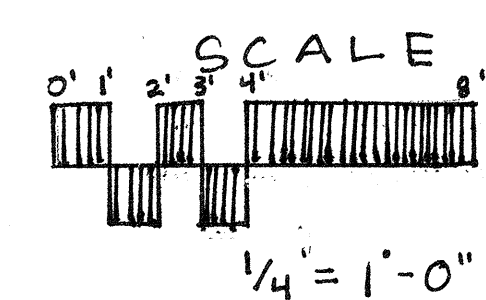
# SOUTH ELEVATION

NOTES:  
 1. STRUCTURE IS MASONRY COVERED IN STUCCO (POSSIBLY NATURAL CEMENT)  
 2. BUILT ON BRICK PIER FOUNDATION  
 3. HVAC ARE LOCATED IN CRAWL SPACE  
 4. ALL MEASUREMENTS FOR WINDOWS AND DOORS ARE FRAME TO FRAME  
 5. ROOF CONSTRUCTION IS SLATE  
 6. TOP OF ROOF IS LINED WITH TERRA COTTA  
 7. SLATE SHINGLES ARE 9" TALL  
 8. ROOF MEASURED BY SHINGLE COUNT  
 9. ROOF HAS ISSUES WITH FLASHING AND IMPROPER INSTALLATION OF MATERIALS

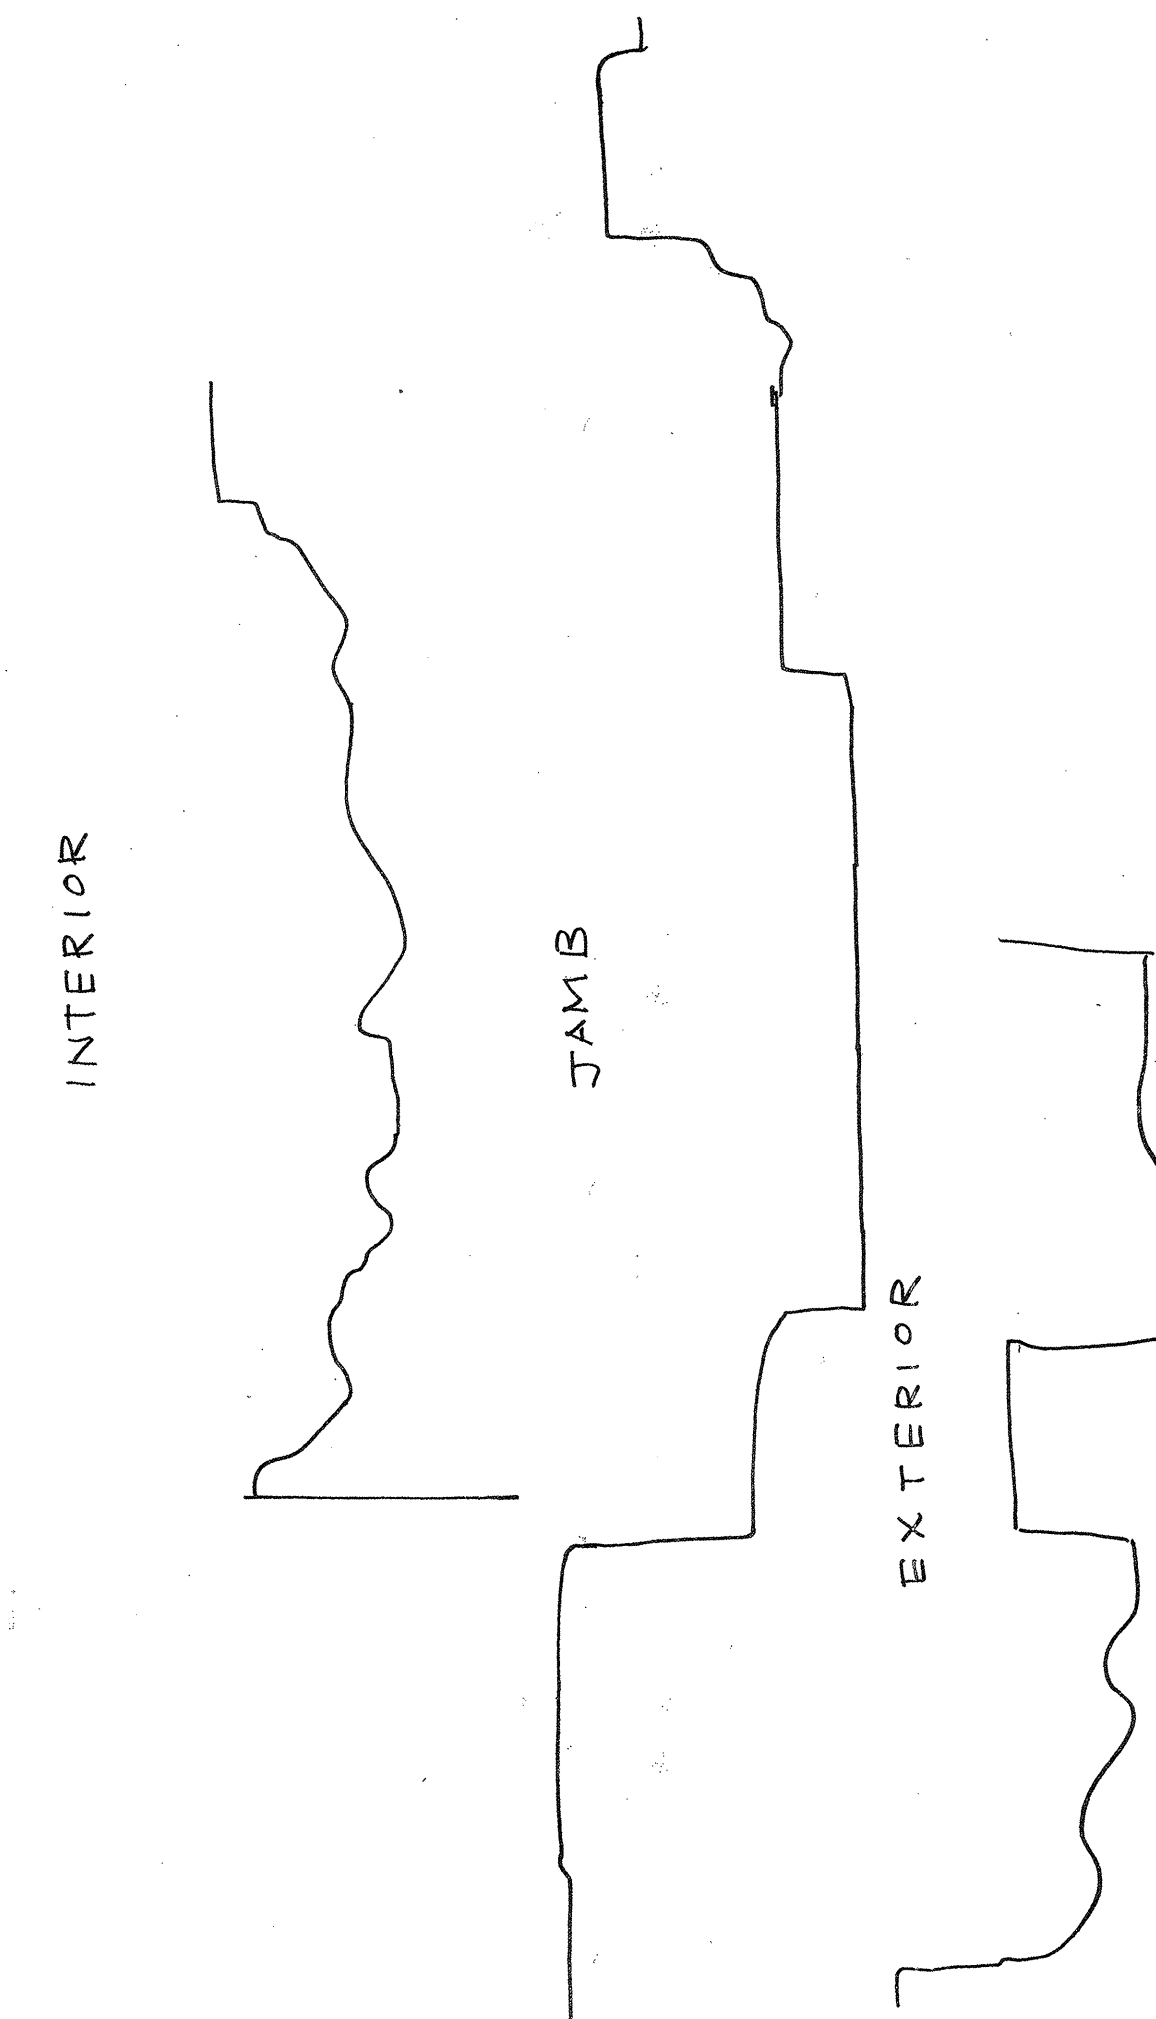
MOLDINGS  
FULL SCALE

NOTES:  
 ① THE ORIGINAL DOOR HAS BEEN REMOVED AND REPLACED BY A GENERIC DOOR.  
 ② CURRENT DOOR HAS BEEN RECESSED DEEPER INTO LOGGIA.  
 ③ THE GLASS ETCHING OVER THE DOOR IS ORIGINAL.  
 ④ STEPS ARE MARBLE.  
 ⑤ MARBLE IS CHIPPED AND CRACKING.  
 ⑥ CRACKING SHOULD BE STABILIZED TO PREVENT FURTHER DAMAGE.  
 ⑦ THE MOLDINGS AND HARDWARE ARE NOT ORIGINAL.
